## **Crash of American Airlines Boeing [December 29, 1995, mountainous terrain near the Cali Airport, Colombia]**

Masayuki Nakao

Institute of Engineering Innovation, School of Engineering, the University of Tokyo

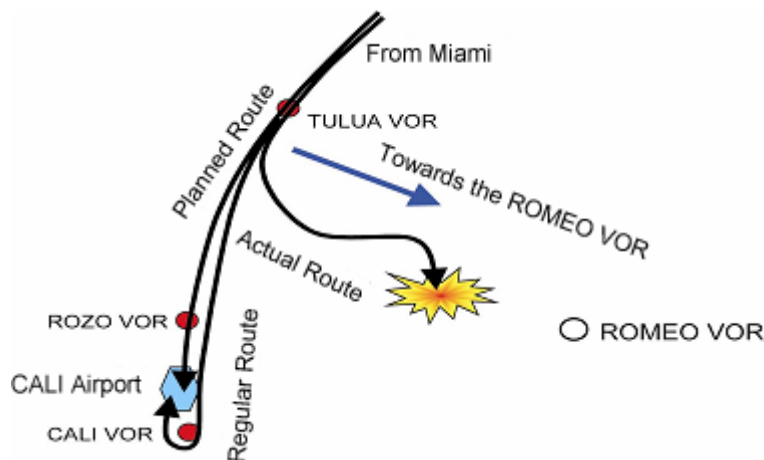
The normal approach route to Cali flies the plane from Tulua VOR (note 1), about 57km north of Cali (Alfonso Bonilla Aragon) Airport, towards Cali VOR, about 14km south of Cali Airport, and lands it at Cali Airport by curling North, however, it could alternate to pass ROZO VOR about 17km north of the Cali Airport and directly land at Cali Airport from Tulua VOR by the ROZO One approach route. Flight 695 decided to take the ROZO One approach route from Tulua VOR, but decided to go directly to ROZO VOR because it had already passed Tulua VOR. In the course of changing the route, a crewmember input "R", for ROZO VOR (ROZO), which was a waypoint of the route after the change, into the FMS (a flight control unit). Then flight 695 deviated to left from the course and was lost in the Andes. The captain who noticed that the course deviated to the left told the copilot to turn right, but the plane had already strayed into the mountainous terrain and GPWS (note 2) began to sound about 1 minute later. The sound of GPWS upset the crew who tried to gain elevation without closing the flight flaps that were activated for a nosedive landing. Although the crew increased the engine power to maximum, the plane crashed while grazing the mountaintop without rising (cf. figure 2).

The plane crashed in near the mountaintop 33 miles northeast from Cali VOR. It was 10 miles away from the usual course, and at an altitude of 8,900 feet (altitude of Cali is 3,153 feet).

Figure 2. the planned course and actual course of AA Flight 695

When a crewmember changed the approach course to the airport to regain a delay in schedule, he input only "R" instead of "ROZO on a computer.

The FMS misjudged the R with instruction to go to the capital Bogotá that had higher frequency of use than that of ROZO (FMS was programmed to choose a course of higher frequency of use when there were other way points that had the same initial nearby).

Because the crew completely depended the course change on the computer without noticing the choice of FMS and did not attempt to grasp the position by themselves, the airplane continued its descent. Due to the steep topography of the Andes around Cali, when the airplane missed the proper course and turned, it crashed into the mountains in the suburbs of Cali.
