Three Mile Island Nuclear Accident March 28, 1979 at Three Mile Island, Pennsylvania, USA

Masayuki Nakao (Institute of Engineering Innovation, School of Engineering, The University of Tokyo)

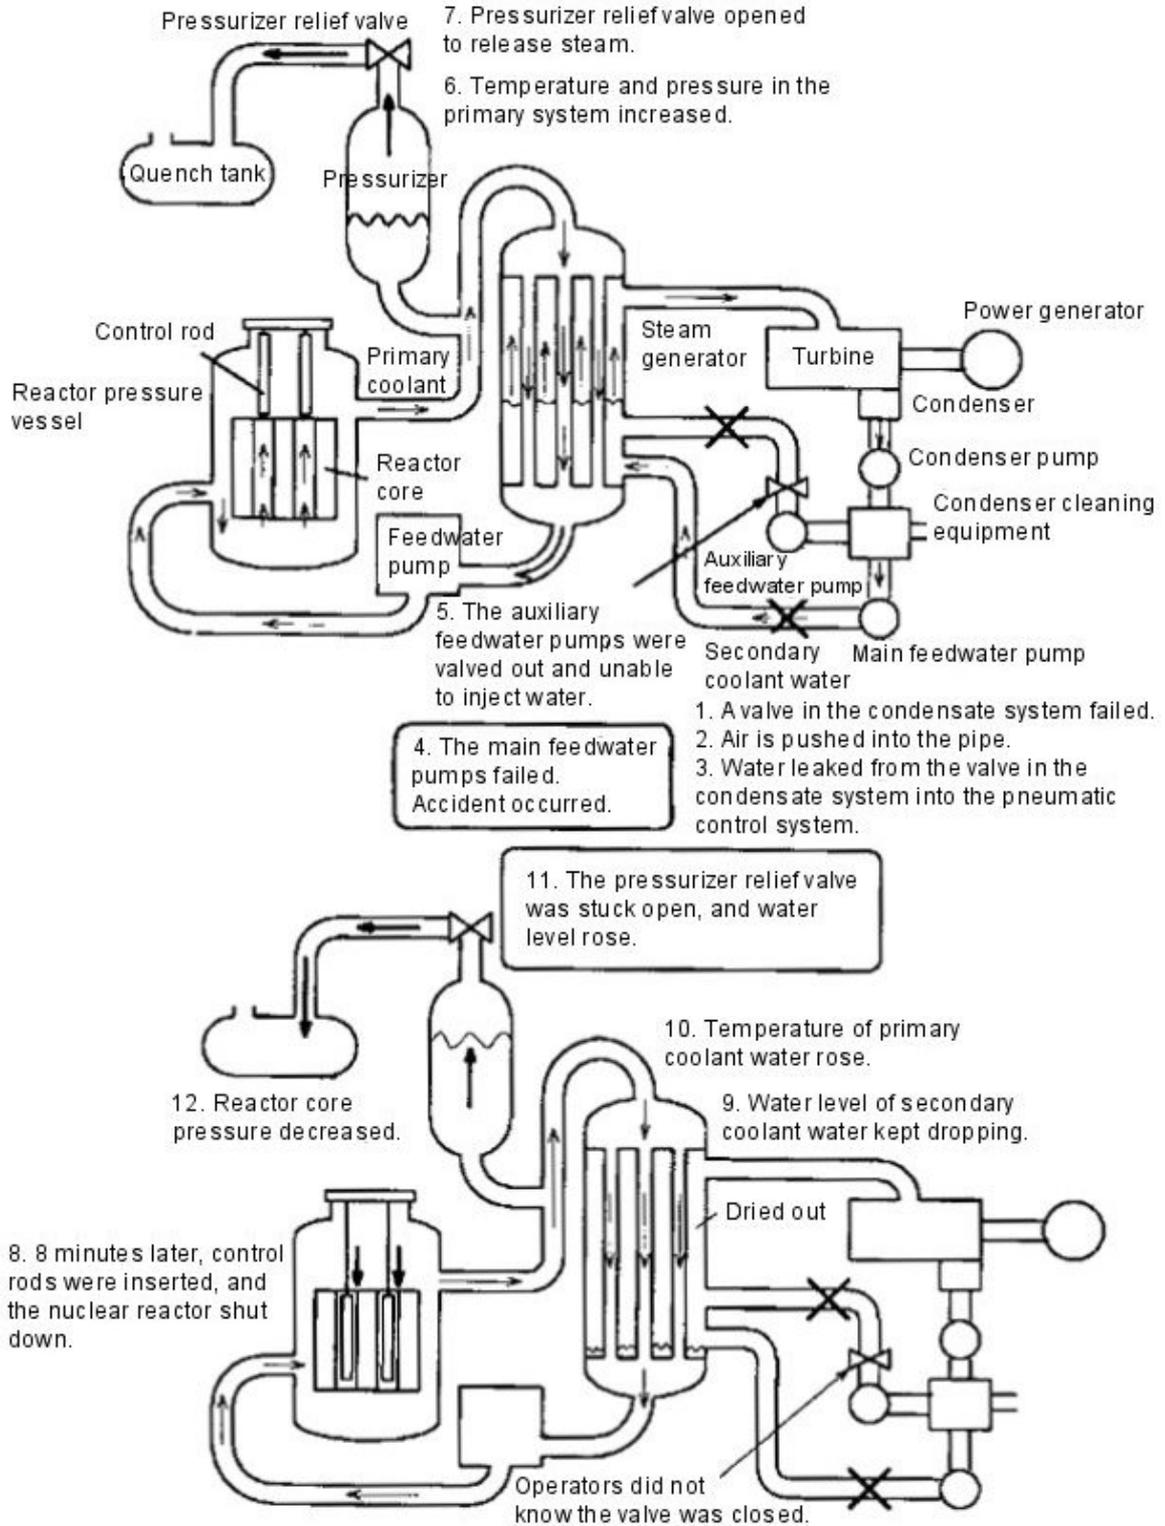
Figure 2. Three Mile Island Nuclear Accident: Sequence of Events 1 [1]

- (1) The Three Mile Island Generating Station had two pressurized water reactors. Unit 2 was rated at 959 MWe. The accident in the Unit 2 reactor began when the plant's main feedwater pumps in the secondary non-nuclear cooling system failed (4 in Figure 2). In response to the failure, the auxiliary feedwater pumps kicked in, however, the water did not reach the steam generator because the outlet valves were closed (5 in Figure 2). The valve was discovered closed about eight minutes into the accident. Responding to the increase in temperature and pressure in the primary system, the pressurizer relief valve automatically opened in the line between the pressurizer and the quench tank (7 in Figure 2). After the nuclear reactor automatically shut down (8 in Figure 2), pressure in the reactor dropped. The valve, which was supposed to close after the pressure dropped below the set-point for closure, failed to re-close (11 in Figure 2). The valve was left open for 2 hours and 20 minutes, leaking 80 ton of primary coolant water from the quench tank. At this point, over 100 warnings tripped in the control room causing a big panic.

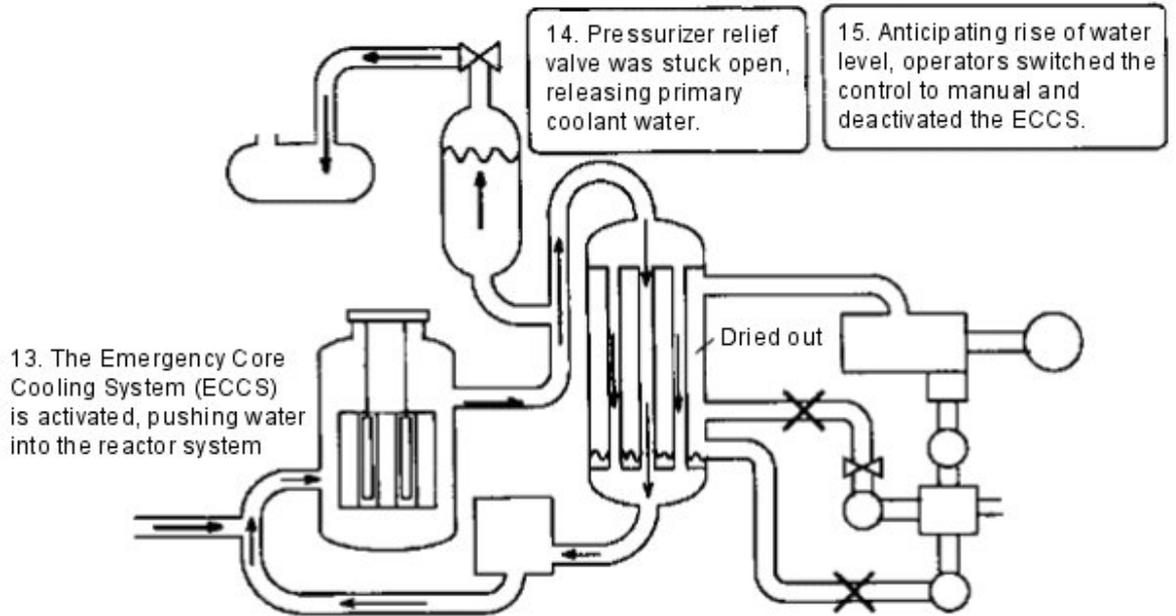
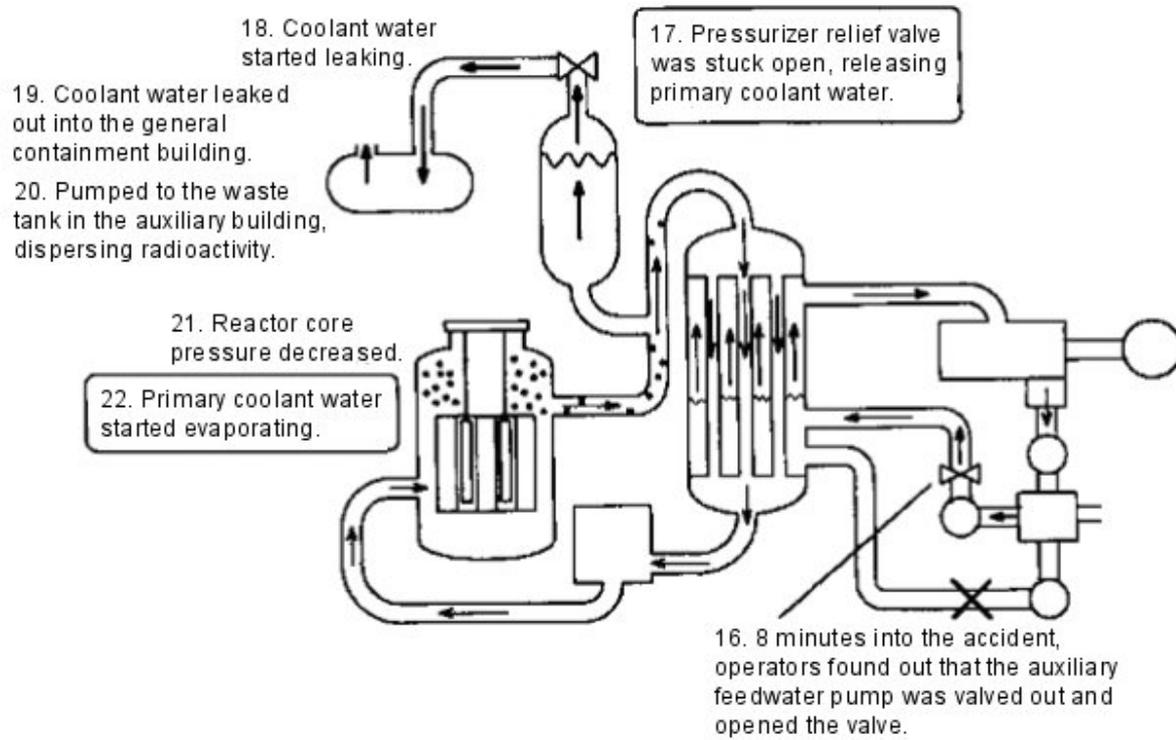
Figure 3. Three Mile Island Nuclear Accident: Sequence of Events 2 [1]

- (2) Pressure drop in the reactor caused the Emergency Core Cooling System (ECCS) to pour water into the reactor system at 4ton/min (13 in Figure 3). As water and steam escaped through the relief valves, coolant water surged into the pressurizer, raising the water level in it. Unaware of the stuck valve and the false indicator readings, operators manually turned off the ECCS (15 in Figure 3). Temperature rose, steam then formed in the reactor primary cooling system (22 in Figure 3). The pumping of the mixture of steam and water caused the reactor cooling pumps to vibrate, and the operators shut down the pumps to stop severe vibrations (24 in Figure 3). As the reactor cooling water boiled away, the top of the reactor core was exposed (26 in Figure 3).

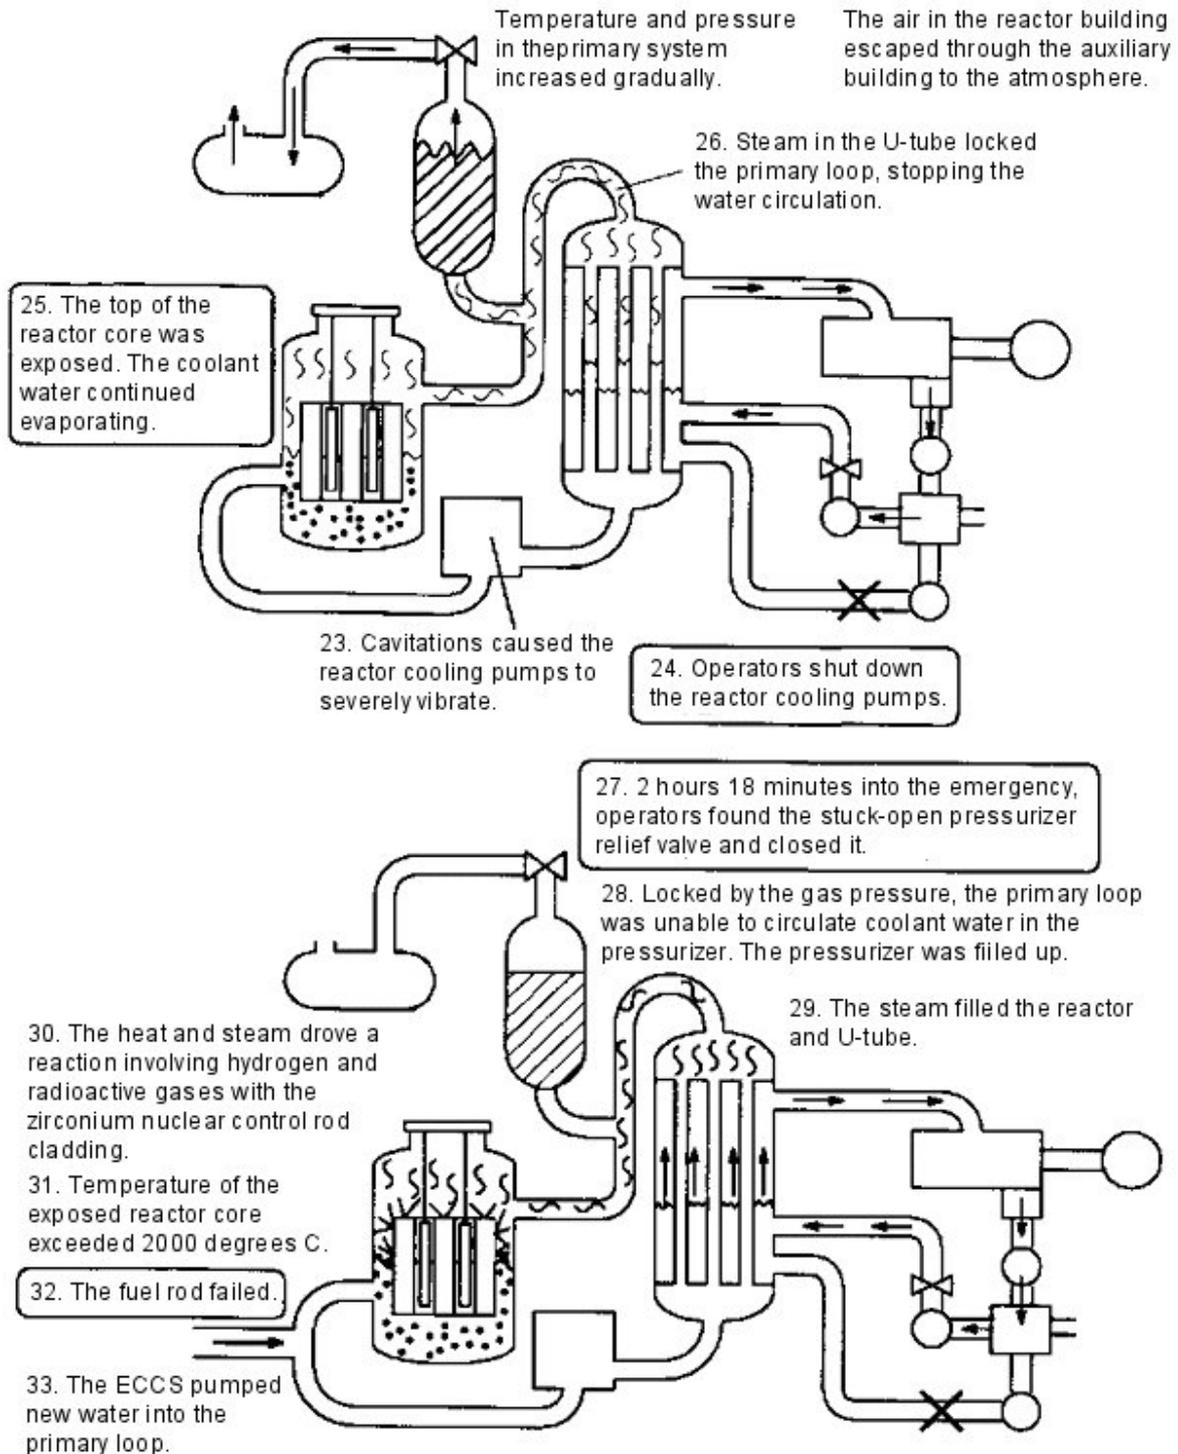
Figure 4. Three Mile Island Nuclear Accident: Sequence of Events 3 [1]

- (3) Coolant water stopped flowing into the pressurizer, the temperature in the primary system reached 2,000 degrees Celsius, and approximately 45% of the reactor core melted down (32 in Figure 4). The coated tubing and water reacted to generate hydrogen gas, and ten hours later, a hydrogen explosion occurred. Water from the pressure relief valves overflowed the quench tank (18 in Figure 4) and flooded the containment vessel floor. The floor pump sent the radioactive coolant to the auxiliary building ventilation system (20 in Figure 4) where the radioactivity escaped to the outside. Eventually, cooling water was added and the reactor (33 in Figure 4) which then started to cool with natural circulation,

however, hydrogen gas and radioactive gas kept generating and approximately 10 million curies of radioactive gas were released into the atmosphere by the event.
