Brittle Fracture of Turbine Rotor in Nagasaki **October 24, 1970 in Nagasaki-shi, Nagasaki**

Masayuki Nakao (Institute of Engineering Innovation, School of Engineering, the University of Tokyo)

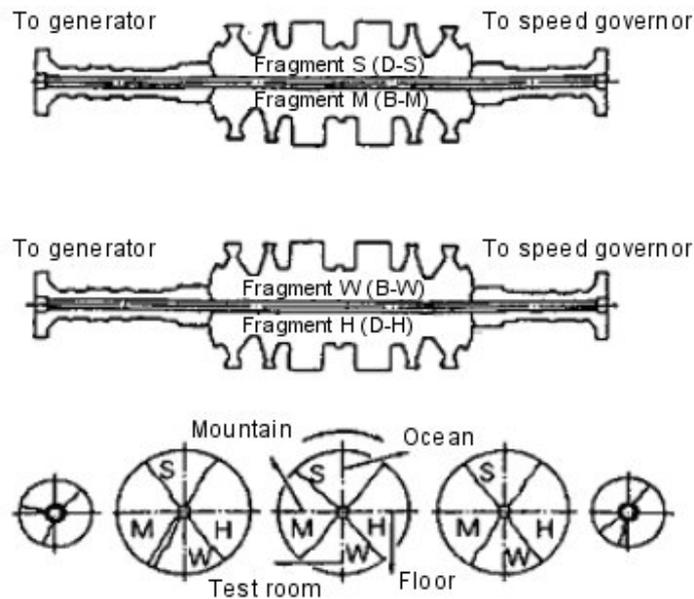
Figure 2. Fractured Turbine Rotor [1]

A brittle fracture occurred in the rotor when the turbine speed was increased to 3,540 rpm, 118 percent of the maximum rotational speed. No abnormal blade shaft vibration was monitored during the test prior to the rotor fracture under the test temperature of 40 – 50 degrees C. (The turbine was not subjected to test with high-temperature and pressure steam. The shaft was rotated by a machine.) The fractures started from the rotor bore and broke the rotor into four pieces, almost quadrisectioned (Figure 2). The four rotor fragments were scattered in all directions (Figure 3).

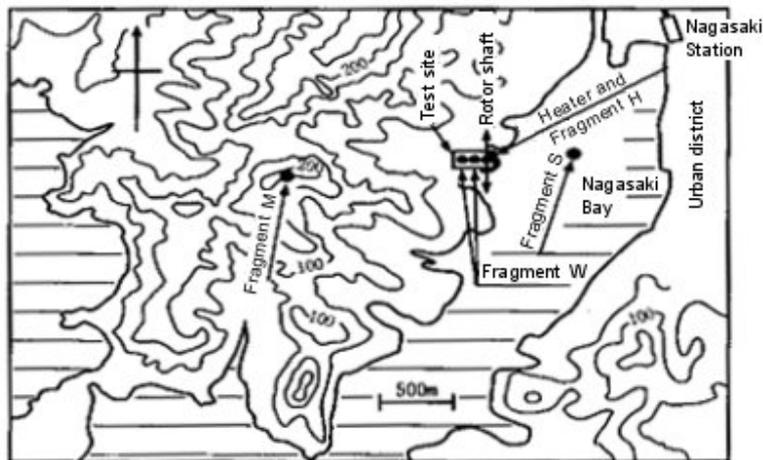
Figure 3. Location of Rotor Fragments [1]

The test site was located at Nagasaki Bay, surrounded by the ocean and mountains. One rotor fragment weighing 9 tons flew 880 meters toward the water (“S” in Figure 3), one weighing 11 tons flew 1500 meters and landed at 200-meter elevation in the mountain (“M”). Two fragments remained in the laboratory - one flew across the test room damaging equipment and injuring people (“W”), and the other struck the floor (“H”).

A new spin rig was implemented to prevent recurrence of the accident that resulted in shattering of fragments and casualties. The test equipment and turbine was placed in a pit on the ground and the rotor was covered robustly so that fractured fragments would not scatter in the area.

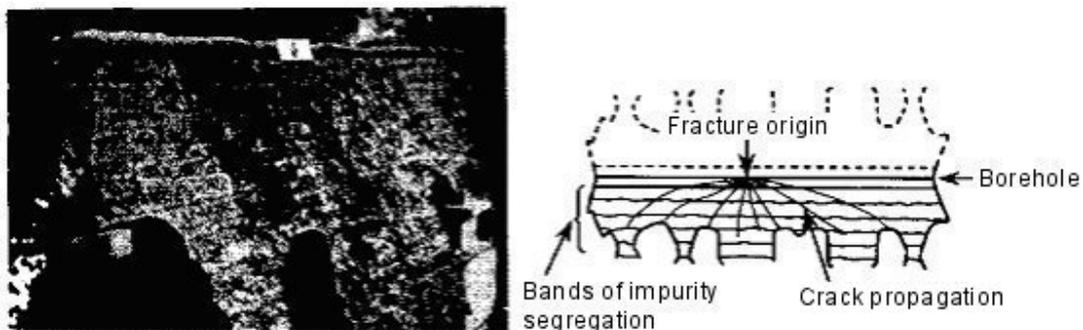
Photo 1. Fracture Origin on the Surface [1]

Photo 1 and Figure 4 show the fracture of the turbine rotor in detail. Failure of the turbine rotor was caused by fractures initiated from a flaw at the rotor bore in the following manner:

- (1) The casting of the turbine rotor produced a microstructural flaw such as a pore, crack, or inclusion in the rotor bore. Air and die lubricant were trapped in the cavity, resulted in microporosity in the castings and columnar dendrites across in the bore region of the rotor.
- (2) The casting process failed to eliminate the formation of microporosity. The cooling velocity was slow in the rotor bore during the final heat treatment, which caused brittleness in the casting.
- (3) The tangential stress increased in the region of the rotor because of the larger rotor size.
- (4) Brittle fracture occurred in the rotor bore as the increased turbine speed applied a greater tangential stress to the bore region. Ductile fracture was initiated at high stress points, resulting in the breakup of the rotor.

The test used an ultrasonic flaw detector to detect an internal flaw of the rotor. However, it only detected premature flaws (Flaw tolerance: Less than 5 mm in size). It was not proven at the time that the collective effect of microporosities in a region is highly destructive to structure, almost equivalent to the destructiveness of a 6 mm flaw. It was still an unknown phenomenon at time related to a microstructural flaw.

The low ductility at the rotor bore resulted in a low tolerance for brittle fracture. In order to eliminate the imperfections and the grain segregation at the rotor bore that caused low ductility, engineers implemented a new casting technology to manufacture the rotor. Instead of the vacuum silicon deoxidation method, they turned to vacuum carbon deoxidation method for producing ingots. In addition to renewing the steel manufacturing process for producing the base material, improvements were made to the heat treatment and the ultrasonic flaw detection methods.
