Fracture of Turbine Shaft in Wakayama

June 5, 1972 at the Kainan Thermal Power Station of the Kansai Electric Power Company

Masayuki Nakao (Institute of Engineering Innovation, School of Engineering, the University of Tokyo)

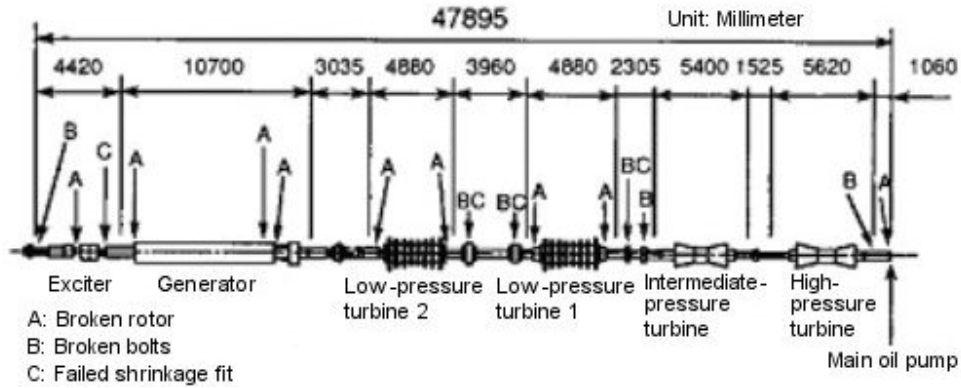
Figure 2. Damaged Turbine Generator Shaft [1]

broke out from the generator. Figure 2 and 3 show the damaged turbine generator and rotor. One of the fragments flew 380 meters, the longest distance of all, as Figure 4 illustrates.

All devices were rebuilt at the factory. Engineers installed the bearing and performed vibration diagnostics.

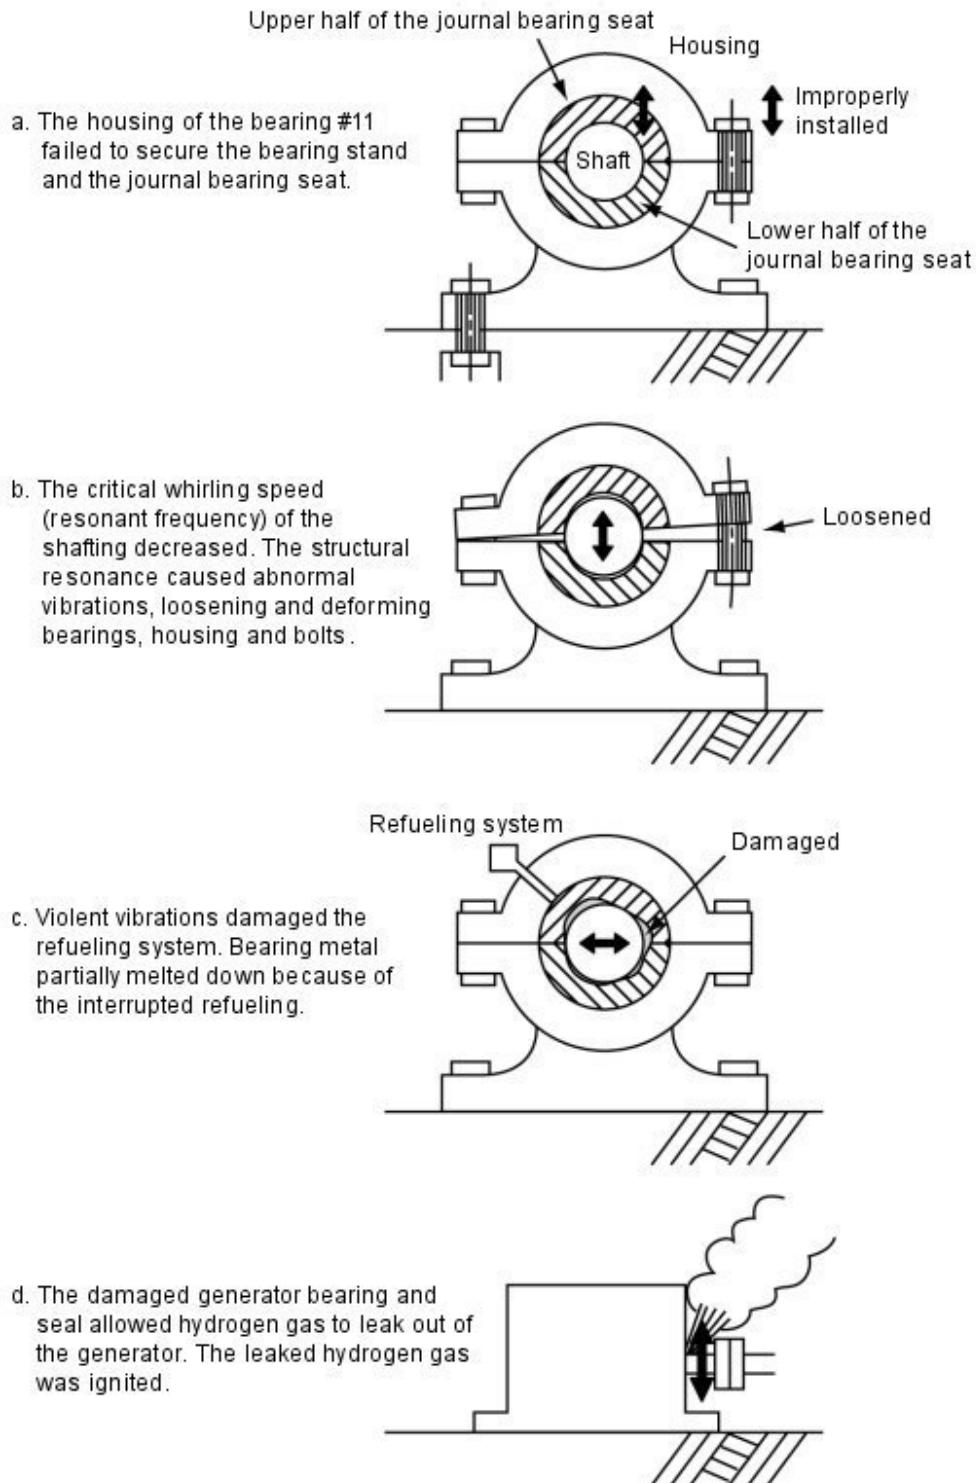
Figure 5. Turbine Failure: Sequence of Events

The housing of bearing #11 failed to secure the bearing stand and the upper vibration-absorbing pad. The vibration occurred during the bearing adjustment loosened the upper vibration-absorbing pad (the upper half of the journal bearing seat), and the loosened pad fell off (Figure 5 a). This decreased the critical whirling speed (resonant frequency) of the shafting, which influenced the bearing vibrations and resulted in structural resonance. The structural resonance caused abnormal vibrations, which led to loose or deformed bearings, housing and bolts (Figure 5 b). Violent vibrations at bearings damaged the refueling system.

Bearing metal partially melted down because of the interrupted refueling. Violent vibrations also scraped off or deformed the bearing metal. Damaged bearings failed to secure the shaft, which led to the destruction of the rotating shaft due to abnormal axial displacement between the shaft and the housing (Figure 5c).

The damaged generator bearing and seal allowed hydrogen gas to leak out of the generator. The leaked

hydrogen gas was ignited, causing a fire (Figure 5d). Most power generating plants use hydrogen gas to cool the electrical windings within the power generator. This improves operating efficiencies by lowering the losses due to the resistance of the windings (windage loss).

Instead of adjusting the bearing for each device and readjust bearings of the assembled turbine generator, the bearings were adjusted as connecting devices so that the assembled turbine generator do not require bearing readjustment.
