Train Fire at Sakuragi-cho

April 24, 1951 at the Sakuragi-cho Station on the Keihin-Tohoku line

Masayuki Nakao (Institute of Engineering Innovation, School of Engineering, The University of Tokyo)

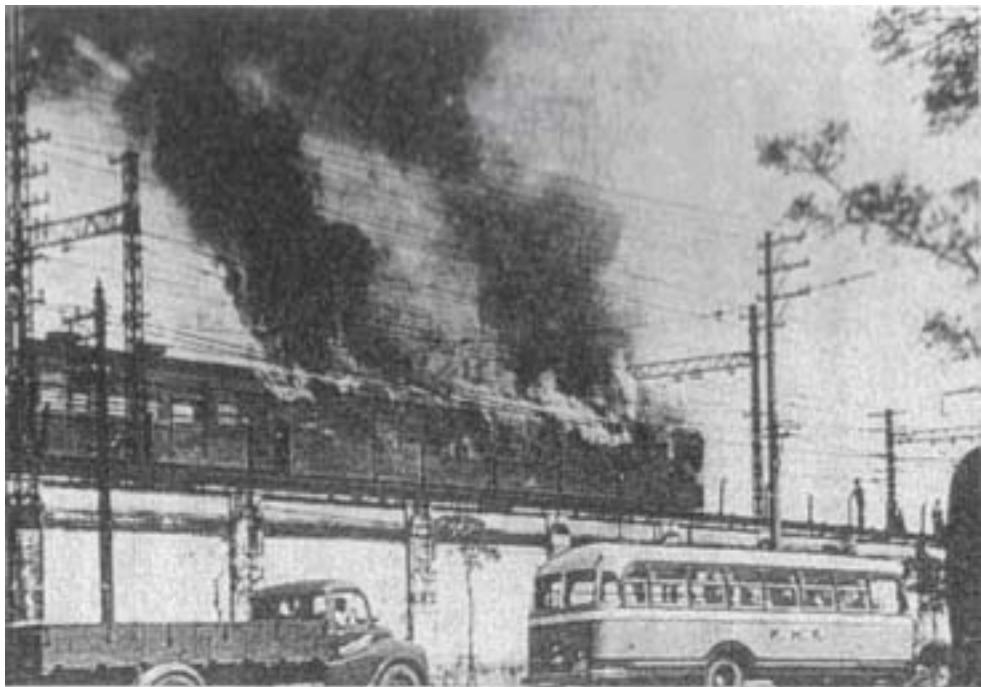
A disastrous train fire occurred at the Sakuragi-cho Station on the Keihin-Tohoku line when a MOHA-63 train touched a sagging overhead wire and sparks caused a fire, killing 106 and injuring 92 passengers trapped in the railcars. Although the direct cause of the train fire was a stringing construction accident, heavy casualties were due to the train operators' inadvertent control input. The passengers were trapped inside the railcars because the operators deactivated the pantograph, locking all doors, and the window structures did not permit evacuation (the middle panel of the three-panel window was fixed to the frame). Photo 1 is the press photo of the accident.

Photo 1. MOHA-63 in Flames (Mainichi Newspapers) [2]

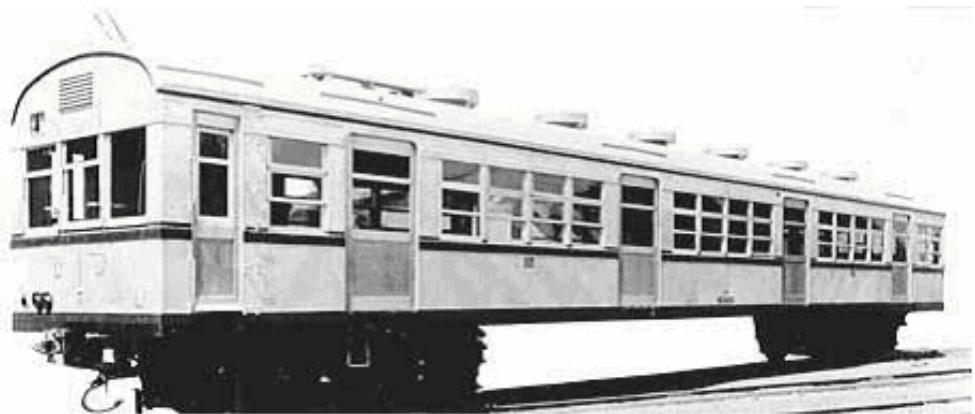
Near the Sakuragi-cho Station on the Keihin-Tohoku line, the first car of a 5-car MOHA-63 train touched a sagging overhead wire and sparks caused a fire, killing 106 and injuring 92 passengers trapped in the railcars. The fire destroyed the first car completely and the second car partially. The heavy casualties were due to the closed doors and the particular window structures in which the middle panel of the three-panel window was fixed to the frame (Photo 2).

Photo 2. MOHA-63 Train [2]

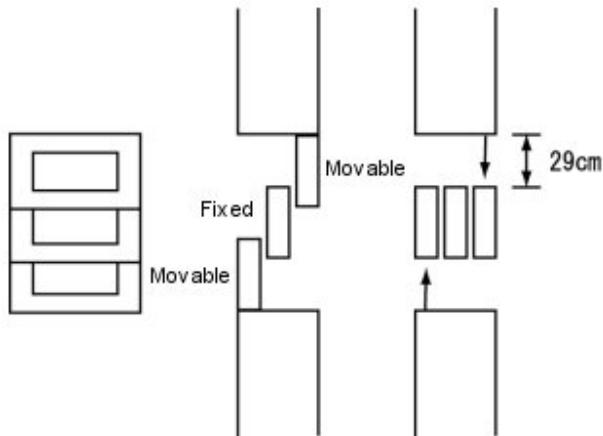
- a. The middle panel of the three-panel window was fixed to the frame (each panel was only 29 cm high). Opening of the window was too small for a person to go through (Figure 2).
- b. There was no sign indicating how to open doors in an emergency.
- c. Through pass age do ors to adjoinin g cars open inward. The doorway was too c rowded with passengers for any of them to open the door inward (Figure 3).
- d. The model w as pr oduced during or right after the war , and it w as a combustible pr oduct with minimum installation of safety devices and with flammable-painted plywood roof.

Figure 2. Three-Panel Window Structure of MOHA-63

- (1) Window structures to permit evacuation. Three-panel windows were changed to two-panel windows. JNR train models adopted three-panel windows after the Sakuragi-cho accident. For all MOHA-63 trains in service, the middle panels of the three-panel window were modified to be movable.
- (2) Signs indicating how to open doors in an emergency. The emergency handle locations under the passenger seat were indicated by red paint and signs "In case of emergency, use this handle to manually open the door" were installed.
- (3) Provision of a through passage to adjoining cars.
- (4) Better insulation of pantograph and roof.
- (5) Fire-retarding coating to improve fire-resistance.
- (6) Mechanisms permitting rapid power shutdown in case of abnormal current flow.

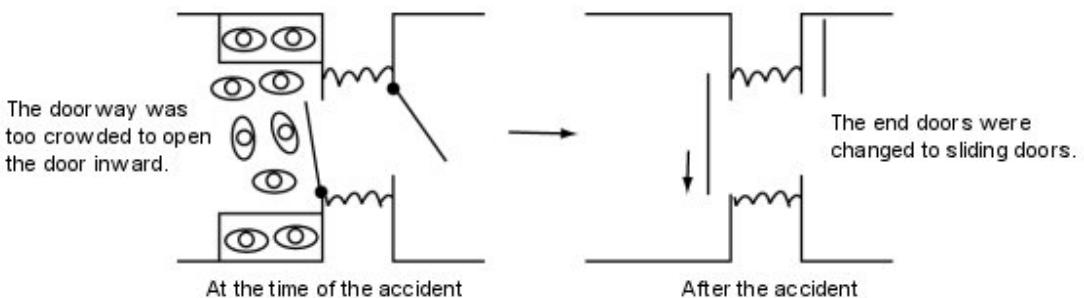
The first car was carrying more than 150 passengers and they attempted to escape from the fire. They were unable to open the automatic doors to outside. They attempted to escape to the second car, but the through passage door did not open. Opening of the window was too small. The passengers were literally all trapped inside the railcars waiting to be burned.

Figure 3. MOHA-63 Doors
