Multiple train collision at Mikawashima May 3, 1962 at Mikawashima on the Joban line

Masayuki Nakao (Institute of Engineering Innovation, School of Engineering, The University of Tokyo)

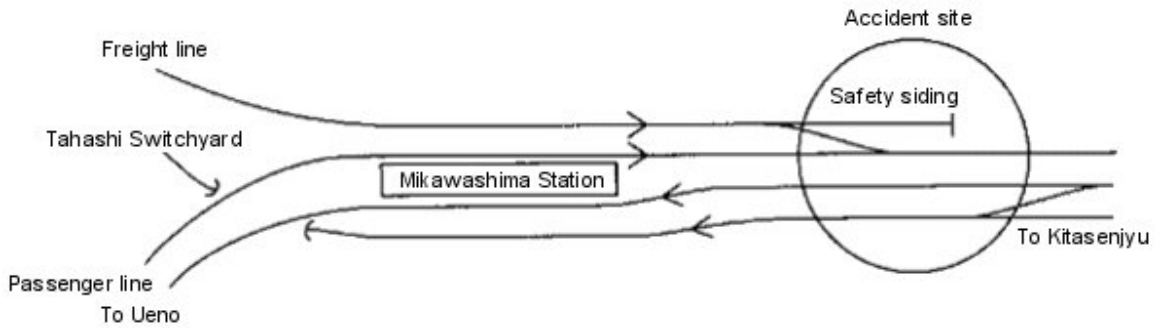
Figure 1. Mikawashima Station on the Joban Line [1]

(The passenger line and the freight line join the main line at the Mikawashima Station.)

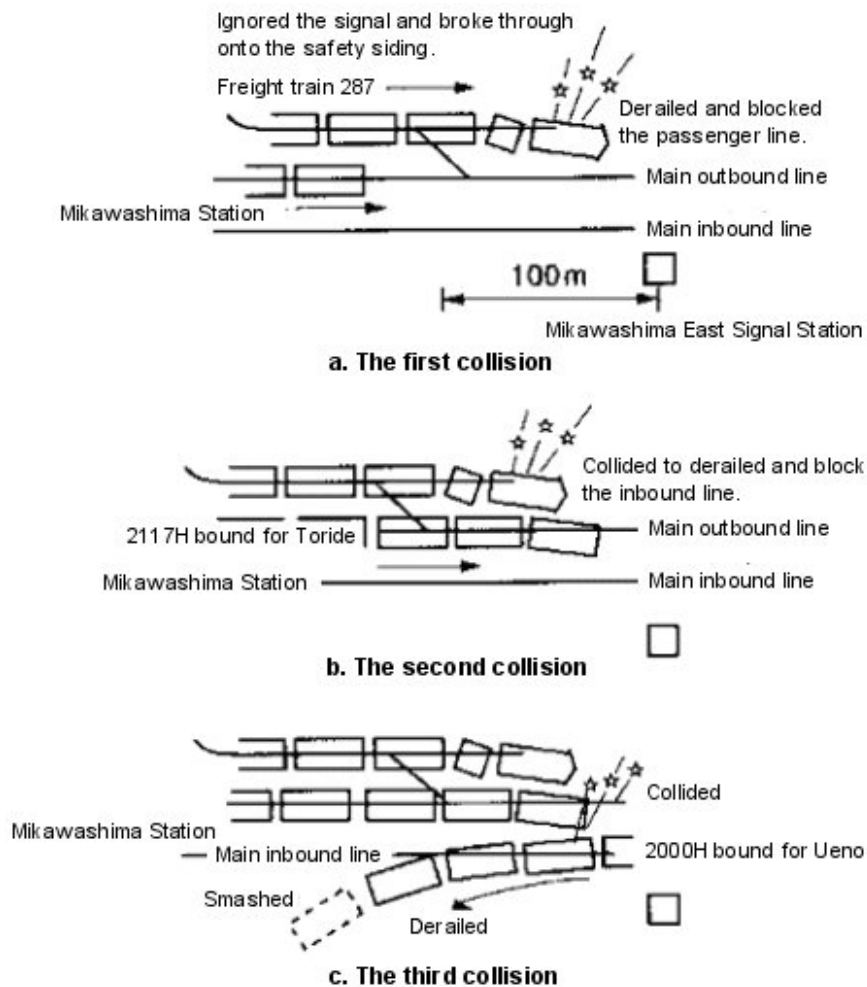
Figure 2. Collision at Mikawashima: Sequence of Events [1]

The first collision: At 21:36, a freight train 287 from the Tahashi Switchyard bound for Mito on the outbound Joban freight line was traveling to join the main line at Mikawashima Station. The freight train operator missed the red signal at the main line (the freight line was to wait for 2117H train on the main outbound passenger line to leave the station). At 21:36:30, the freight train broke through onto the safety siding. The signal connected to the safety siding activated the fail-safe device, preventing the freight train from entering into the main line, however, the loco and first tanker wagon derailed to block the main outbound passenger line.

The second collision: The 7-car passenger train 2117H bound for Toride from the Ueno Station departed the Mikawashima Station at 21:36, 4 minutes behind schedule. At 21:36:40, the passenger train, which was traveling at 40km/h at that time, struck the derailed freighter. The first two cars derailed and blocked the main inbound passenger line. The safety siding prevented a devastating collision, resulted in only 25 injuries. Passengers of the 2117H opened doors using emergency handles and started walking on the inbound line towards the Mikawashima Station. The Mikawashima East Signal Station located 100m from the accident site had 2 operators, but they were too busy confirming and reporting to their manager about the accident to stop the departure of the next passenger train.

The third collision: 5 minutes and 50 seconds after the second collision, the passenger train 2000H bound for Ueno arrived on the main inbound passenger line, ran over people escaping from the accident site and collided with the derailed 2117H. Its first car was smashed and its second cars through the fourth derailed,

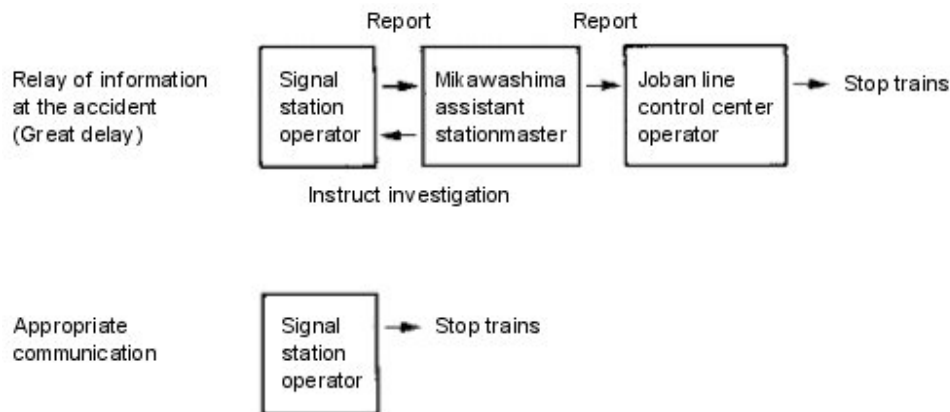
Figure 3. Communication Delay [1]

The delay in stopping the next inbound train 2000H multiplied the damage to the accident. The stationmaster could have taken some action to stop departure of the 2000H in 5 minutes and 5 seconds. However, the relay of information taken by the stationmaster and operators led to delay as shown in Figure 3, resulting in the multiple train collision and many casualties.

- (1) An automatic train stop device (ATS) had been installed on all lines of the Japanese National Railways. The ATS activates the emergency brake when the train passes through a red signal.
- (2) The railway's operation policy changed from "do not stop trains unless absolutely necessary" to "stop trains as soon as an accident happens regardless of its scale". To increase safety further, a train radio system was installed to enable direct communication between train operators and the center.
