Train Fire in Hokuriku Tunnel **November 6, 1972 in the Hokuriku Tunnel**

Masayuki Nakao (Institute of Engineering Innovation, School of Engineering, The University of Tokyo)

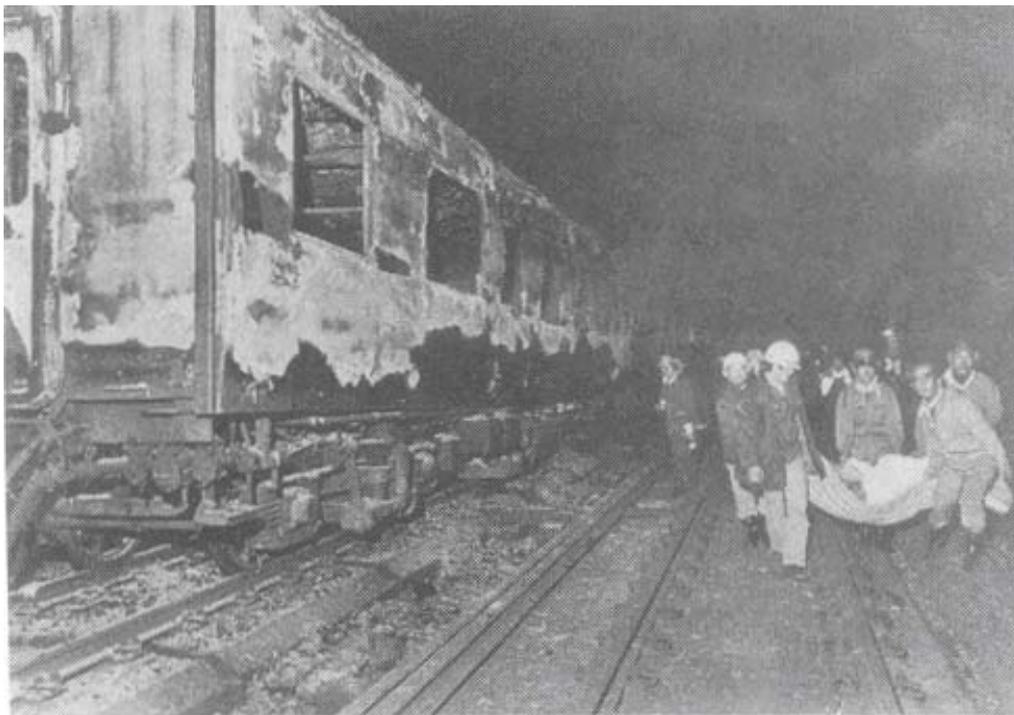
The late night train “Kitaguni” bound for Aomori from Osaka caught fire while the train was in the 13,870m long Hokuriku Tunnel located in Fukui prefecture. The accident killed 30 people including 1 crew and injured 714. The cause of death was carbon monoxide poisoning, not death by fire. Photo 1 is a press photo of the accident.

Photo 1. Burnt-out Dining Car and Rescued Passenger [1]

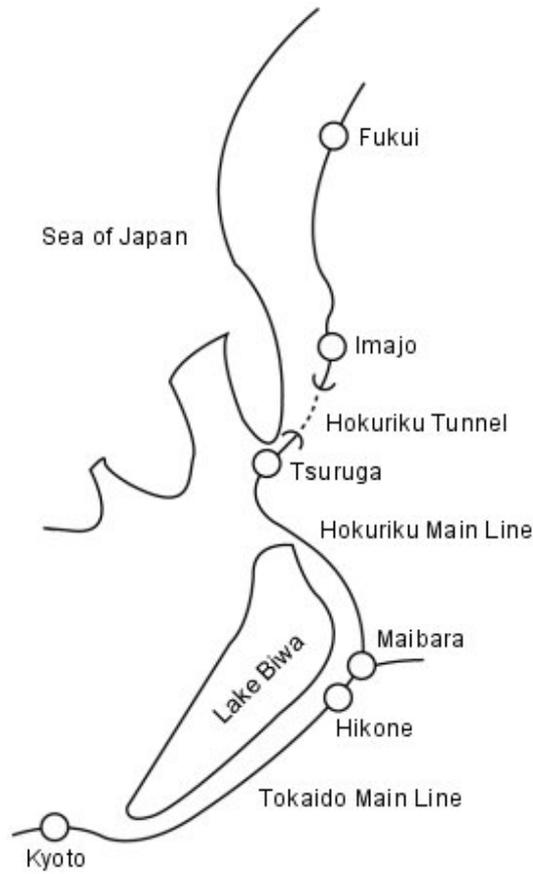
Figure 1. Hokuriku Tunnel

train conductor. The train conductor immediately arranged an emergency stop, and at 1:13 am, the train stopped at 5.3km from the Tsuruga Exit (Figure 1).

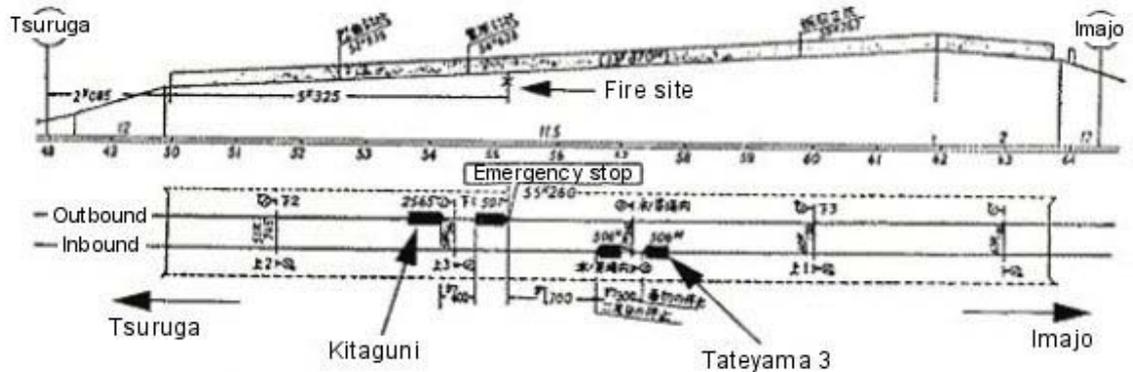
Figure 2. Schematic Illustration of Fire Site (Hokuriku Tunnel) [1]

Two of the train crew tried fire extinguishers to stop the fire, but the force of the fire did not abate. The crew then decided to disconnect the burning car and evacuated the train. At around 1:24 am, railcars were separated between 11th and 12th by 60m (Figure 2).
