## **Amarube Railway Bridge Accident**

**December 28, 1986 at the Amarube Railway Bridge on the Sanin Main Line in Amarube, Kasumi, Kinosaki, Hyogo**

Masayuki Nakao (Institute of Engineering Innovation, School of Engineering, The University of Tokyo)

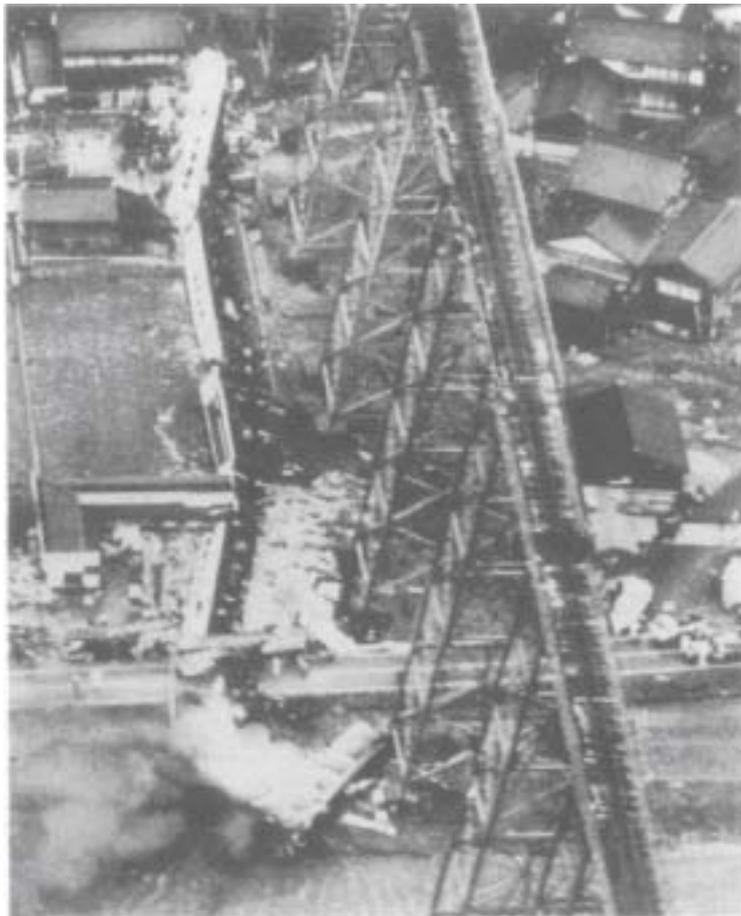
An outbound train was traveling from Fukuchiyama to Hamasaka on the Sanin Main Line when a strong gust of wind blew it off the Amarube Railway bridge. The maximum wind velocity was 33 m/s at the time. Seven passenger cars fell approximately 41m on a seafood processing factory and residences. The accident killed 1 train operator and 5 female factory workers, and injured 6 people. The conductors did not stop the traffic even though they knew that they should have avoided crossing the bridge during strong winds. Photo 1 is a press photo of the accident.

Photo 1. Train was blown off the Amarube railway bridge and caught fire [1]

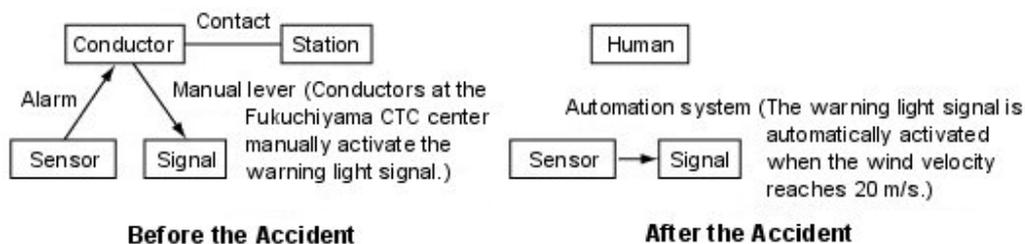
Figure 1. Control Loop of Safety System [1]

- (1) The warning light signal was directly connected to the wind velocity sensors to automate the alert tripping. Human operation was eliminated as shown in Figure 1.
- (2) The wind velocity to stop the train operation was set lower to 20 m/s from the previous 25 m/s.
- (3) Windscreens were installed to the railway bridge.

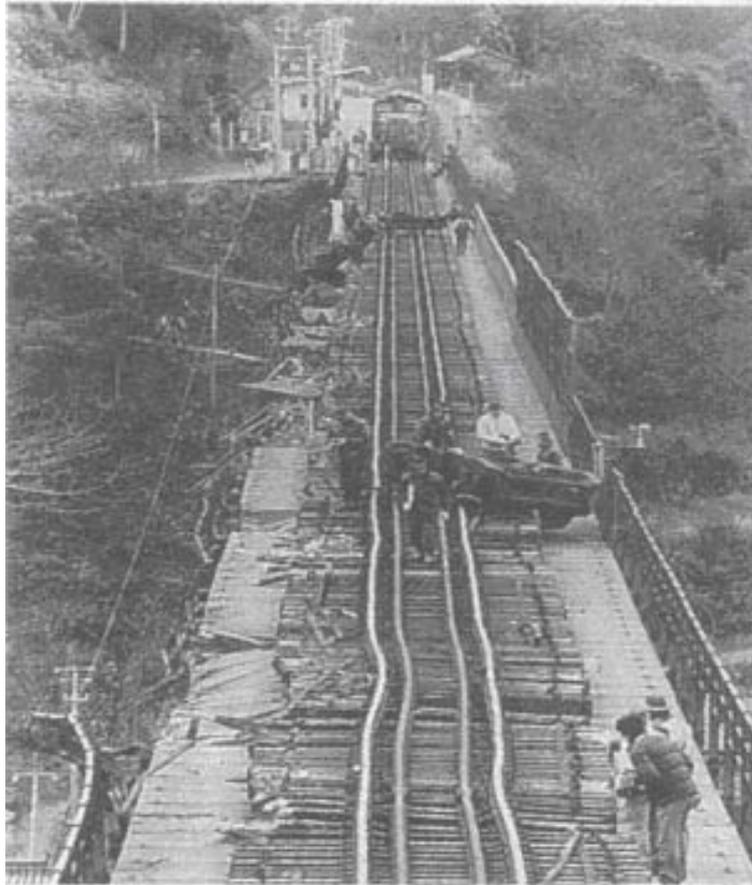
Some argues that the accident was not caused by a strong gust of wind, but by self-excited oscillation, like in the case of Tacoma Narrows Bridge accident, induced by imbalance in the repaired bridge columns (only horizontal elements were replaced). The train derailed traveling on the track warped by self-excited oscillation (Photo 2).

Photo 2. Warped Track (Wind blew from the ocean on right to the mountains on left) (Jiji Press Co.) [1]
