## **Head-on Collision on Shigaraki Kogen Railway May 15, 1991 Shigaraki Kogen Railway at Shigaraki, Shiga**

Masayuki Nakao (Institute of Engineering Innovation, School of Engineering, The University of Tokyo)

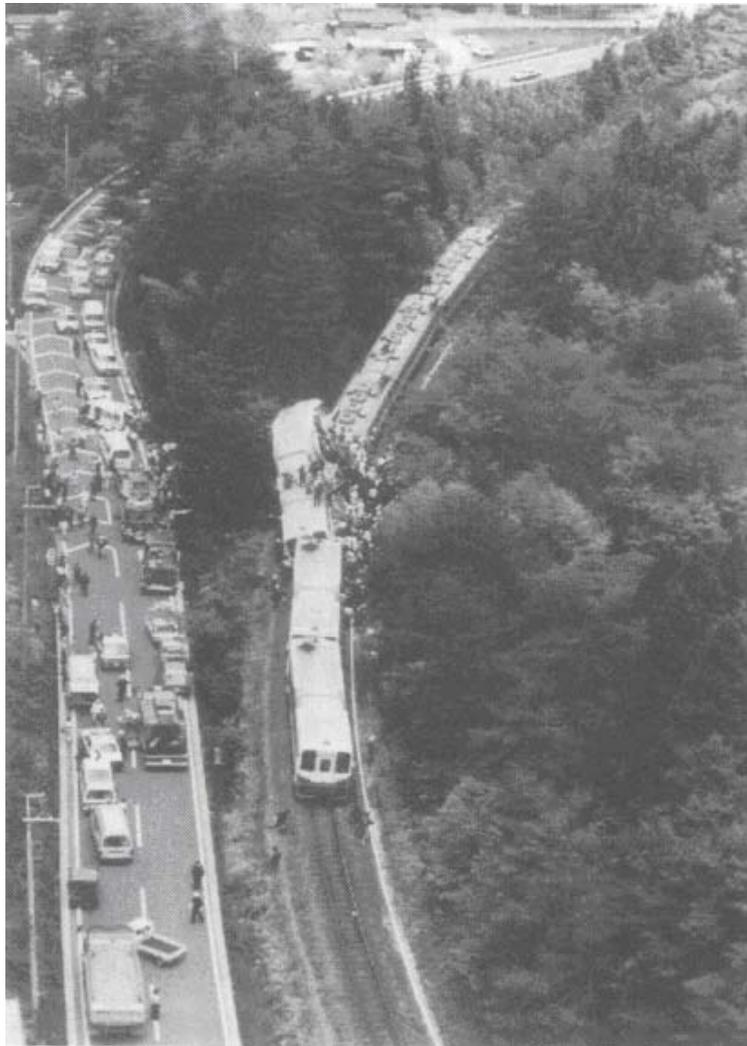
The JR West special three-car train, 501D traveling from Kyoto to Shigaraki for The World Ceramic Festival, and the Shigaraki Kogen Railway (SKR) four-car railbus, 534D from Shigaraki to Kibugawa collided head-on between the Onodani Signal Station and the Shigarakinomiyaato Station. 42 people died and 614 were injured. Basic rules in the safety check procedures, which are the most critical in train operations, were neglected. This caused the accident. Photo 1 is a press photo of the accident.

Photo 1. SKR Collision [1]
