## Hibiya Line Derailment Accident

**March 8, 2000 at Naka-Meguro on the Teito Rapid Transit Authority's (TRTA) Hibiya line**

Masayuki Nakao (Institute of Engineering Innovation, School of Engineering, The University of Tokyo)

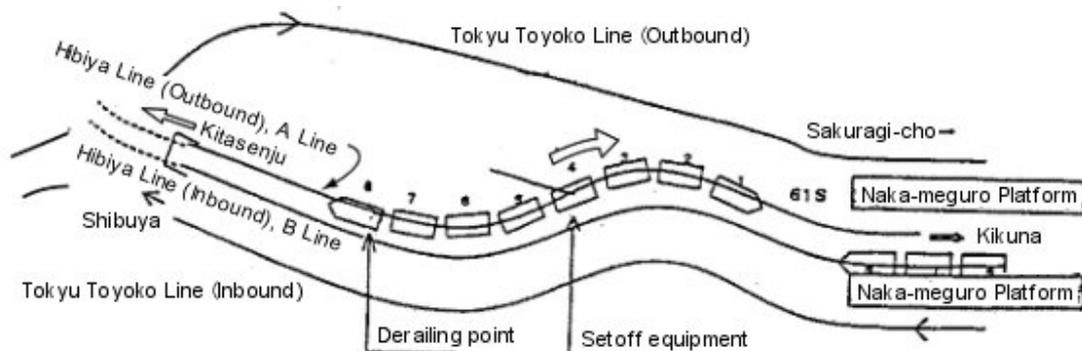
**1. The 8th car of the A861S derailed.**

At 9:01 am, two wheels of the last car (carrying 6 passengers) of the subway train derailed 150m before the Naka-Meguro Station when it was traveling at approximately 12 – 13km/h on a sloped (35/1,000) transition curve (between curve and straight lines) following a left curve of radius 160m. The derailed train stopped on the railway sleepers at the branching of the setoff equipment (for bringing a maintenance train to the main line) located 50m away from the derailed point. The derailed train was hit by the oncoming Tobu Railway's 8-car train B801T bound for Takenotsuka from Naka-Meguro carrying 1,000 passenger, which was traveling on the inbound line (B line) that had a 3.5m track-center distance from the outbound line (A line).

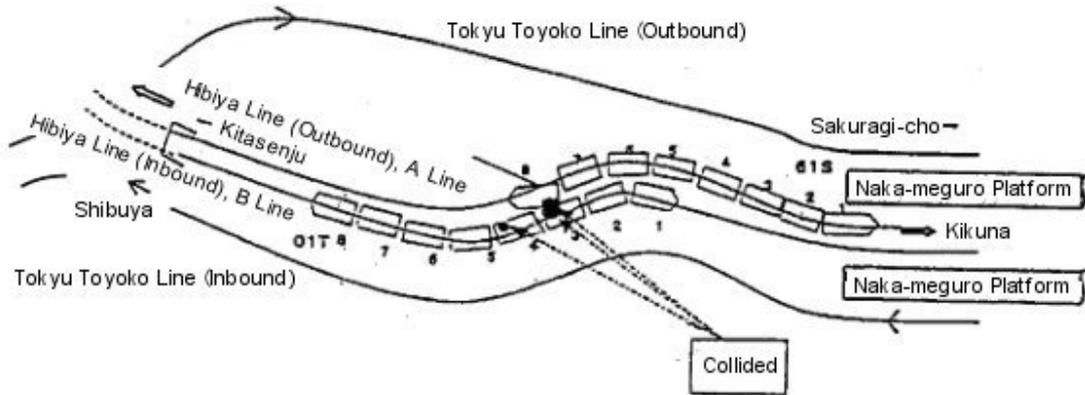
**2. The B801T collided with the A861S.**

The collision badly damaged the 8th car of the A861S as well as the 5th and the 6th cars (each carrying 125 passengers) of the B801T.

The 8th car of the A861S had its right side in the traveling direction damaged severely from its front towards the center door area. The 5th car of the B801T had its right front area damaged and its right side heavily scratched in the center door area towards the end of the car. The 6th car of the B801T had its right side damaged severely from its front towards the first door area. The collision also left scratch marks in the rear area of the 4th car, the center area of the 7th car and the right side of the 8th car. The electric cable and the brake pipe were also damaged on the right side at the connection between the 5th and the 6th cars.

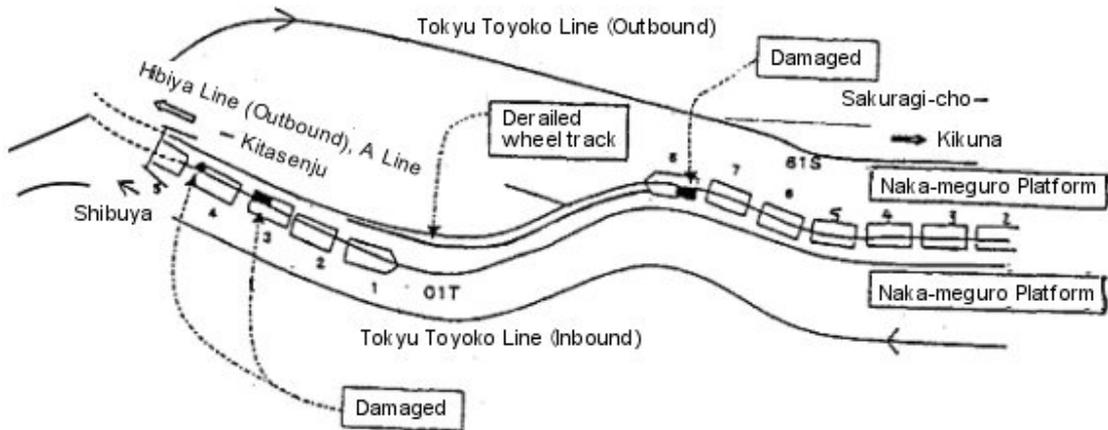
**3. The B801T and the A861S stopped.**

After the collision, the A861S operators activated the emergency brake and stopped the train. The B801T stopped traveling as the emergency brake was automatically activated in response to the rupture of the brake pipe located between the 5th and the 6th cars.

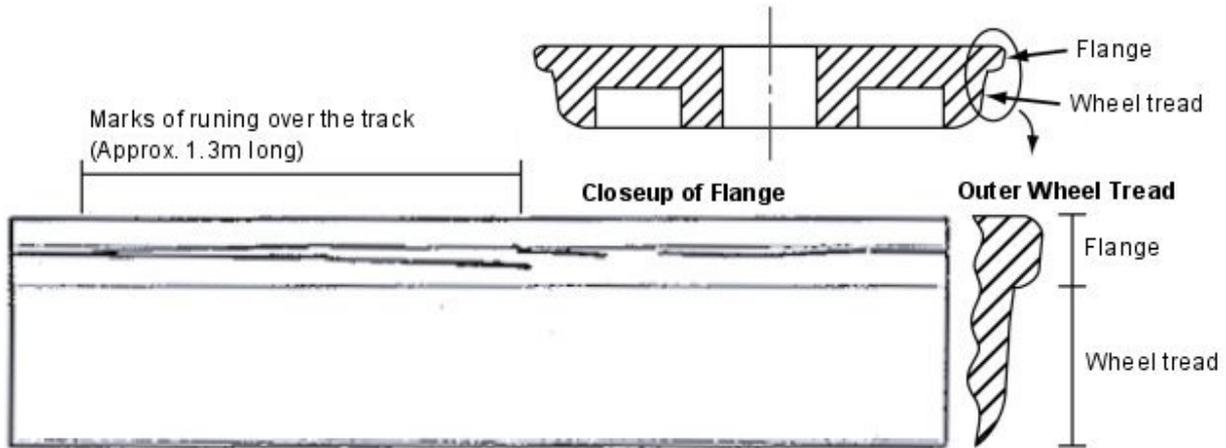
Figure 2. Derailment Marks [1] (Modified)

The outer track on the curve where the wheels derailed had 7m-long skid marks made by the flange starting at the 18.333 km point and shorter marks at the 1m-point from where the wheels derailed. The inner track

on the curve also had small marks.

The outer wheel tread and the flange had marks shown in Figure 1 within the 1.3m-radius of the first axle.

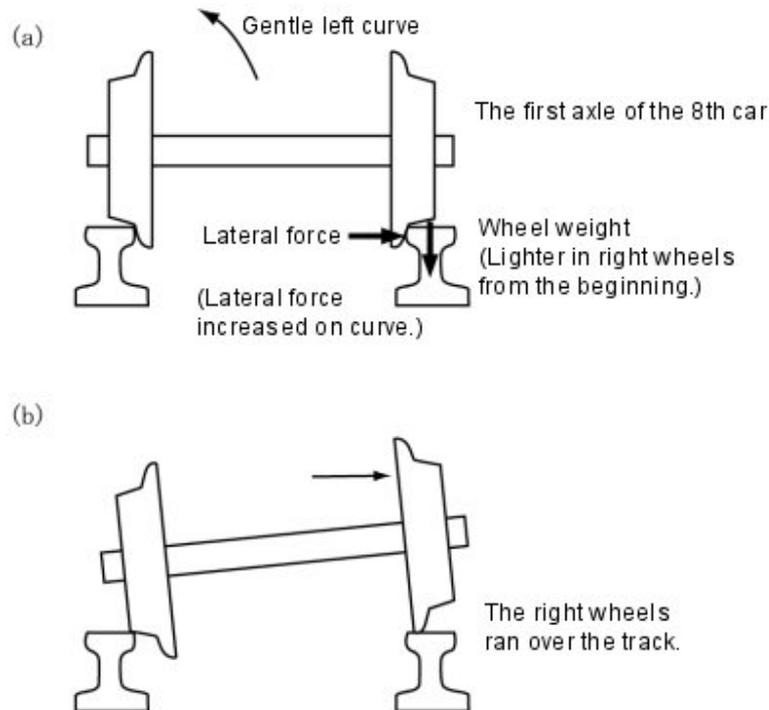
Figure 3. "Ran-Over-the-Track" Derailment

The derailment occurred at the entrance to a transition curve following a sharp left curve, where moderate torsion of the track surface (within the limits allowed by the safety standard) causes weight imbalance in the train wheels on both sides (weight decrease in the right wheels and lateral force increase, see Figure 3a). It is believed that this and other factors increased the derailment coefficient in the right wheel of the 8th car's first axle, causing the wheels to run over the track before actually jumping the track (Figure 3b). Derailment of this sort is called the "run-over-the-track" derailment.

The investigation made the following discoveries and concluded that weight imbalance in the first-axle train wheels contributed to the derailment:

- (1) The production measurement showed the first-axle and the fourth-axle train wheels supported less weight of the train. The weight of the train was not distributed evenly.
- (2) The railways did not perform maintenance of weight balance after the railcar was put in service.
- (3) Other railcars of the same model (Model 03) showed the same weight imbalance in the train wheels.

On October 30, the TRTA announced the derailment prevention measures in response to the advisory report given by the Accidents Investigation Commission of the Transport Ministry. The TRTA completed adjusting the wheel weight ratio (indicating the balance of weight in the train wheels on both sides) to within 15% or less for all Model-03 railcars allocated to the Hibiya line by June and for 90% of all Model-03 railcars on all lines by October 10. In 2001 the TRTA set the stricter guidelines and adjusted the wheel weight ratio to be 10% or less. It also installed 5 new control systems (40 – 50 million yen per a system).

The flanges were angles were set to 60 degrees for all railcars in service on the Hibiya, Chiyoda and Yuraku-cho lines at the time of the accident, and TRTA changed this angle to 70 degrees for railcars on the Hibiya line by November 9, Chiyoda and Yuraku-cho lines by September 2001. The railcars in service on other lines originally had flanges angles of 67- 70 degrees.

The TRTA lengthened the transition curve at the derailment site by 10m from 30m to 40m.
