Failed Launch of H-II Rocket No. 5 February 21, 1998 at the Tanegashima Space Center

Masayuki Nakao (Institute of Engineering Innovation, School of Engineering, The University of Tokyo)

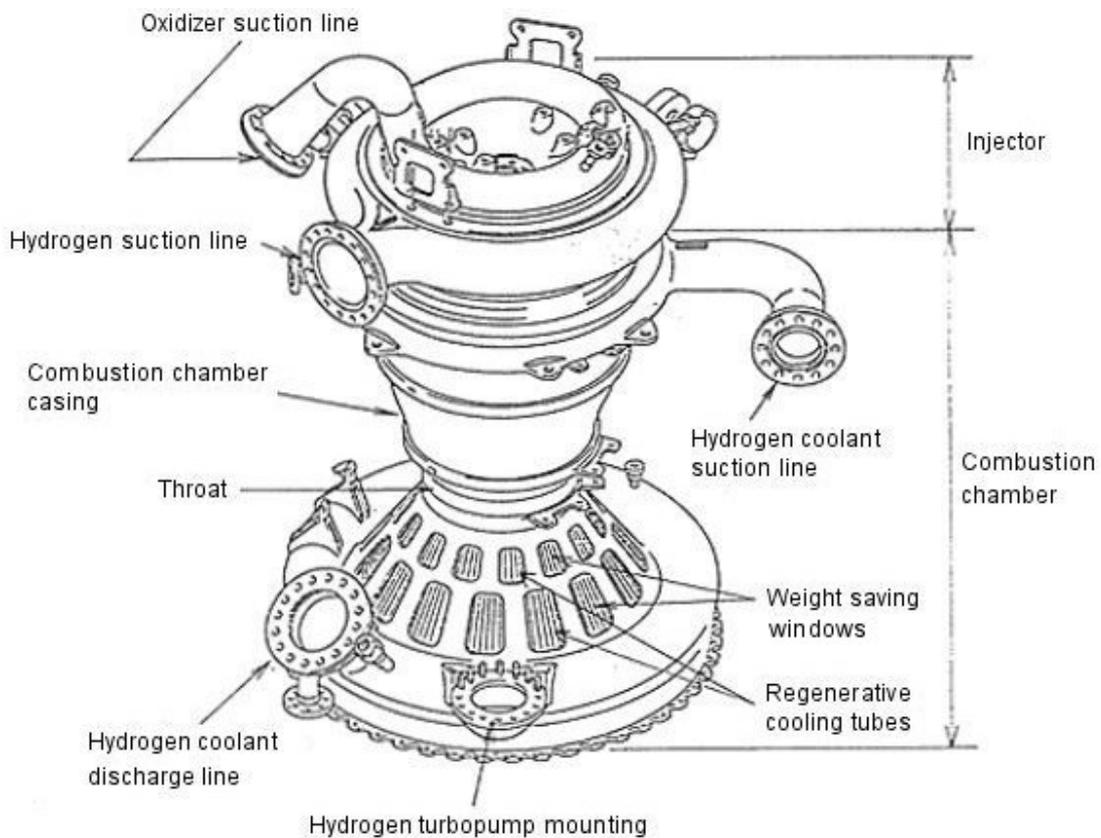
Figure 2. LE-5A Engine (Exterior) [1]

Hot combustion gas penetrated the weight-saving windows on the LE-5 engine's nozzle skirt (Figure 2). This gas cut the electrical power wiring to the engine control box (ECB) located near the weight-saving windows on the engine nozzle skirt. The loss of electrical power closed the main valve to shutdown the engine.

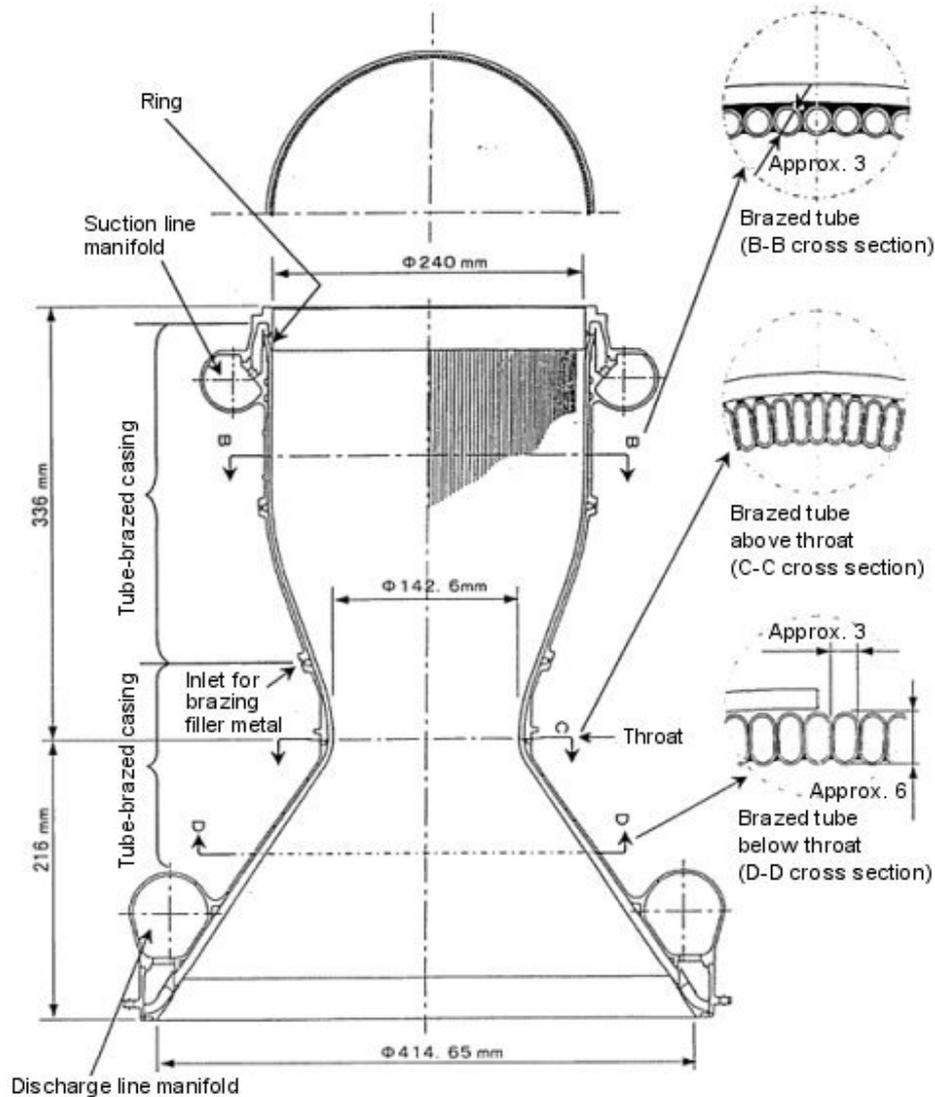
Figure 3. LE-5A Engine Diagram [1]

At about 41 seconds into the second firing of the second-stage engine, a crack in the brazing caused hot combustion gas to heat up cooling tubes in the lowest part of the combustion chamber. One second later, the overheated tubes buckled, allowing a large amount of combustion gas to escape through gaps between the brazed tubes (0.17kg/sec through a 5cm² area). As the combustion pressure decreased, liquid hydrogen leaked from the damaged cooling tubes of the cooling system (0.04kg/sec). These

gases heated the ECB electrical power wiring to above 1,500 degrees C. The electrical power supply was cut off at 46 seconds into the second firing of the second-stage engine.

- (3) There are two possible explanations to how the brazing failed.
 - a. The brazing of the tubes was relatively weak at the center of weight-saving windows where brazed metal was only present on the inside. In the second captive firing test of the LE-5A engine, cracks started from the outside and which then developed into openings at the end of the first firing of the second-stage engine. Liquid hydrogen started leaking and grew bigger during the second firing of the second-stage engine. (Probable cause I)
 - b. Shape irregularity increased at the center of weight-saving windows where cooling tubes were not brazed to the casing. The structure could not withstand multiple firings, and the overheated tubes

buckled during the second firing of the second-stage engine, allowing a large amount of combustion gas to leak through gaps between brazed tubes. (Probable cause II)

In either case, variations (voids and fillets) in the brazing material and the brazing metal brittleness at the temperature of 500 degrees C also contributed to the failure.

Improvement and through inspections were made to the brazing and the nozzle structure of the LE-7A engines of the 7th H-II launch vehicle and the LE-5A engines of the H-IIA launch vehicles (the successor aircraft to the H-II launch vehicle) to ensure the higher reliability of the engines.
