## Silane Gas Explosion at Osaka University 【October 2, 1991; School of Engineering Science, Osaka University】

Masayuki Nakao

Institution of Engineering Innovation and Engineering Research Institute Department,  
 Graduate School of Engineering, The University of Tokyo

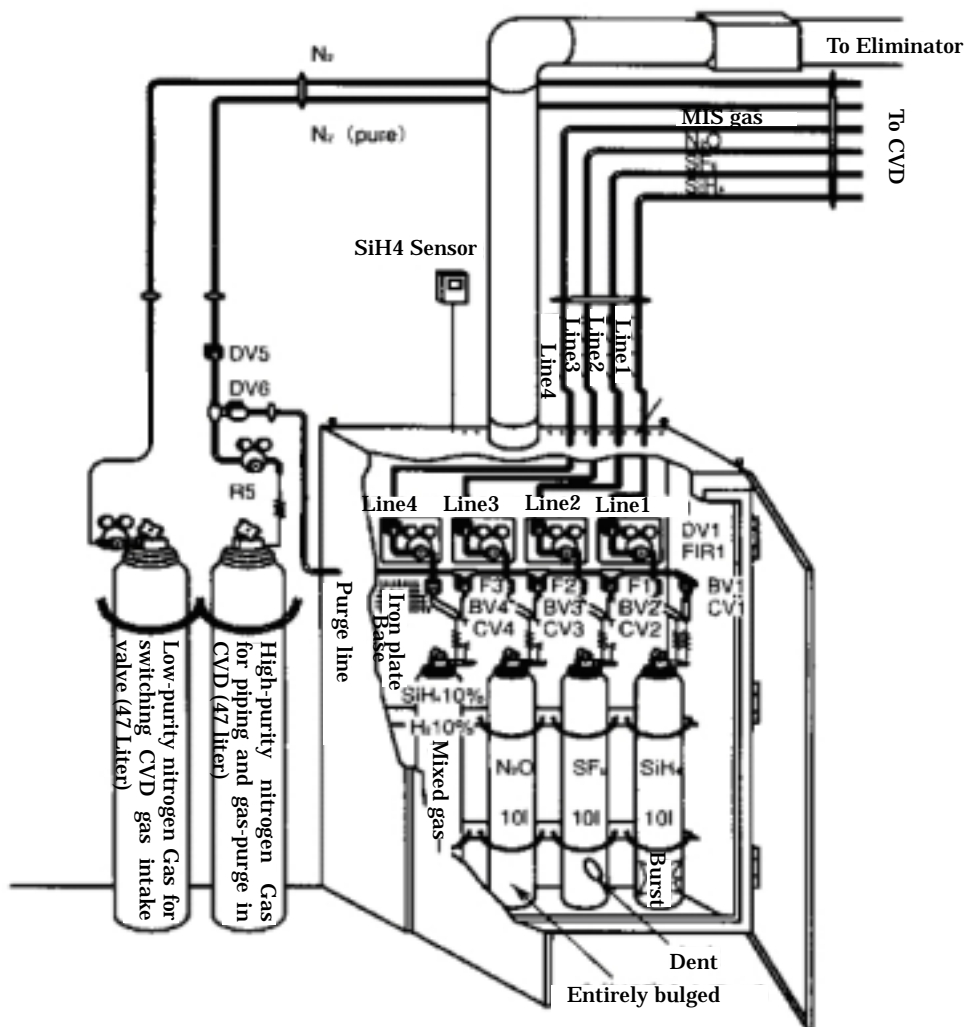
Figure 1: Piping outline around the containers for CVD system (estimation) [3]

Around 4pm on October 2, 1991, at the School of Engineering Science, Osaka University, a student closed a valve (DV1 in Figure 1) of a plasma CVD system. The closure triggered a sudden explosion in the Silane container that supplied gas to the CVD system. The Silane container burst, and the blast forced everything including the test equipment and people to the walls. The explosion and flying debris from it killed two students and injured five others. The explosion also ignited the city gas and organochlorine solvents to start a fire.

- (3) Efforts to improve working property or reduce cost can reduce the margin of safety.
- (4) If fatal accidents are possible, designing inherent safety into systems is absolutely essential. The original layout in Figure 1 is dangerous, for example, if an earthquake happens during an experiment, piping can get slacked to mix gases, and any spark can readily cause an explosion like this case.

- (5) Gas-leak sensors are not versatile. It appears that they thought the system was safe enough with the gas-leak sensor (indicated in the center of Figure 1).

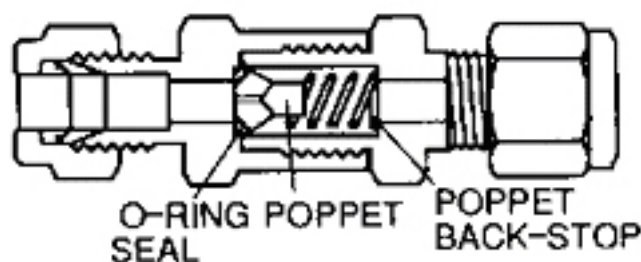
Figure 2: Check valve [3]

What exploded in the Silane container was mixed gas of Silane ( $\text{SiH}_4$ ) and Nitrous Oxide ( $\text{N}_2\text{O}$ ). The O-ring within check valve ( $\text{CV}_3$ ) in Figure 2 had been degraded by Nitrous Oxide, and the check valve (i.e., non-return valve) had lost its function. As a result, a reverse flow of Nitrous Oxide through the check valve ( $\text{CV}_3$ ) flew into the Silane container via the purge lines. The purge lines remove noxious fumes and combustible gas inside the pipes by introducing inert gas such as Nitrogen after each system operation. When the student closed the valve ( $\text{DV}_1$ ) the mixed gas in purge lines compressed, generated heat and ignited. The flame then traveled back to the container through the piping and exploded the container. The pressure inside the container at the time of explosion was estimated at 2,000 to 3,000 kgf/cm<sup>2</sup>. The safety valves for preventing heat meltdown of the container had no time to activate.

Due to the degradation of an O-ring in a check valve, Nitrous Oxide flew into Silane through purge lines and caused the explosion. When designing systems with potential hazards like this case, it is necessary to make sure that all the safety features such as check valves function properly at all time. It is also important to periodically inspect such safeguards components. Furthermore, it is essential to design inherent safety into such systems like separate purge lines. At the time of the accident the industry rumored the university's loose management being the root cause. Shared purge lines, however, were also used in some industry systems.

- (1) To prevent the O-ring degradation by Nitrous Oxide, the check valve (CV<sub>3</sub>) and the ball valve (BV<sub>3</sub>) were relocated. The original location of the check valve close to a gas cylinder kept the O-ring exposed to Nitrous Oxide. The pressure of Nitrous Oxide (typically 50 atmospheres) is higher than the pressure of Nitrogen (usually a few atmospheres). A new ball valve with metal contact was placed next to the gas cylinder.
- (2) Separate purge lines were placed for each gas type. Shared pipes have advantage in easy operation and lower system cost, however, could generate dangerous gas mixture like in this case.

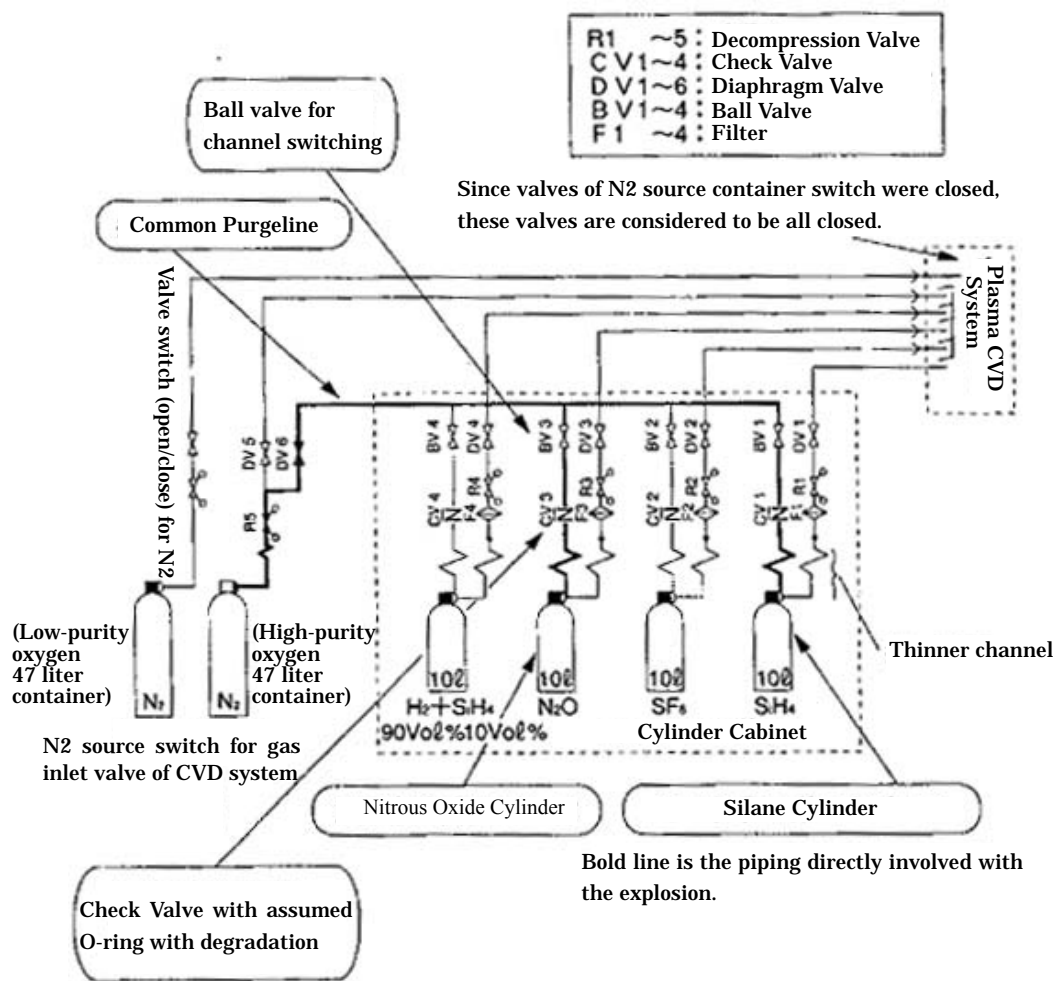
### 3. Cause (Refer to the piping layout of gas supply facilities in Figure 3)

Figure 3: Piping layout of gas supply facility [2]
