China Airlines Airbus A300-600R (Flight 140) Misses Landing and Goes up in Flame at Nagoya Airport

April 26, 1994 at Nagoya Airport

Masayuki Nakao (Institute of Engineering Innovation, School of Engineering, The University of Tokyo)

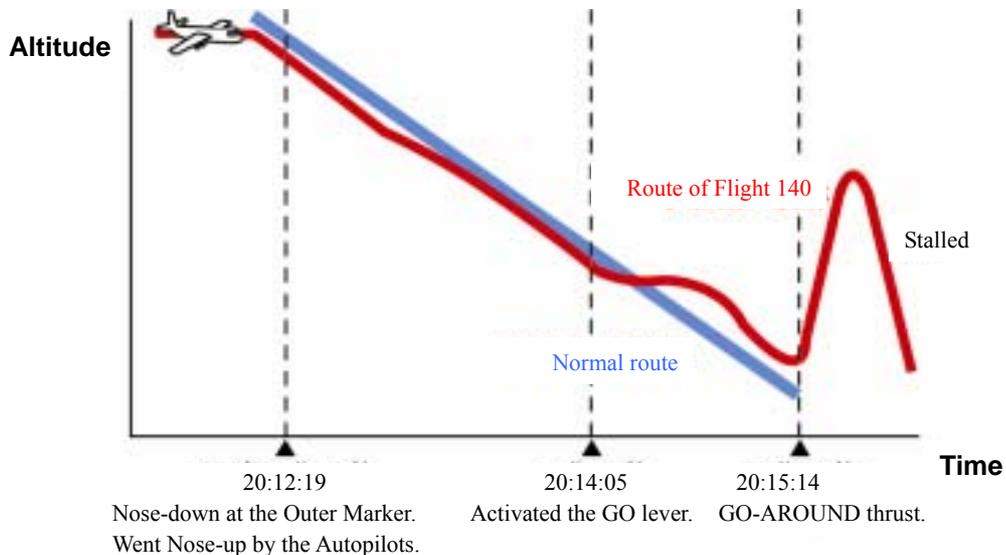
Figure 1. Descent path of China Airlines Flight 140 (Created referring to [4])

- (1) China Airlines Flight 140 aircraft approaching the Nagoya Airport passed the outer marker (the radio beacon furthest from the runway) at 20:12:19, and started landing.
- (2) The pilot was performing a normal ILS approach (ILS guides an approaching airplane to enter the runway using radio waves) to the runway. At 20:14:05 the copilot mistakenly triggered the GO lever (a lever that maximizes engine thrust for take-off or GO-AROUND) and the plane entered the GO-AROUND mode and increased its thrust. The captain cautioned the copilot that he had triggered the GO lever, and instructed him to disengage the GO-AROUND mode. This thrust increase lifted the aircraft off the regular path.

- (3) The captain instructed the copilot to lower the course, and the copilot operated the control lever in the direction to lower the nose. He also activated the auto-pilot in an attempt to engage the auto-landing mode. The GO lever, however, kept the plane in GO-AROUND mode and the tail wing elevator (stabilizing plate) moved against the copilot's operation to lower the nose and suddenly move in the other direction to lift the nose. The autopilot computer was simply trying to execute GO-AROUND. The captain repeatedly instructed the copilot to descend, and the copilot acknowledged it, however, the horizontal stabilizers were at their other limits to lift the nose. The Autopilots were disengaged at around 14:50.

- (4) The aircraft kept climbing with its pitch angle in the nose-up direction. After 14:57, the stall prevention system, Alpha Floor function activated to prevent a stall. The function maximized the thrust and the plane further pitched upwards. The captain took over controls at 15:03 but the aircraft's pitch angle continued to increase above 10 degrees.

- (5) At around 15:14, the captain then gave up landing notified Nagoya tower that he will "GO-AROUND."
- (6) The increase in the thrust, however, with the horizontal stabilizer at its full up position further turned the plane up. The pitch angle eventually reached 53 degrees and the aircraft stalled and crashed at around 15:45.
