Loss of the deep sea remote operated vehicle (ROV), KAIKOU

May 29, 2003, About 130km South East Off the Muroto cape, Kohchi Prefecture

Masayuki Nakao (Institute of Engineering Innovation, School of Engineering, the University of Tokyo)

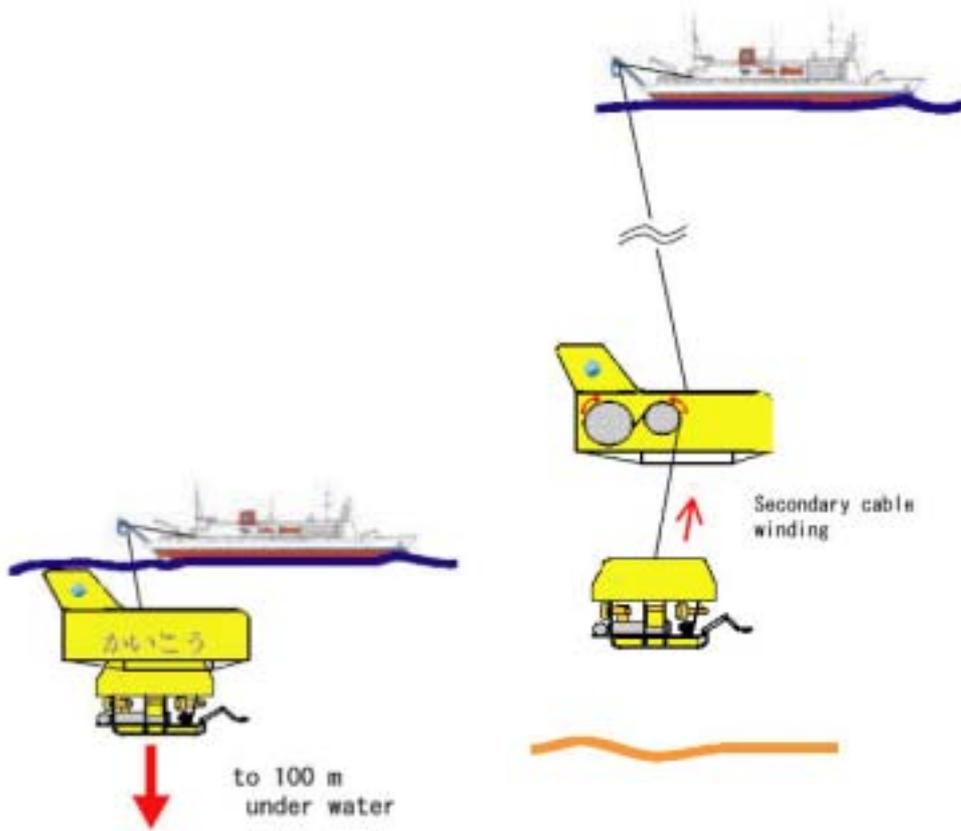
Fig1. Launch (9:30)

Fig2. Secondary cable winding (13:12)

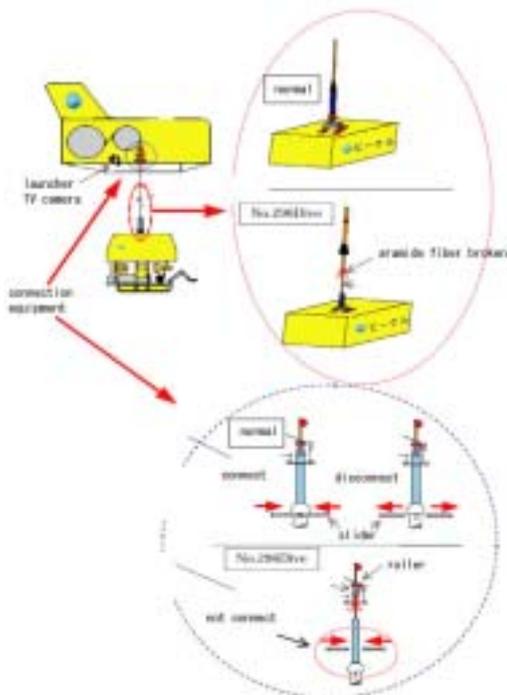
- 13:22 Just before the completion of the reeling in, an abnormal condition of the secondary cable was recognized. The bell-mouth and detaining harness, which under normal conditions should be right under the rubber mold (note: they were taped rather than bonded to the outer sheath of the secondary cable), were visibly confirmed to be lower than usual. Furthermore, a material that appeared to be aramid fiber, a high tensile strength material, fluttered out from the cable, and the naked inner sheath could be seen below the outer sheath. At this point, it was judged that the aramid fiber had become severed (fig 3). The operating officer of the KAIKOU explained the condition to the captain of KAIREI, and considering the worst situation that it would be impossible to dock the vehicle with the launcher, he also informed the captain that there was the high possibility that the vehicle would become separated from the launcher at the site.

Fig3. Secondary cable anomaly (13:22)

1. The damage to the secondary cable
 - a. The strength of the aramid fiber around the opening of the sheath near the detaining harness was deteriorated by the normal operation of separating and docking of the launcher and vehicle. It is also considered that insufficiency of the structure of the detaining harness and the high water pressure durability of the cable may have also contributed to the damage to the secondary cable.
 - b. The operational blind point was the lack of clear standards for the safety and regulations in the operating manual for maintenance of the detaining harness of the secondary cable.
 - c. Despite confirmation of partial damage to the braiding near the detaining harness, the No.0 cable was used without recognizing the importance of damage.

However, during the 51st operation of the cable on May 29th, the aramid fiber braids near the mouth of the detaining harness of the No.0 secondary cable were severed.

1. A new development procedure for the secondary cable according to the following directions.
 - a. The selection of the most suitable high strength materials, including the aramid fiber.

- b. In order to assure that pressure of the high strength fiber level is equalized, the fiber should be soaked with resin.
 - c. Design based on reexamination of the structure, detaining method, and other characteristics together with sufficient testing of the test manufactured secondary cable.

- d. Targeting the development of a detaining harness whose end can be processed on the ocean surface.
2. The improvement of the operation of the secondary cable.

- a. It is impossible to estimate the deterioration of the strength from the outer inspection. Therefore, together with the inspection of the detaining harness following each dive, the disassembly inspection and the strength test should be carried out regularly. These operating rules are to be established in the operating manual.

- b. It is possible that a snapping tension might be applied on the secondary cable. Therefore, the 0.2 second sampling interval should be changed to 0.1 seconds in order to obtain the accurate peak value of the tension applied on the secondary cable.

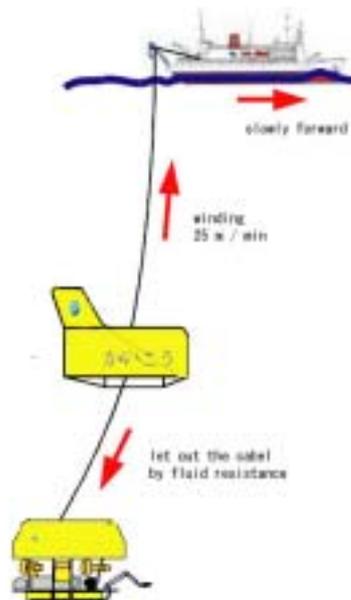
forward at 0.5kt speed and the primary cable should be reeled in at a speed of 25m/sec. The ship proceeded to move forward at 0.5 knots taking the course of 120 to 130 degrees according to the instruction. After that, the tools and operating procedure for picking up the separated vehicle and launcher were consulted. The direction finder was prepared on the beacon receiver to use in the case that the vehicle surfaced (fig 4).

Fig4. Primary Cable winding (13:29 ~ 16:47)
