Chain Reaction Collapse of a High-rise Apartment due to a Gas Explosion May 16, 1968 in Ronan Point, East London, England

Masayuki Nakao (Institute of Engineering Innovation, School of Engineering, The University of Tokyo)

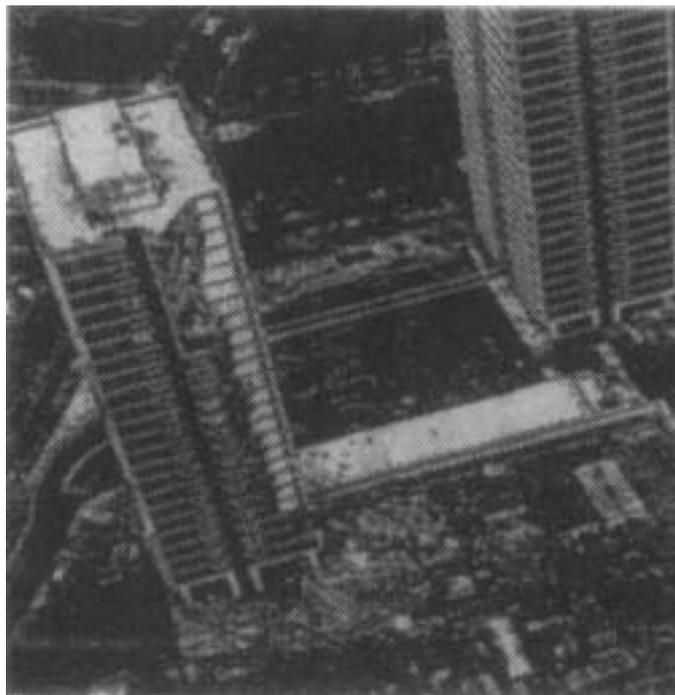
A gas explosion on the 18th floor caused the collapse of an entire corner of a 24-story block of flats called Ronan Point in east London. Three were killed and 11 people were injured after the 22-story southeast corner came crashing down. Photo 1 shows the collapsed building.

Photo 1. Collapsed 22-Story Southeast Corner [1]

In the early morning of May 16, 1968, a gas explosion occurred in the southeast corner flat on the 18th floor of Ronan Point. The pressure of the gas explosion blew out the pre-cast concrete panels which formed the side of the building, then ripped through four flats above and sent all the floors below crashing down like falling dominoes. The entire corner of Ronan Point collapsed as shown in Photo 1, killing 3 people and injuring 11.

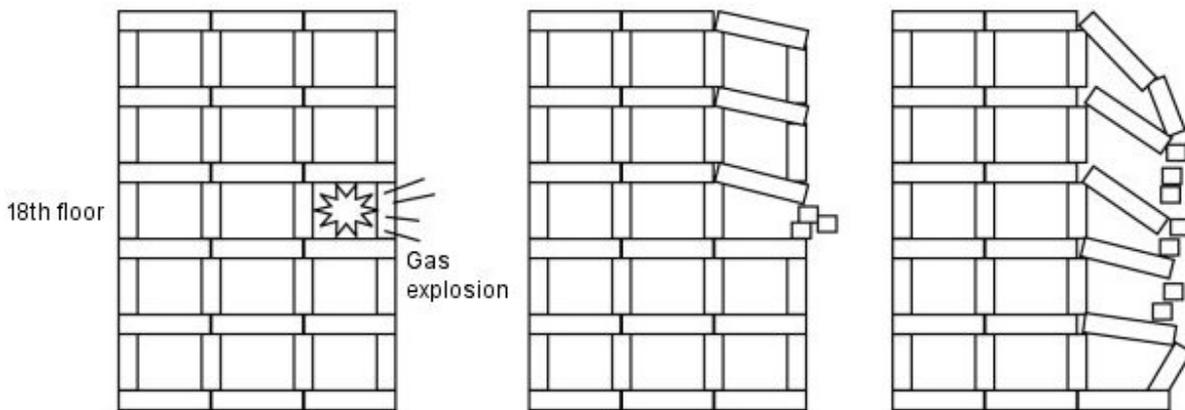
The force of the explosion knocked out external walls of the southeast corner flat on the 18th floor, leaving the panels above unsupported. This created a chain reaction in which the 19th floor collapsed, then the 20th floor and so on, propagating upward. The collapse of four floors on to the 18th floor initiated a second phase of progressive collapse. The sudden impact loading on the 18th floor caused it to give way, smashing the 17th floor and progressing until it reached the ground (Figure 1). The collapse of Ronan Point was due to its lack of structural redundancy. The structure had no fail-safe mechanisms, and no alternative load paths for the upper floors when a lower level gave way.

Figure 1. Domino Style Collapse

The Building Regulations and the Code of Practice for concrete design added special that the structure would provide a certain minimum resistance to special load conditions, like gas explosion, and progressive collapses.
