InterCity Express Accident **June 3, 1998 in Eschede, Niedersachsen, Germany**

Masayuki Nakao (Institute of Engineering Innovation, School of Engineering, The University of Tokyo)

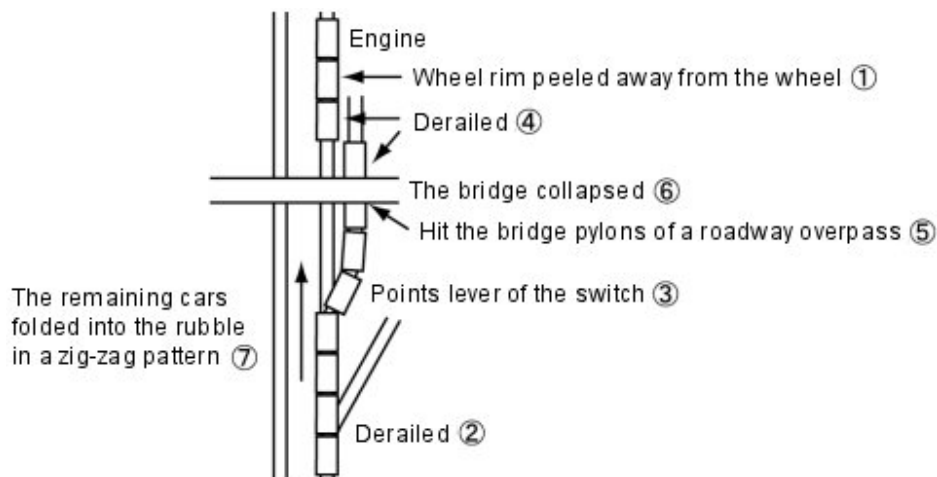
Figure 1. The InterCity Express Accident [4]

The Inter-City Express (ICE) high-speed train operated by DB Fernverkehr derailed, and some of the railcars were thrown into the bridge piers of a roadway overpass. The accident killed 101 and injured 200 people. The direct cause of the accident was damage due to metal fatigue in a wheel rim of a two-part wheel. (Visit <http://nedies.jrc.it/index.asp?ID=216> for the press photo.)

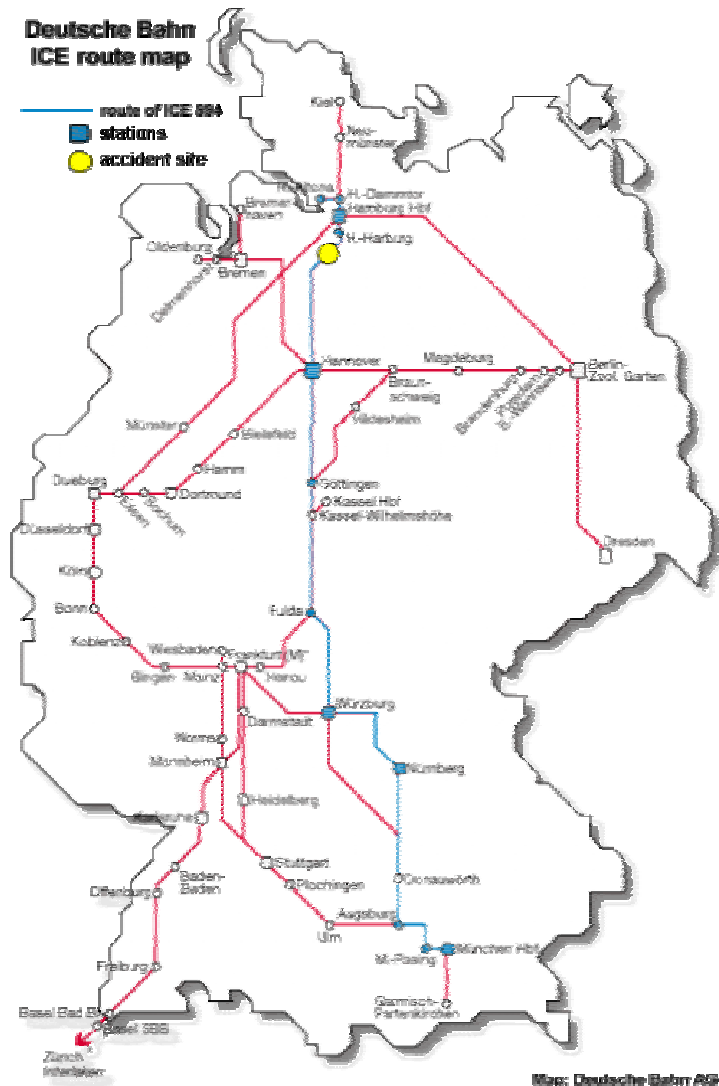
Figure 2. Accident Site [3]

The ICE high-speed train 884 was on the route from Munich to Hamburg, carrying 300 passengers. It derailed near Eschede in north-western Germany, and some of the railcars were thrown into the bridge piers of a roadway overpass (Figure 2). The accident killed 101 and injured 200 people.

The derailed first, the second and the third passenger cars came to a halt several hundred meters down the track from the roadway overpass. The fourth passenger car passed intact under the roadway overpass and rolled onto the embankment immediately behind it. This impact caused the roadway overpass to collapse as the second half of the fifth and the sixth passenger car were passing under the bridge.

The collapsed bridge flattened the rear part of car 5 and car 6 completely. The remaining cars all derailed and slammed folded into the rubble in a zig-zag pattern, as the collapsed bridge had completely obstructed the track. The vehicles parked on the collapsed bridge plunged into the pile.

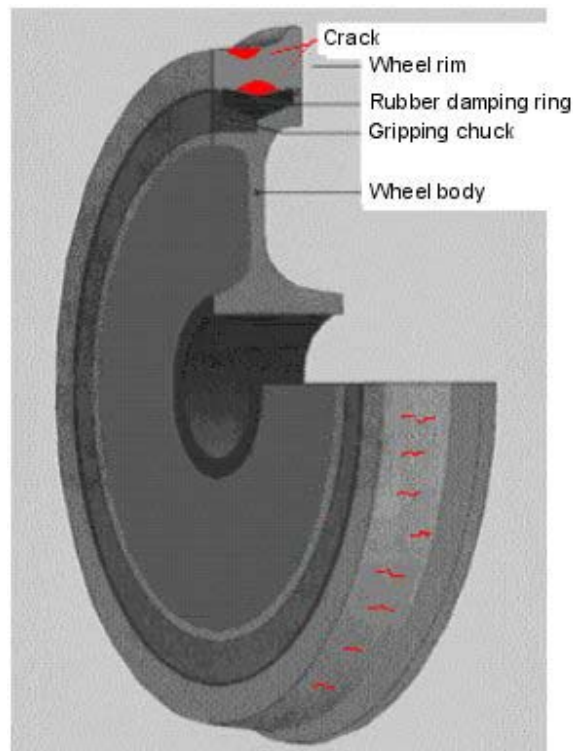
Figure 1. Wheel Design and Failure (Translated) [2]

- (1) A wheel rim that was lining a wheel on an axle of the first passenger car broke. (Direct cause)

In order to reduce costs and improve ride comfort, the ICE cars employed the wheel design that uses a rubber damping ring between a metal wheel rim and the wheel body. The wheel rim failed due to metal fatigue (Figure 1).

The ICE884 was one of the 60 first generation railcars of the older model, and it still had the wheel rims of the “wheel-tire” design at that time of the accident.

By the end of June 1998, the 59 railcars of the first generation ICE had their wheels replaced with the single-cast wheels equipped in the second generation ICE.
