Explosion of the Space Shuttle Challenger

[January 28, 1986, USA]

by Masayuki Nakao

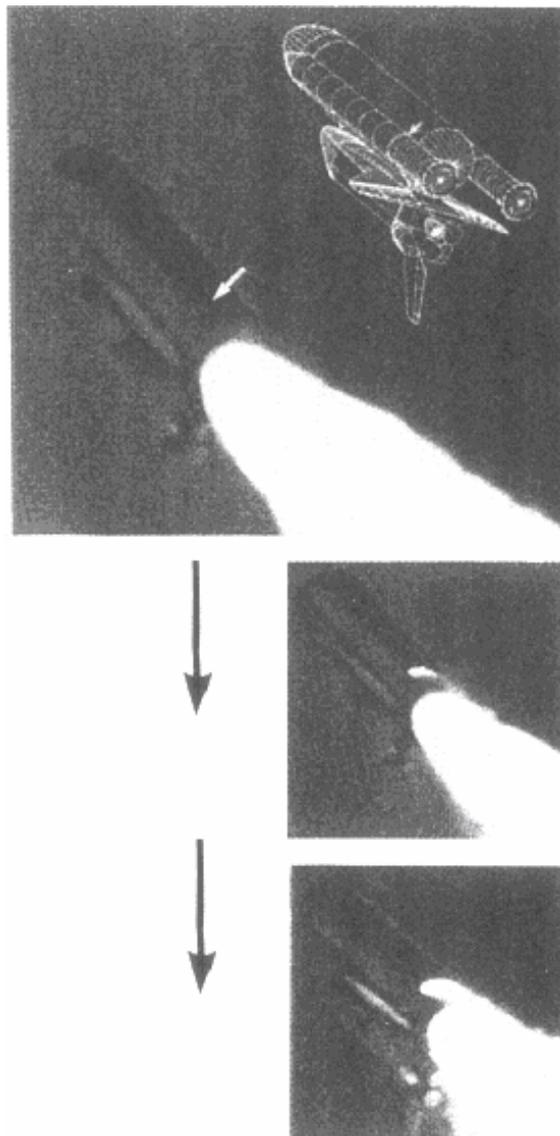
On January 28, 1986, the space shuttle Challenger developed flame on the side of the Solid Rocket Booster shown in Fig. 1 (Photo 1, arrowed) immediately after the launch, and exploded soon after.

Photo 1. Explosion [2]

The above shows pictures of the Orbiter attached facing down. Here, the black smoke is spurting from the rocket booster in front due to the gas leak from the arrowed area, and the picture at the bottom shows white smoke coming out.

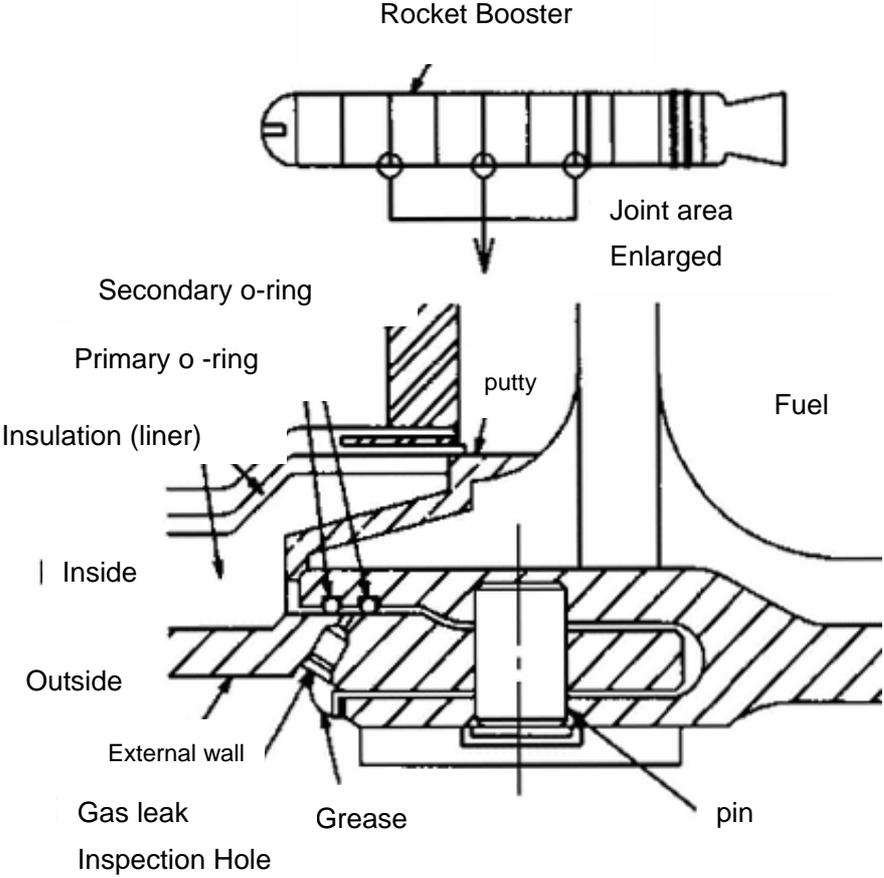
- 1) There were two solid Rocket Boosters on this shuttle for shooting the shuttle into orbit. Some assembly was necessary for these Solid Rocket Boosters at the launch site and O-rings (as shown in Fig. 2) were used in the joint area. (1/4 inch thickness and 12 feet in diameter). The ambient temperature at the day of the launch was -1 to 2 degree Celsius (36 °F), about 13 to 14 degrees colder than the

next coldest previous launch. Due to the cold weather, the o-rings stiffened and lost elasticity causing seal failure. It is presumed that fuel leaked from the gas leak inspection hole was ignited by flame from the aft field, and resulting in an explosion. Photo 2 shows black smoke puffing due to the gas leak from the booster before the launch (arrow at right-bottom corner of the photo). In order to prove this, Feynman did the experiment at a public meeting placing an o-ring in ice water to prove the loss of elasticity in the o-ring.

Fig. 2, Structure of the Joint area of the Rocket Booster [2]

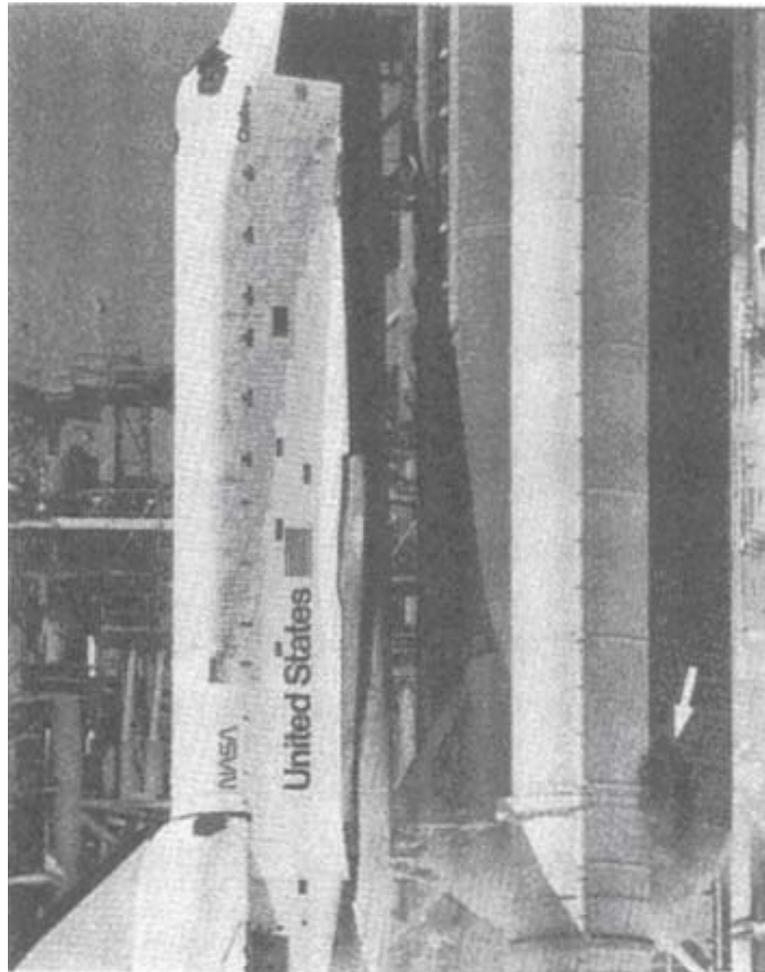
Photo 2, Black smoke photographed from the launch pad [2]

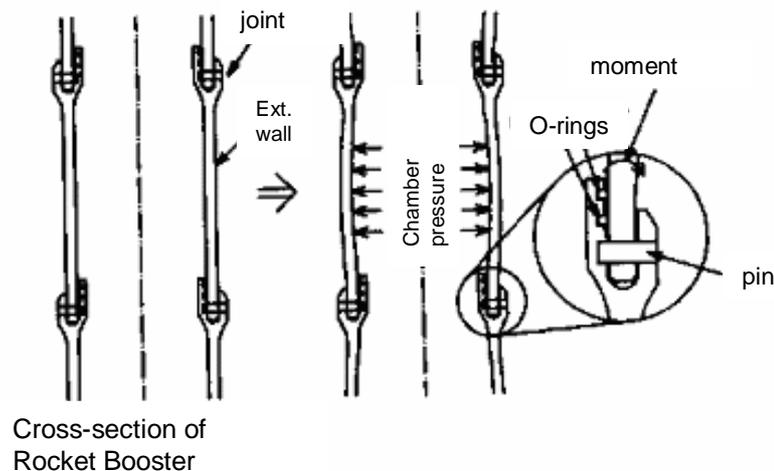
- 3) The direct cause of the o-ring seal failure was loss of elasticity due to low temperature, but faulty design was also a contributing factor. When chamber pressure in the rocket booster increased during use, the external walls between joints expanded, called "joint rotation" phenomenon, because the walls of the joint area was thicker than the external walls between the joint areas. In this situation, (shown in Fig. 3) moment of inertia occurs to break the joint where the o-ring seals. In addition, there were some distortions from the previous use on the rocket boosters. Those distortions were corrected before re-use but there were still some problems which were not completely corrected and caused gaps in the seal area. They knew these possibilities, but no effective solutions took place.

Fig. 3, Joint Rotation [2]

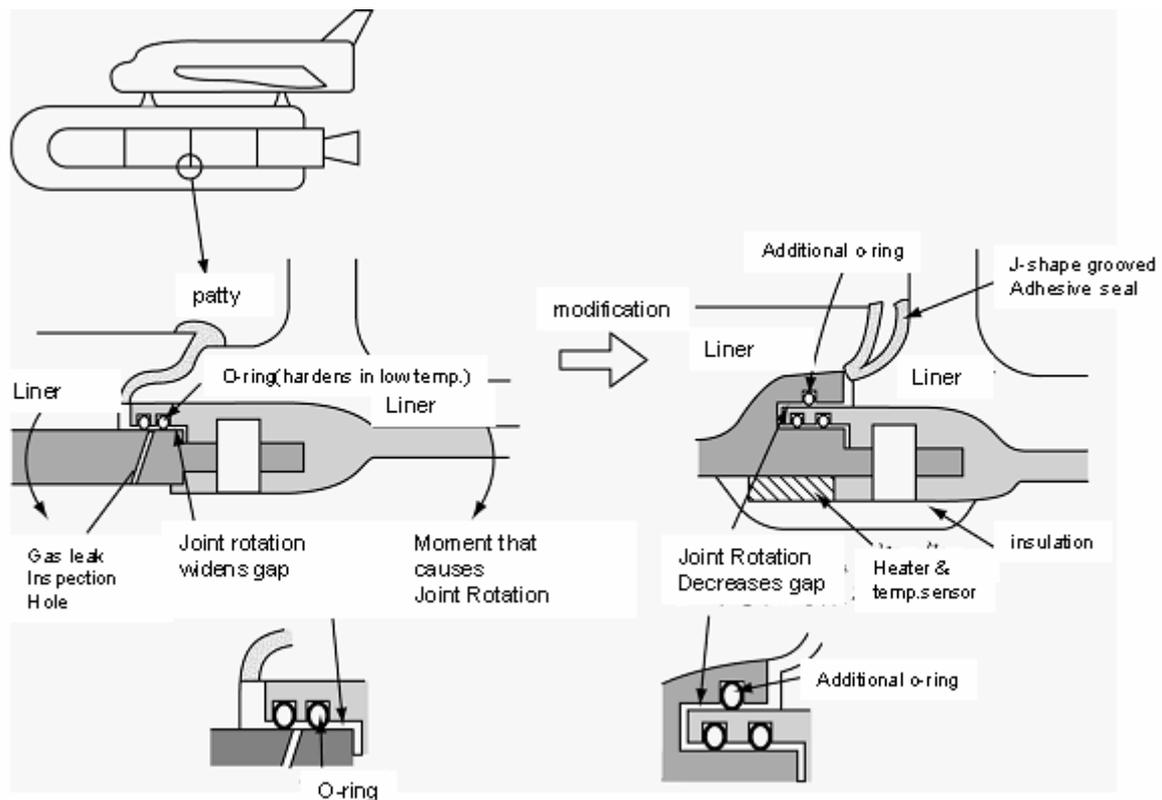
Fig. 4, Fuel Leak Prevention after the explosion of Space Shuttle Challenger [5]

A. Countermeasures for fuel leaks (Fig. 4)

- 1) J-shape grooved adhesive seals replaced the previous putty seals. Even if the chamber pressure increased after launch, the pressure would go to the J-shape groove and improves the seal effect.
- 2) The seal area had an interference with the o-ring added in order to decrease gap against joint rotation phenomenon.
- 3) Heaters were installed to avoid loss of o-ring elasticity
- 4) Gas leak inspection holes were added to improve the confirmation of o-ring seal function.
