Loss of Mars Polar Lander **December 3, 1999 in the vicinity of space Mars**

Masayuki Nakao (Institute of Engineering Innovation, School of Engineering, The University of Tokyo)

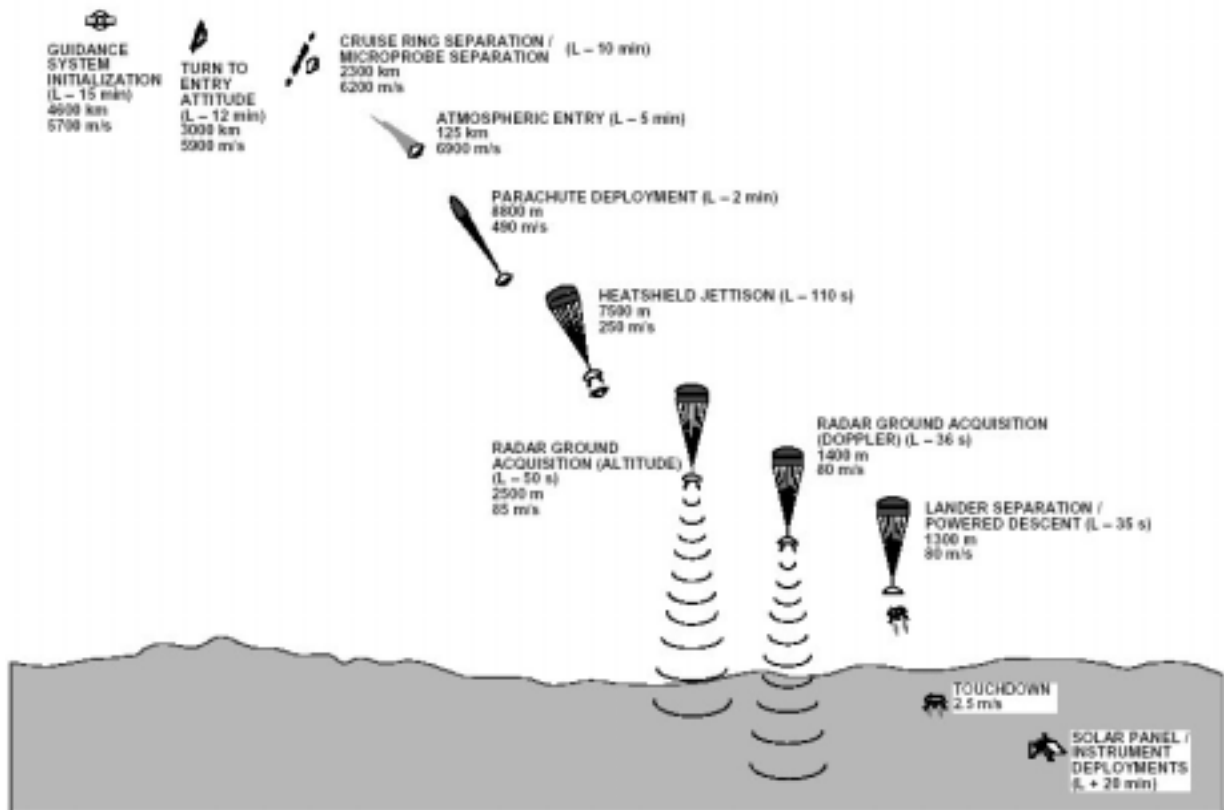
Figure 2. MPL's Entry, Descent and Landing Phase [1]

At about an altitude of 7.5 km to landing, while the Lander was still moving at 250 km/sec, it would deploy its 8.4-meter-wide parachute. Although the parachute would substantially slow the descent, it would be unable to slow it below 80 m/sec in Mars' thin atmosphere. 10 seconds after parachute deployment, the heat shield would be released to crash onto the surface so that the friction produced by the Martian atmosphere would quickly decelerate the vessel from its initial velocity. 16 seconds after the release of the heat shield, the MPL's three legs, folded up to fit inside the shield, would swing down and latch in position. When the Lander was about 1800 meters above the surface and descending at 80 m/sec, the parachute and backshell would separate from MPL, and in 0.5 seconds, the three clusters of landing thrusters would start firing. The engine thrust would be modulated during the remaining descent in accord with data from the probe's multi-beam landing radar to gradually slow the vessel to a gentle 2.4 m/sec final descent.

NASA concluded that the MPL's onboard systems confused the jolt from the deployment of a landing leg with ground contact, and shutdown the engines prematurely at 40 meters altitude down to the actual landing. MPL was assumed to have crashed on the Martian surface at 22 m/sec (about 80 km/h).

When the MPL's landing legs first swung down to lock into position after the release of the heat shield, sufficient force on flexible parts of the legs bounced the legs upwards again, and triggered the ground-contact switch to send false indicator signals to the computer system.

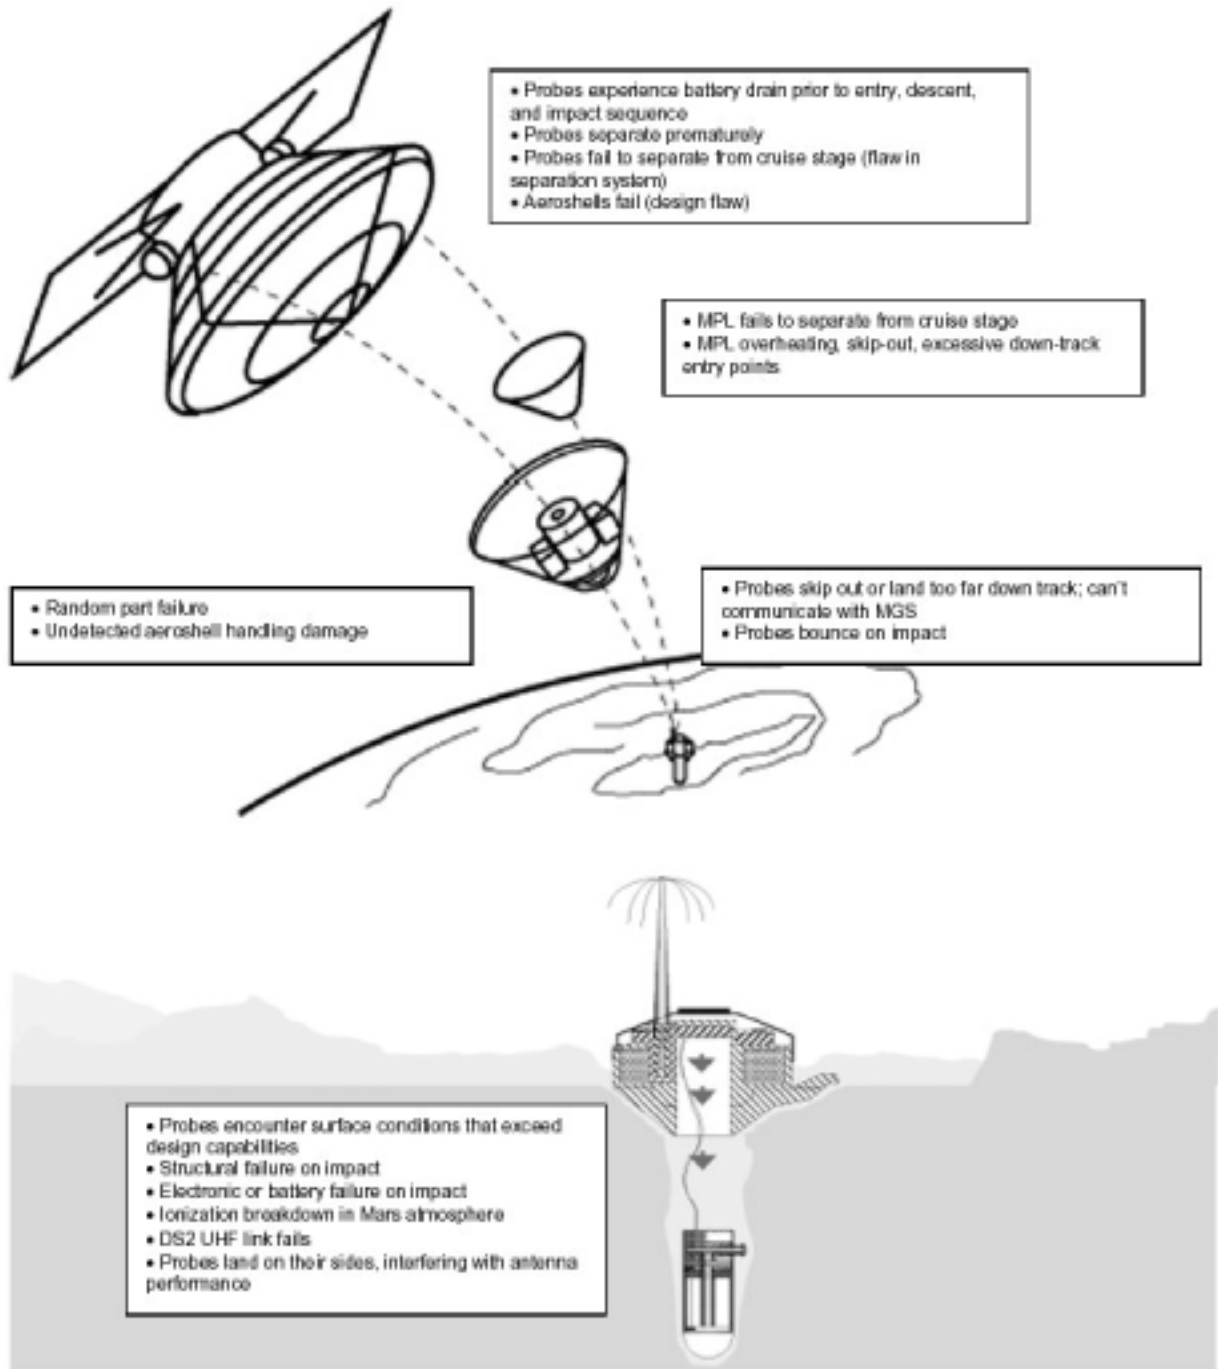
Figure 3. DS2 Entry, Descent, and Impact Sequence with Potential Failure Modes [2]

After detaching from MPL, the two DS2 probes were to extend and drill deeper into the ground to search for water as shown in Figure 3. The first data from the DS2 probes was expected to reach the Earth at 7:25 pm PST on December 4, about 7 hours after MPL touchdown. However, no communication from the probes was received.
