# Bursting of a scuba cylinder made of an aluminum alloy

June 30th, 2000, Miyako-jima, Okinawa Prefecture

KOBAYASHI, Hideo (Tokyo Institute of Technology)

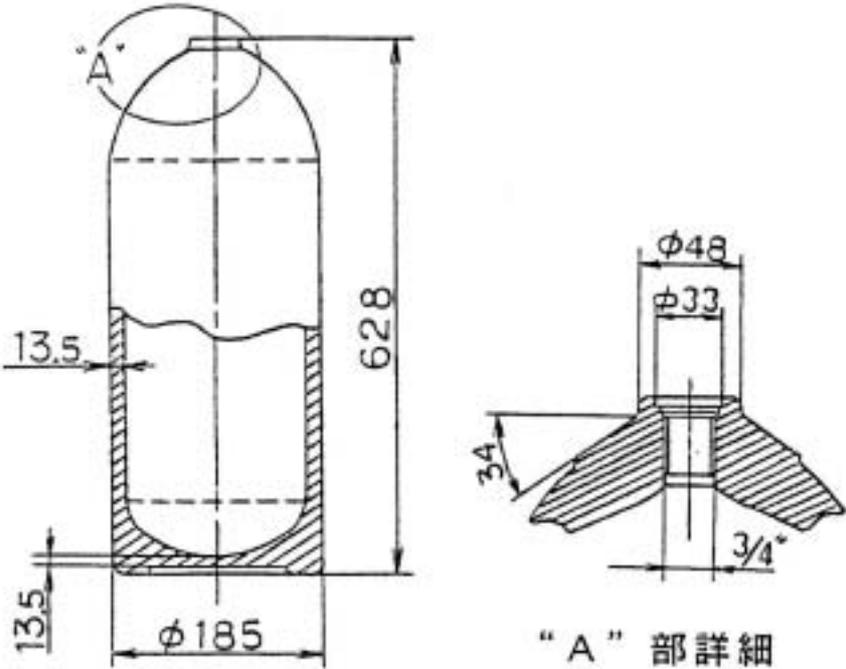
A scuba cylinder made of an aluminum alloy (Capacity : 10.3 liter, External diameter : 185 mm, Thickness : 13.5mm, Length : 628mm, Material : A6351-T6, Maximum filling pressure : 21.6MPa (220kgf/cm<sup>2</sup>), Manufacturer : Luxfer Gas Cylinders. (See Fig. 1)

Fig. 1 Major dimension of cylinder.

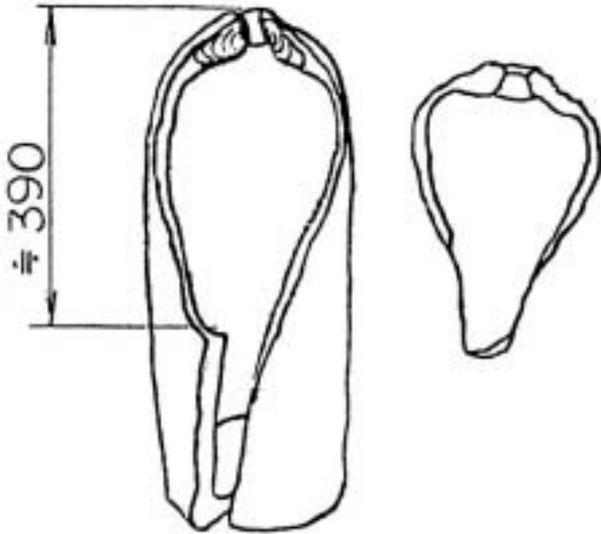
The scuba cylinder burst into two pieces without showing LBB (Leak Before Burst). The fracture surface consists of a symmetrical old surface and a newly created surface in the screw part of the cylinder. The origin of the failure is the old fracture surface, and the final rupture was occurred in a ductile fracture mode. The old fracture surface was the axial crack from the screw of cylinder, and the fracture was caused by inter-granular corrosion. The crack did not propagate from the screw surface to the outer surface of the cylinder, but from the screw surface to inside the cylinder through its shoulder. The fracture had the "thumb-nail shape" (Figure 4). The "thumb-nail shape" is a distinctive feature of stress corrosion cracking. The thumb-nail cracking did not penetrate into the cylinder: however, the cracking propagated remaining very thin layer of the ligament, and the scuba cylinder burst at last.

Fig. 2 Fracture surface of broken cylinder.

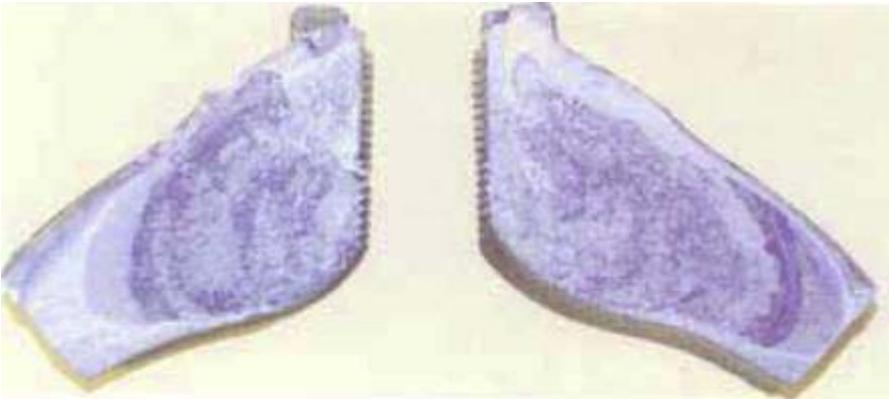
Fig. 3 Old fracture surface.

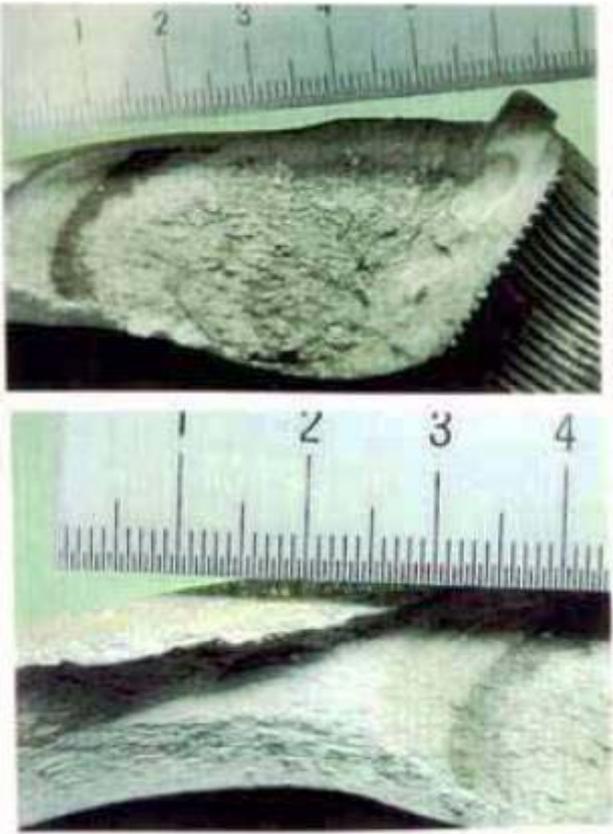
Stress corrosion cracking, which induces thumb-nail cracking, resulted from inter-granular corrosion at the surface of the screw part of the cylinder. Although there was some general and localized corrosion at the inside of the shoulder, body and bottom part, deep inter-granular corrosion was not found. Through the metallographic observation of the vertical section of the cylinder, it was found that the crystal grain became coarse and crystal grain showed anisotropic growth. They were caused by the warm working during manufacturing the head and the recrystallization during solution treatment. The susceptibility to inter-granular corrosion and stress corrosion cracking was increased by the coarseness and the aeolotropic shape of the crystal grain.

Fig. 4 Thumbnail-shape fracture surface.

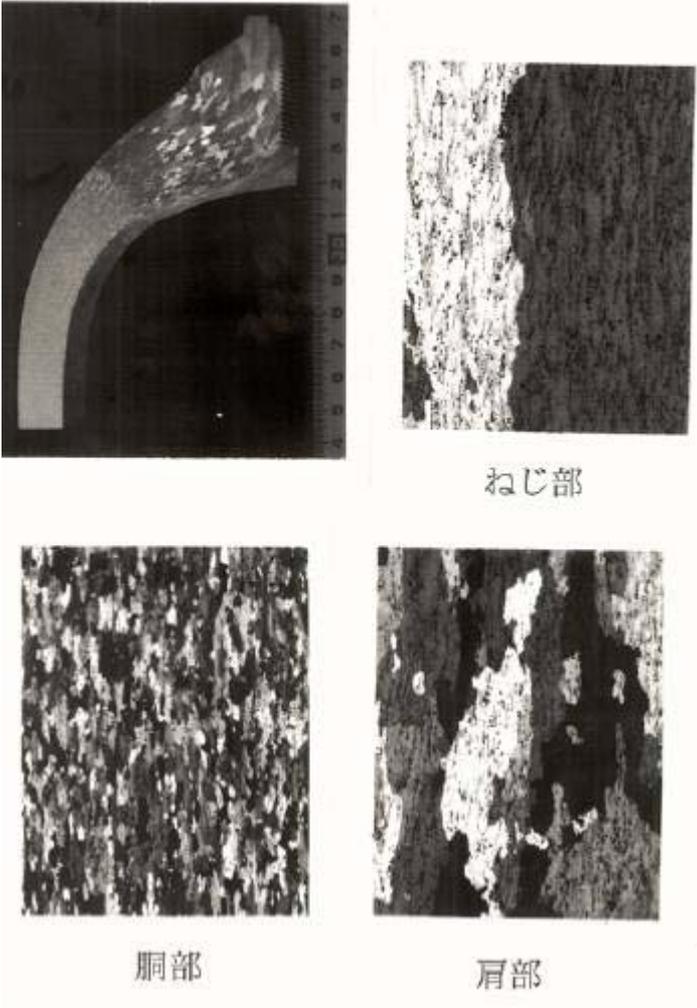
The scuba cylinder was made of the problematic A6351-T6 aluminum alloy. Furthermore, the grain around the part of the screw become coarse and the grain shape aeolotropic due to the warm working and the solution treatment during the manufacturing of the head part of the cylinder. On the other hand, it appears that water and salt got into the cylinder during the filling of the air. Therefore, the inter-granular corrosion apparently had been accumulating for a long time, and the stress corrosion cracking by the hoop tensile stress caused by the inner pressure of the cylinder changed the inter-granular corrosion into the thumb-nail cracking form. The thumb-nail cracking was not observed by visual inspection of the cylinder. The cracking grew under the continuous use of the scuba cylinder. Finally, the scuba cylinder burst, starting at the cracking, during the filling of the air.

Fig. 5 Metallographic observation results.
