Leakage of Sodium Coolant from Secondary Cooling Loop in Prototype Fast Breeder Reactor MONJU

Dec. 8th, 1995, Tsuruga, Fukui pref.

KOBAYASHI, Hideo (Tokyo Institute of Technology)

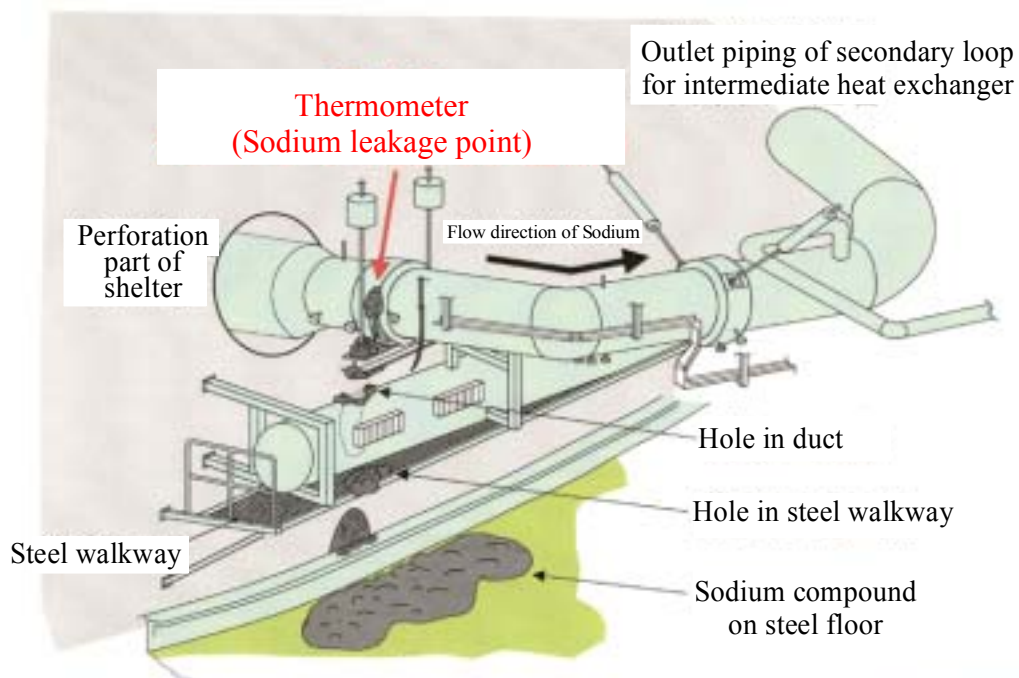
Terminal of the thermometer sensor on the outlet piping of the secondary main cooling loop in the intermediate heat exchanger. The schematic diagram of the equipment, the appearance of the site, and the broken thermometer well together with the route of the leakage are shown in Figures 1, 2 and 3, respectively.

Fig. 2 Appearance of leakage point of sodium.

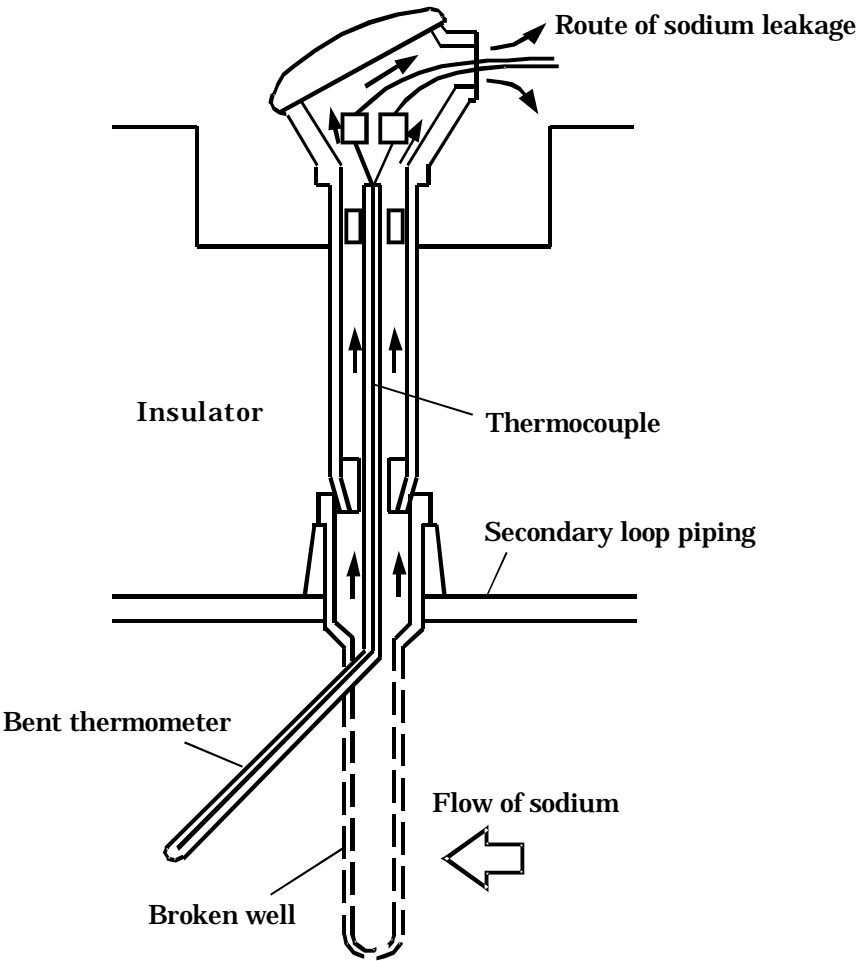
Leakage of sodium occurred as a result of a break in the thermometer well. The break point corresponded to a part of the thermometer well where its diameter had been changed sharply. Investigation and observation of the fracture surface confirmed the cause of the break to be a high frequency fatigue due to fluid vibration in the direction parallel to the flow. The direction of the fatigue crack propagation coincided to that of the sodium flow, which had caused the well to vibrate in a direction parallel to the flow. The flow-induced vibration was clarified afterwards as being due to a symmetrical vortex.

Stress concentration at the point where the diameter of the well changed sharply in a step-wise caused the fatigue crack fracture. In order to reduce the stress concentration, it is necessary to take a large radius of curvature at the changing point of the well's diameter. Inspection for the design with the step-wise shaped thermometer well was insufficient.

On December 8, 1995, a leakage of sodium coolant occurred in the secondary main cooling loop of the prototype fast breeder reactor MONJU. The leakage was caused by a break in the thermometer well that had been inserted into the pipe. The break was caused by fluid vibration (Figure 3).

Fig. 3 Broken thermometer well and leakage route of sodium.

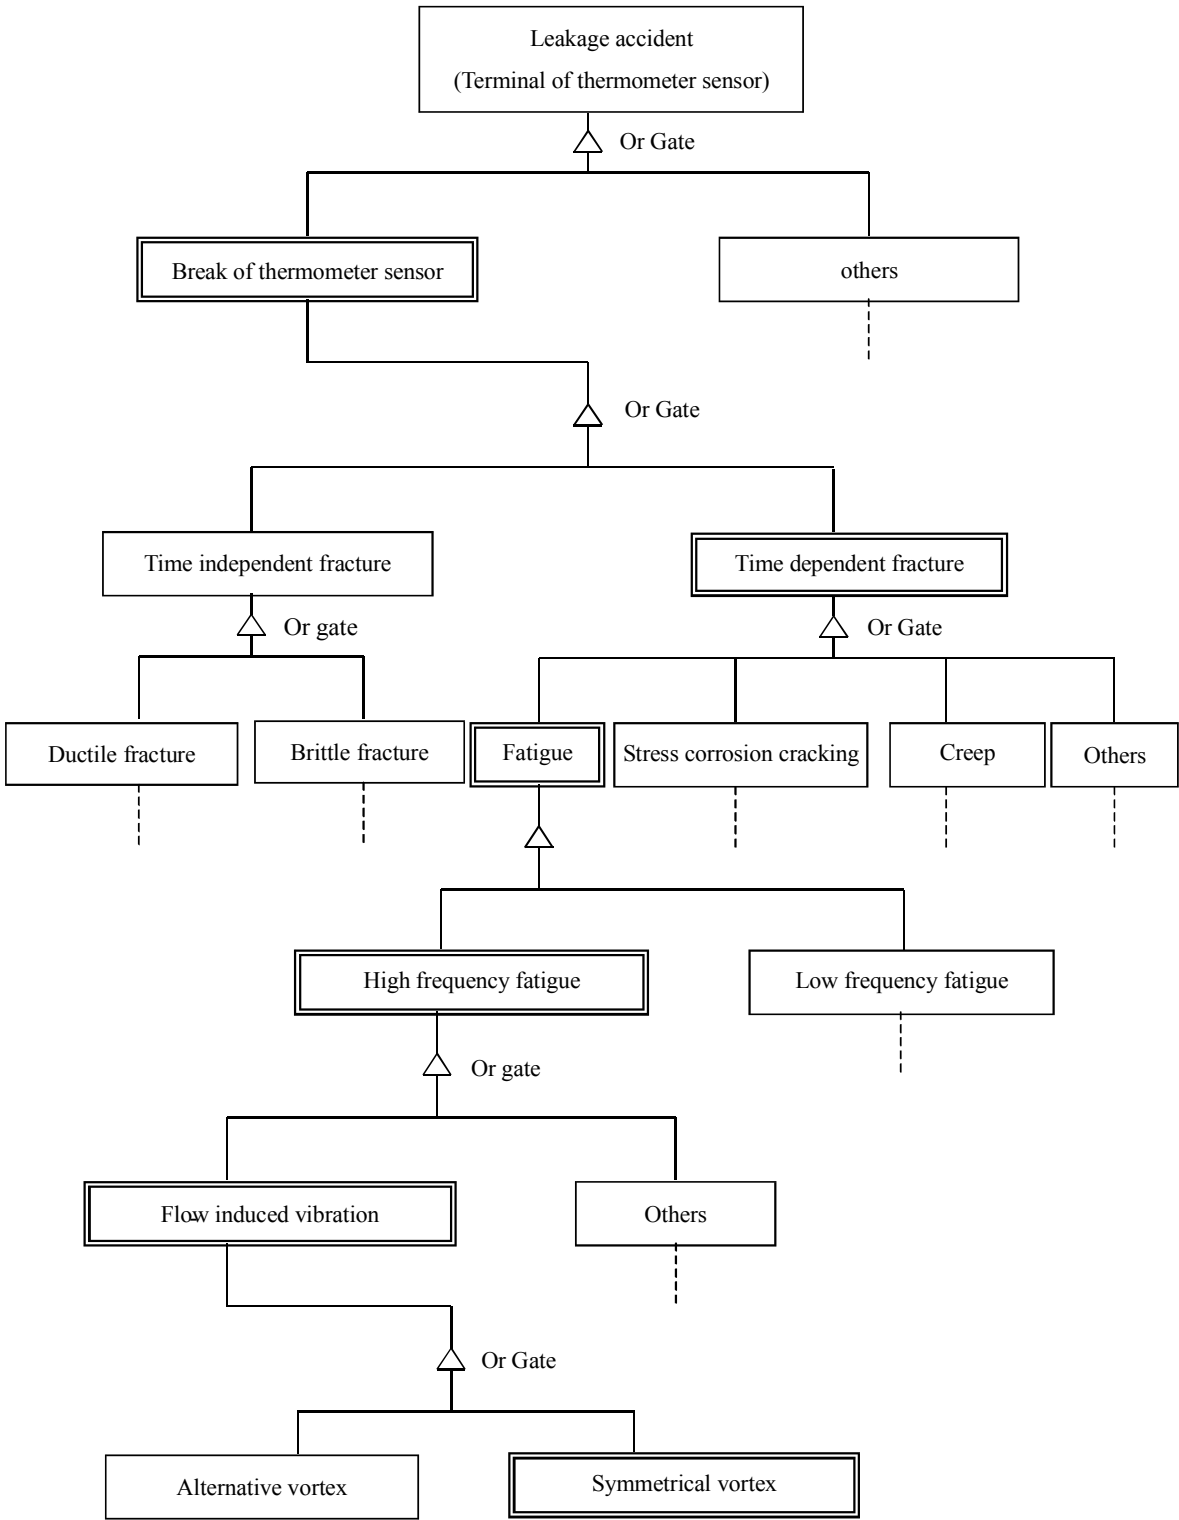
Fig.4 Fault-tree diagram based on morphology, mechanism, and process of fracture.

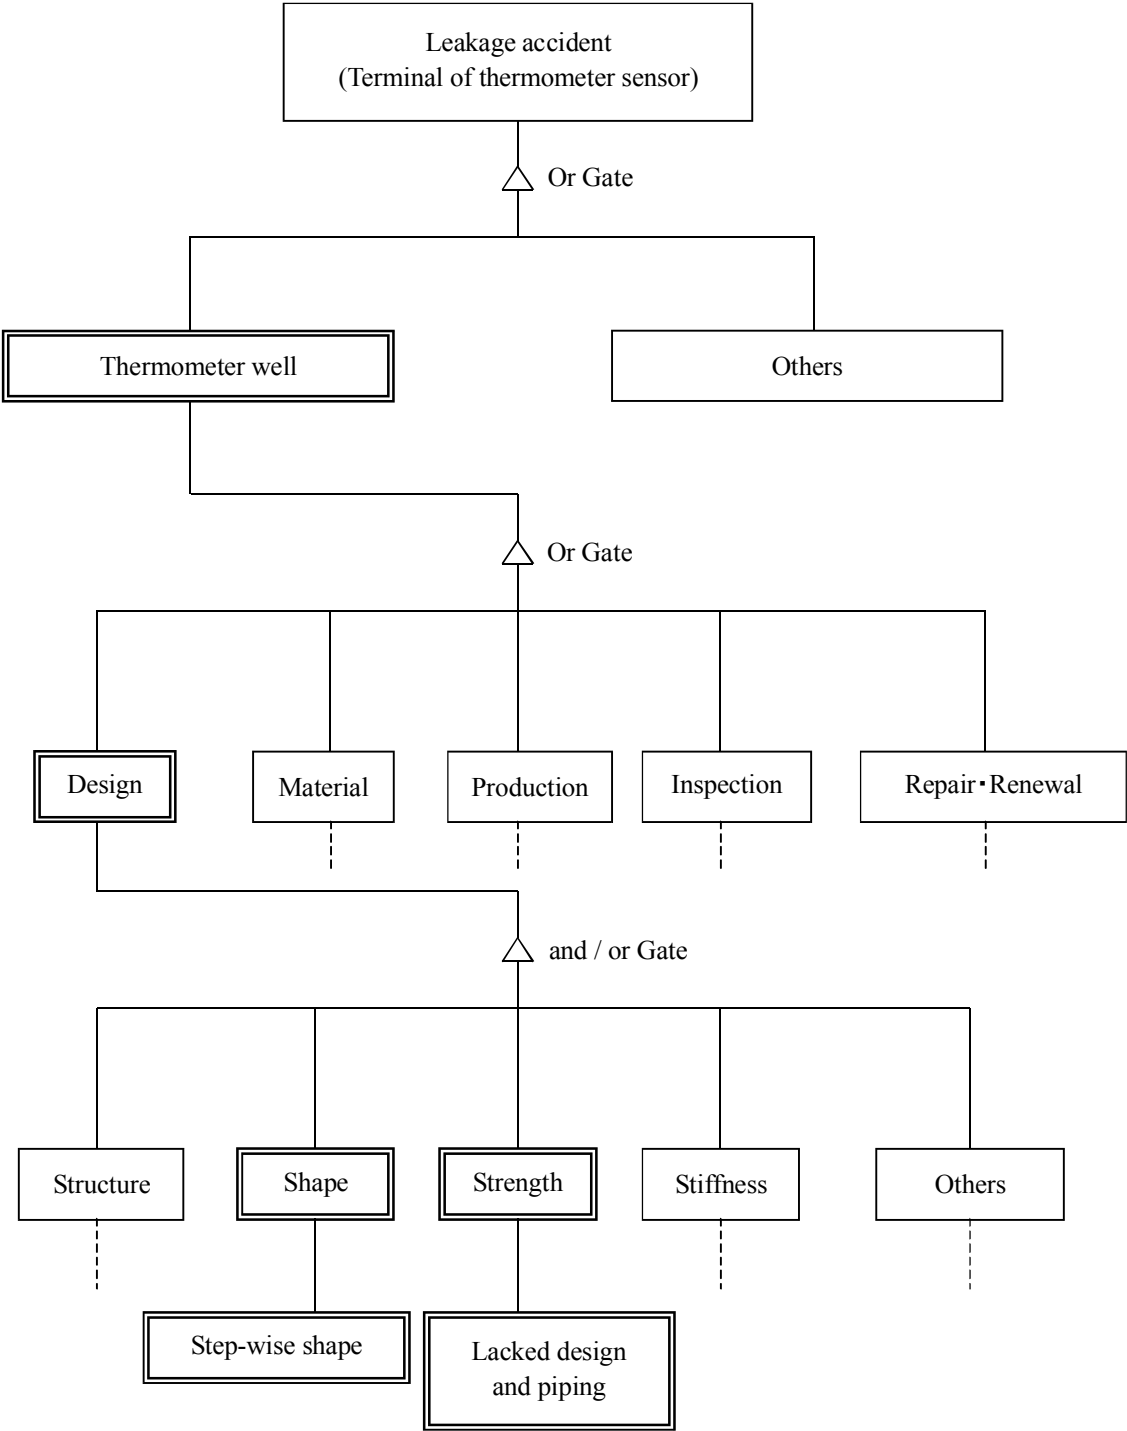
Because of a mistake in the design standard, the designer had evaluated only the vibration in the direction perpendicular to the flow that is caused by an alternative vortex. In addition, the shape of the well had been designed to have a part where the direction changed sharply, and a stress concentration was induced at the region of diameter change that caused the fatigue crack.

Fig. 5 Fault-tree diagram based on wrong design and fabrication of equipments.

The design standards should be periodically reexamined and updated with the newest technical information. In 1997, the PNC established a design guideline for preventing the flow-induced vibration of the thermometer (PNC TN94-10-97-042). Based on this guideline, the Japan Society of Mechanical Engineers established the guideline for evaluating the flow-induced vibration of a cylindrical structure on piping (JSME S 012-1998) in 1998.

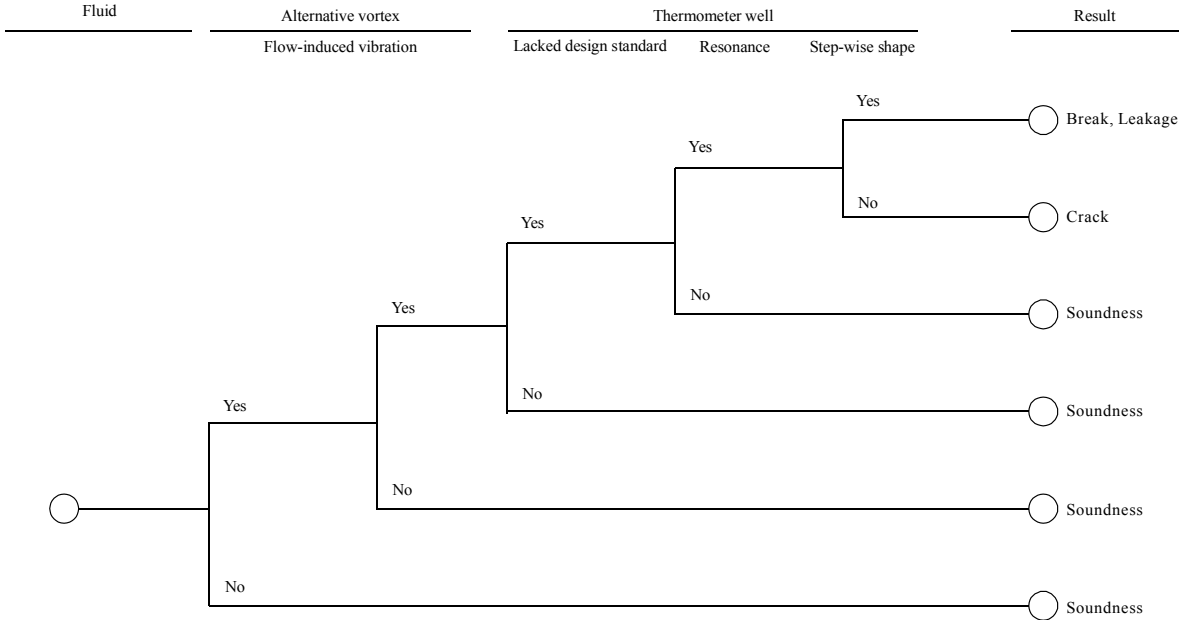
There are two kinds of flow-induced vibrations that are induced by Karman's vortex row, a vibration in the direction perpendicular to the flow caused by an alternative vortex, and a vibration in the direction parallel to the flow caused by a symmetrical vortex. The relation between the amplitude and flow rate in vibration of the thermometer well is shown in Figure 7. Based on the defective design standard, the designer had evaluated only the former perpendicular vibration in the design of the thermometer well, not the later parallel vibration. However, the vibration in the direction parallel to the flow that was caused by the symmetrical vortex resulted in a high frequency fatigue fracture in the well due to the resonance and the stress concentration. The resulting break in the well caused the leakage of sodium.

Fig. 6 Event-tree diagram on the break of thermometer-well caused by a flow-induced vibration due to a symmetrical vortex

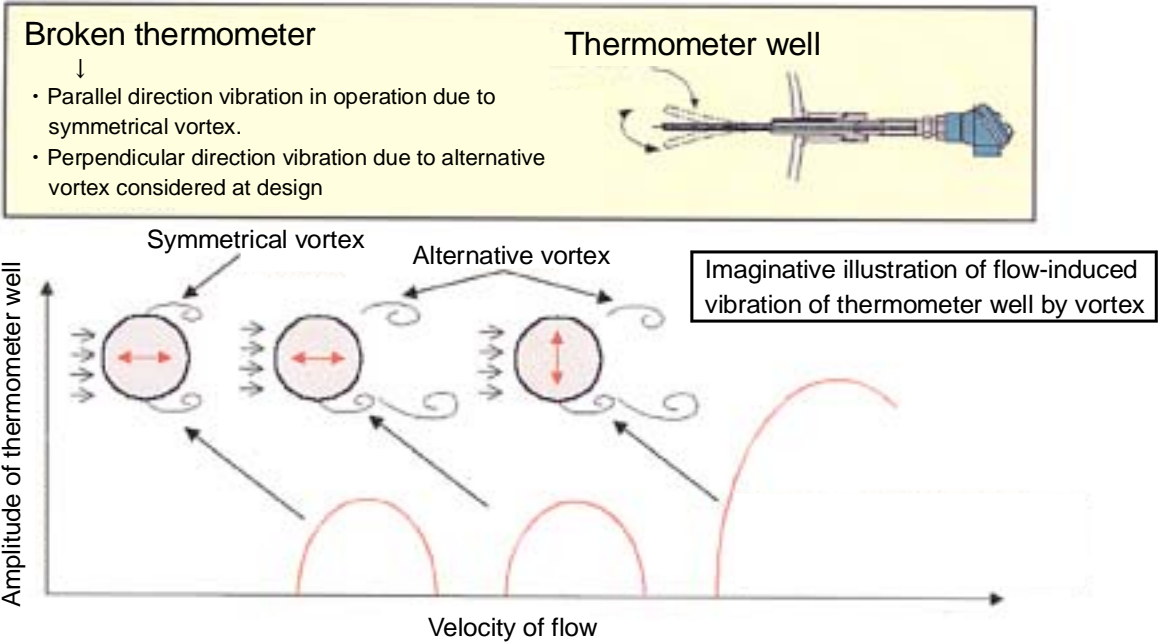
Fig. 7 Relation between amplitude and flow rate in vibration of thermometer.

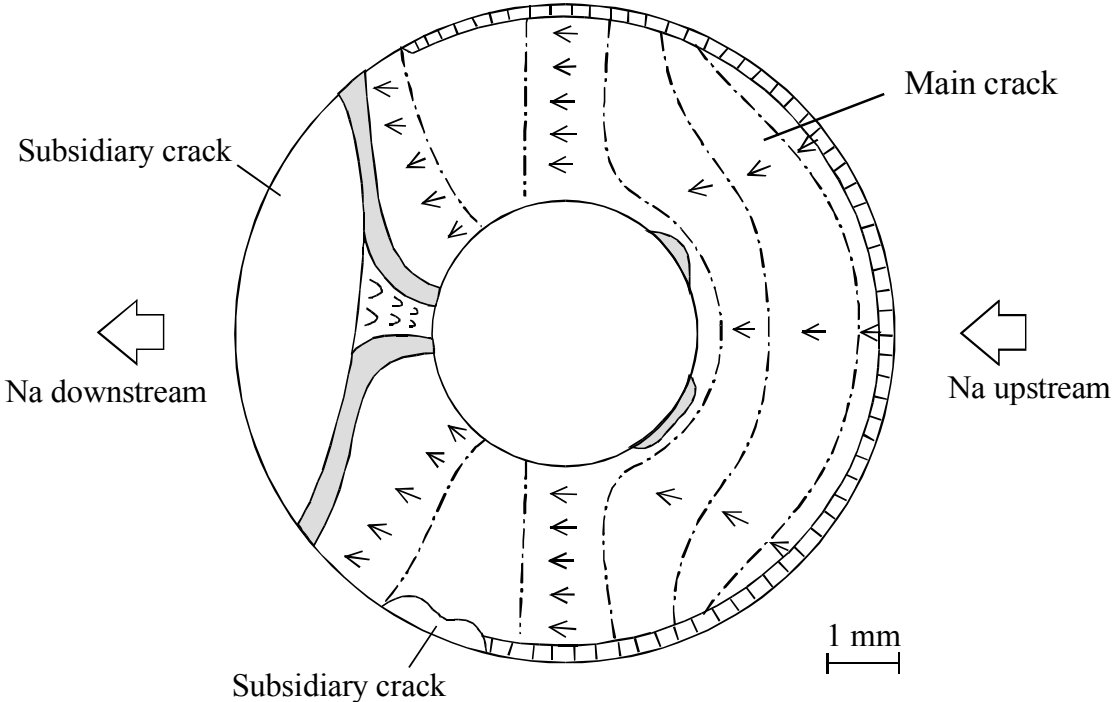
Furthermore, the vibration under a low frequency of the vortex row continues to vibrate the well in the same direction to the flow, so that it causes the fatigue failure sooner or later. The fracture surface shown in Figure 9 shows that the vibration in the direction parallel to the flow caused the well to break by the fatigue failure.

Fig. 9 Fracture surface of well and direction of crack .

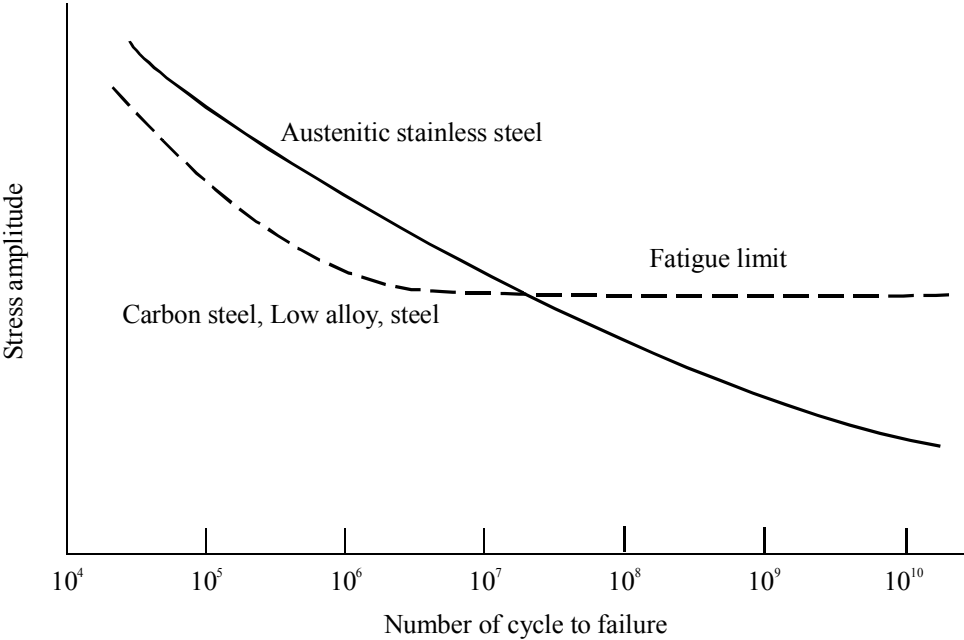
Another problem is the material of the well. The relation between the stress amplitude of the well materials and the number of cycles to failure for the well (S-N curves) is shown in Figure 10. The well material was an austenitic stainless steel, which has a lower strength against high frequency fatigue than carbon steel or low alloy steels, and shows a monotonic decrease in strength without any fatigue limit. Therefore, fatigue failure will always occur no matter how small the stress amplitude is. The problem is that we do not currently have data for S-N curves where the number of cycle to failure is $10^7 \sim 10^{11}$, which is the range that corresponds to objects subjected to fluid vibration fatigue.

Fig. 10 S-N curve of material (log-log plot)
