# Explosion and fire caused by the breakaway of the cover plate from the heat exchanger of the desulfurization equipment

Oct. 16th, 1992, Sodegaura-city, Chiba prefecture

KOBAYASHI, Hideo (Tokyo Institute of Technology)

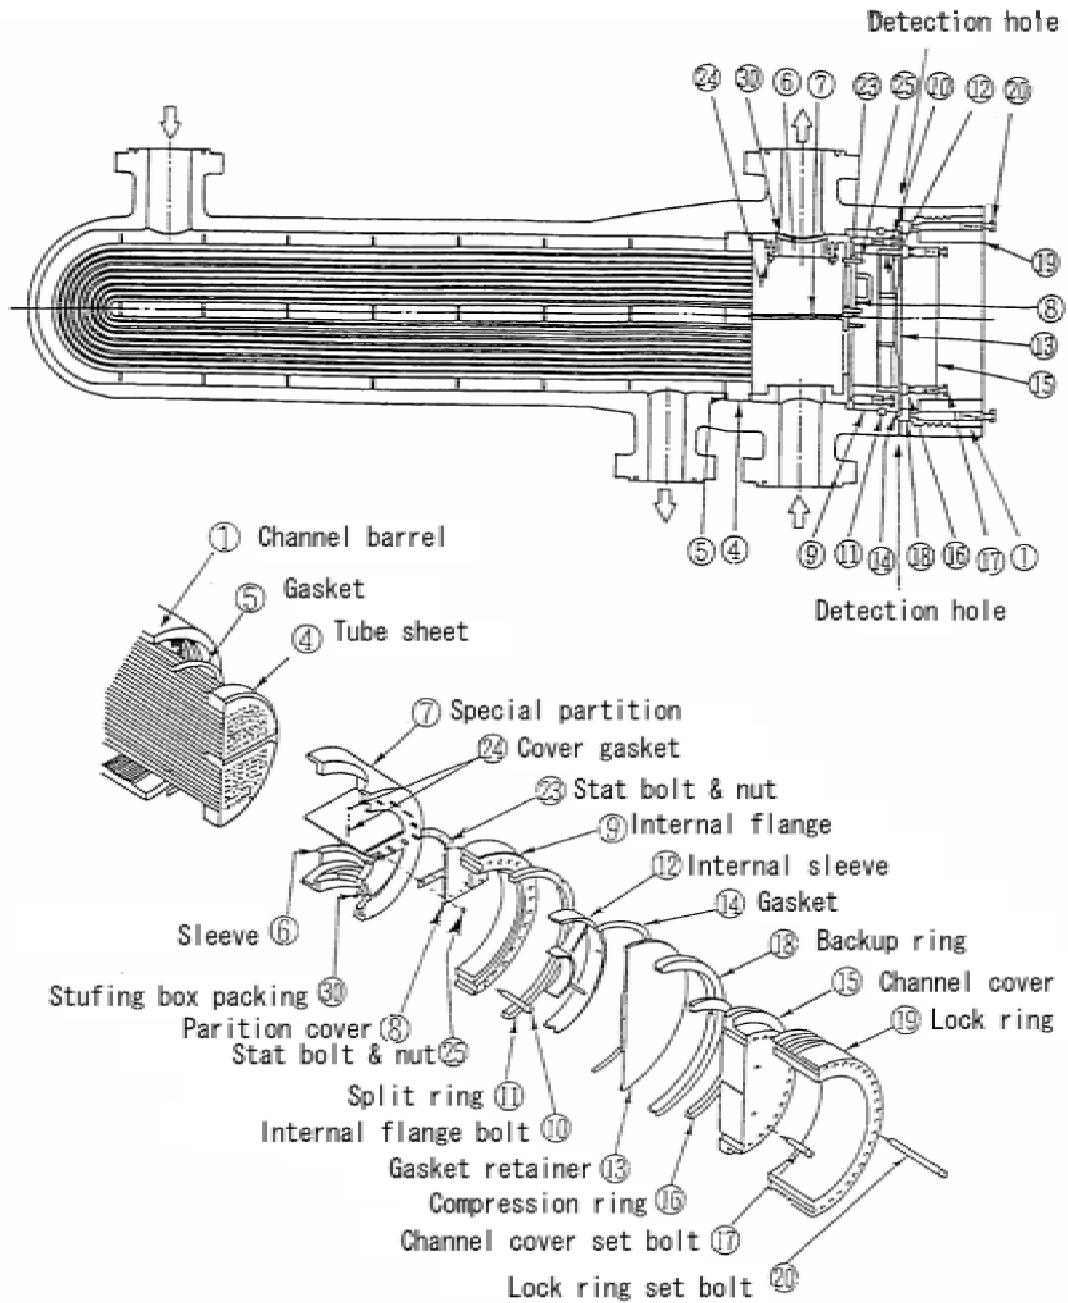
Fig. 1 Structure of BLC type heat exchanger.

Figure 1 shows the structure of the BLC type heat exchanger. Figure 2 shows the details of the airtight design. The pressure exerted on the channel cover of the heat exchanger is supported by the screw thread of the channel barrel via the lock ring. The airtightness between the inside and outside of the heat exchanger is kept by gaskets through the torque of the bolt which fastens the lock-ring. The piping area and the body area are separated by the tube sheet. The separation between the piping area that is at high pressure and the body area that is at low pressure is kept airtight by gaskets through the torque of the channel cover set bolt that is applied through the special partition.

- 2) The thermal deformation of the inner parts of tube area was absorbed by the destruction of the tip of the internal flange bolt set (10). However, the internal flange set bolts were not adequately replaced. Therefore, the load on the channel cover set bolts (17) was increased, and the lock ring was bent. Gradually, the diameter of the lock ring decreased.

- 3) There were two main causes for the increase of the diameter of the channel barrel (1). One was the thermal deformation caused by the difference of temperature resulting from the removal of the insulation. The other was the variation of the inner pressure caused by the leak of hydrogen gas.

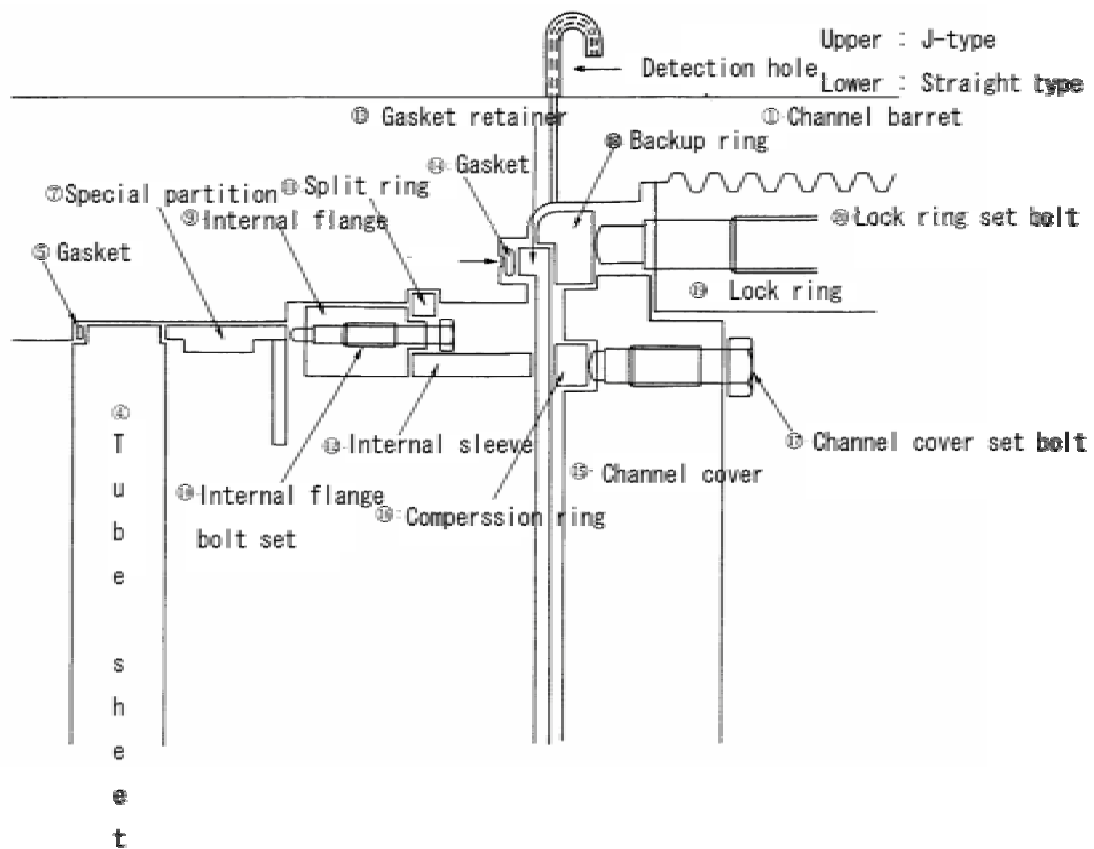
Fig. 2 Detail of airtightness.

- 1) Although the diameter of the gasket retainer (disk-shaped, SUS321) that was set at the back of the channel cover to keep it air tight was being reduced by the repeated ratcheting, it was not correctly replaced.

- 4) Through the combination of the decrease of the lock ring's diameter and the increase of the channel barrel's diameter, the overlap of the screw threads was decreased. Finally, the lock ring was broken by the plastic deformation of the top of the screw threads which were set in front of the channel barrel.
