# Failure of Return to the Earth of Space Shuttle 'COLUMBIA'

Feb. 1st, 2003, High Above Texas

KOBAYASHI, Hideo(Yokohama National University)

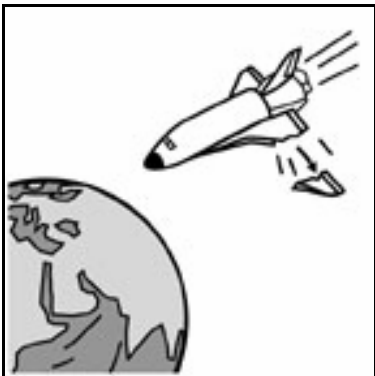
Space shuttle Columbia disintegrated in midair over Texas while it was returning to the earth after killed. (See, Fig. 1) This became the second tragedy in the 113 flights of the Space Shuttles, the first tragedy being the midair explosion of Challenger soon after the lift-off in January 1986. The Independent Accident Investigation Committee concluded that damage that had occurred to the leading edge of the left wing at the moment of lift-off was the cause of the accident.

At around 9 am, small glowing pieces like meteors were observed from the ground, and some wreckage from the space shuttle was also recovered in Texas afterward. Then it was concluded that Columbia had disintegrated in midair.

Fig. 1 Midair Disintegration of Columbia.

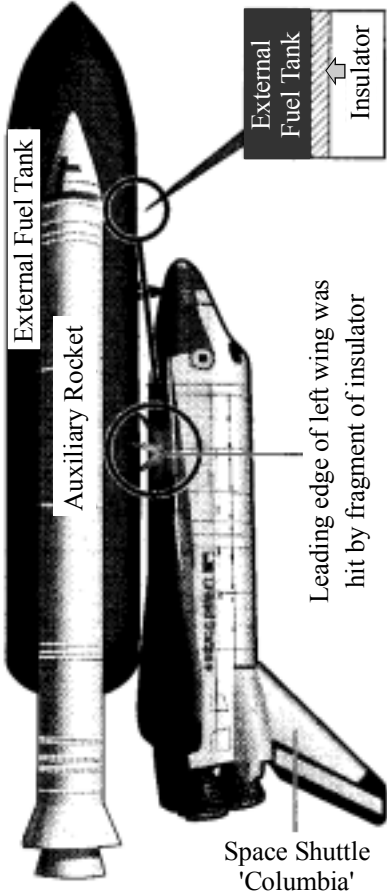
Just after lift-off, a piece of the insulator of the external fuel tank came off and hit the leading edge of the left wing of the orbiter. (See, Fig. 2) At that time, NASA made the following statement in a press interview: "There is no problem and the space shuttle will land as scheduled".

On January 16th, about eighty seconds after lift-off, a piece of the insulator of the external fuel tank came off and hit the leading edge of the left wing of the orbiter with the speed of 850 km/h. It was concluded that the orbiter disintegrated at the moment of reentry on February 1st, because air with very high temperature blew in from the damaged area.

Fig. 2 Insulator Fragment of External Tank Hit the Leading Edge of Left Wing.

- Periodical inspection of the leading edge of the orbiter wings
- Photographing the moment of lift-off using a high sensitivity camera
- Observation of the orbiter in orbit utilizing a reconnaissance satellite
- Live coverage of the entire surface of the orbiter from reentry to landing using onboard cameras.
- Establishing a system to repair the space shuttle in orbit
