Steam Eruption from Secondary System Piping in Nuclear Power Plants

August 9th, 2004, Mihama-cho, Fukui-pref.

KOBAYASHI, Hideo (Tokyo Institute of Technology)

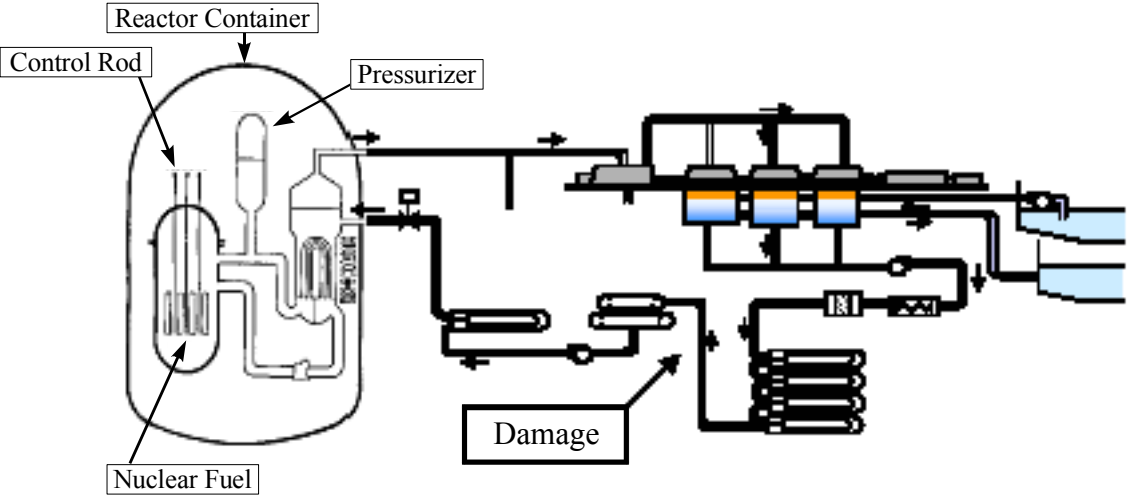
The central system of PWR and location of the damaged section is shown in Fig 1. The damaged section of piping was situated near the downstream of orifice flow meter in "A" system condenser piping. Two condenser piping system labeled "A" and "B" were installed, which connect low pressure water absorption heater No.4 near ceiling to deaerator in the 2nd floor turbine room. Orifice is a mechanism which reduces cross sectional area of pipe to measure the fluid flow.

Fig. 1 Main damaged area of PWR.

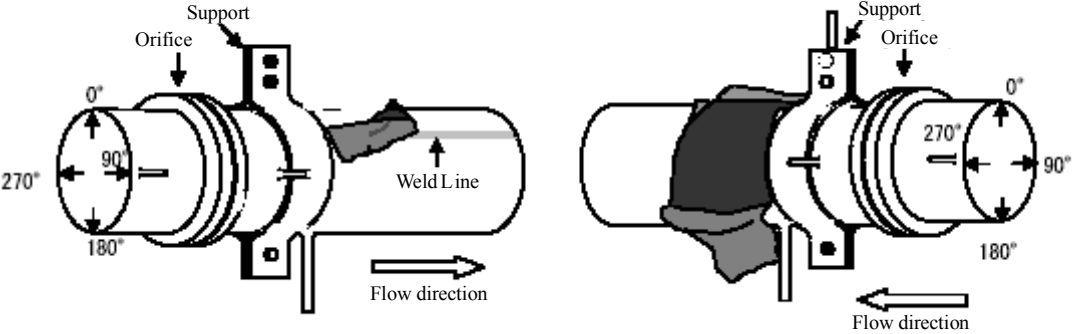
The detailed appearance of the damage is shown in Fig. 2. The material used for the piping was Carbon Steel (SB42), having an outer diameter of 538.8mm, a nominal thickness of 10mm, a temperature of around 140 degrees Celsius, a pressure of around 0.93 MPa, and a flow rate of 1700 m³/h. The reduction of thickness was significant at upper part. The maximum size of fissure was 515mm in axis direction and 930mm in radial direction. The thinnest wall-thickness was 0.4mm.

The scale pattern, a feature of erosion and/or corrosion, was observed at downstream of orifice except for the lower part of a pipe. On the other hands, a nominal thickness was remained at the lower part of a pipe and the section had the thick surface coating (0.4mm). The scale pattern was not observed there.

It can be supposed that the pipe rupture was caused by the plastic collapse at thinner part by pressure in service as a result of reduction of pipe thickness due to erosion and/or corrosion. Here, reduction of pipe thickness due to erosion and/or corrosion at downstream of vent occurred before the reduction of pipe thickness at downstream of orifice. Fortunately, the leakage was not happened at downstream of the vent because the flange was installed to support the orifice. This was typical case of the localized metal loss and the rate of reduction is very high. The part is not in the inspection list because the inspection of this part is impossible. The cause of erosion and/or corrosion at downstream of vent must be clarified. The localized metal loss at downstream of vent indicates the other parts of erosion and/or corrosion which were not realized. Furthermore, it is supposed that the turbulent flow that caused erosion and/or corrosion at downstream of the vent combined with the flow that caused erosion and/or corrosion at downstream of the orifice, hence accelerating the erosion and/or corrosion.

Fig. 2 Piping Damage.

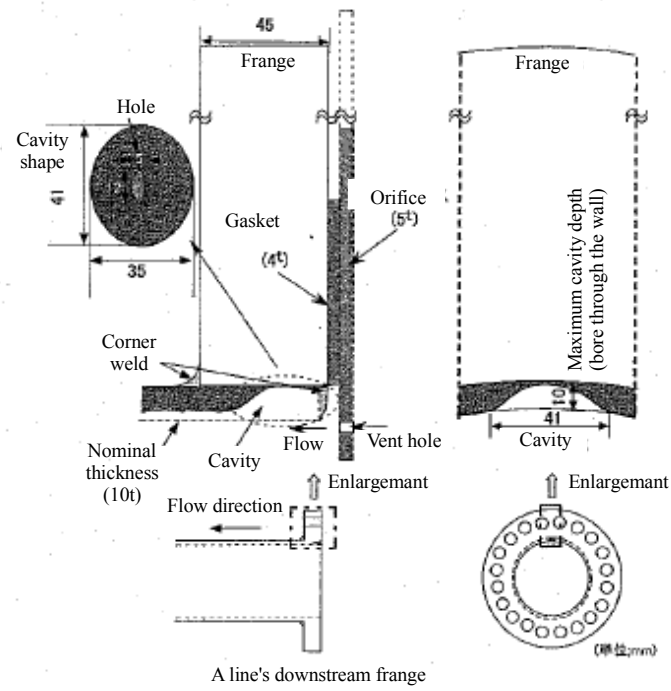
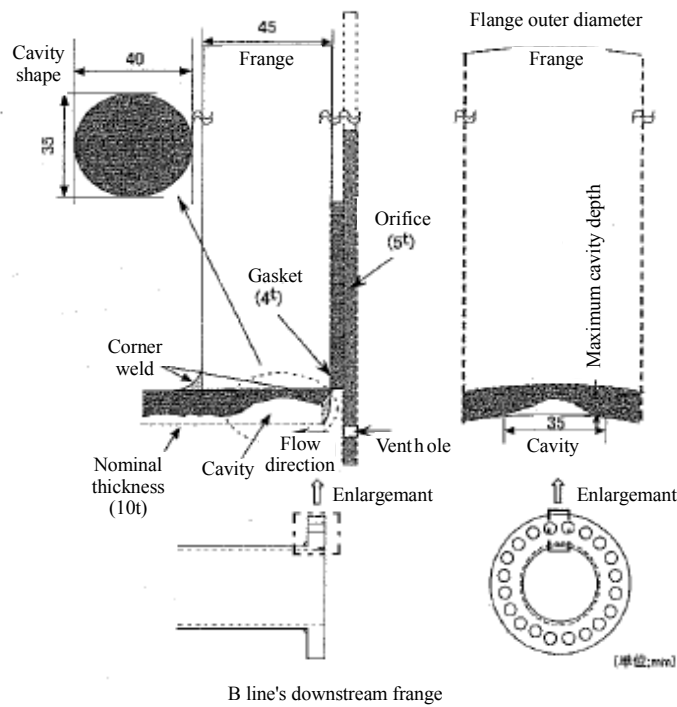
Later investigation reported that the thickness of pipe was penetrated, and reduction of thickness of flange which supports the orifice was also observed at the downstream of a vent. The situation of the downstream of the vent is shown in Fig. 4. The vent is installed at upper part of orifice to release air. In this case, the diameter was 4mm.

Fig. 3 Downstream of Vent.

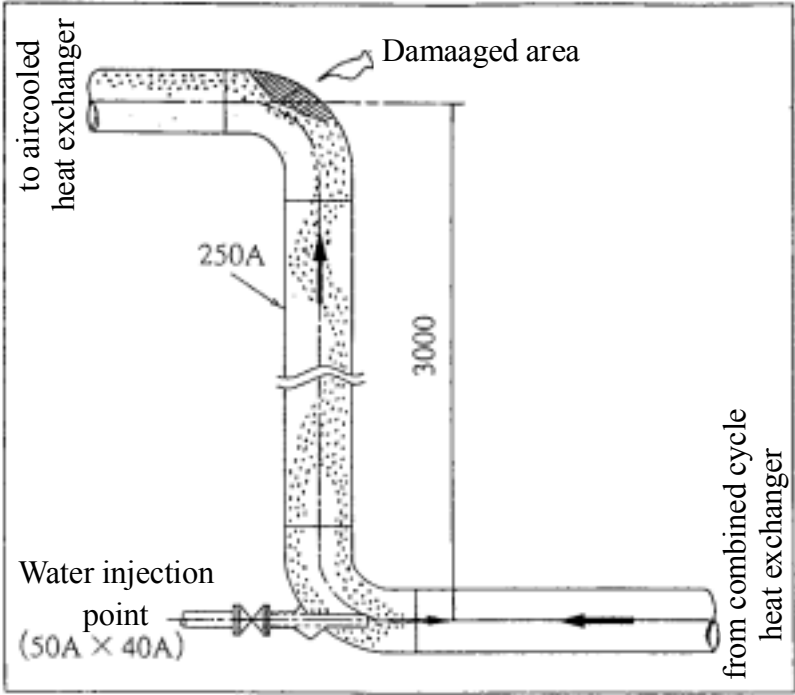
Figure 5 shows a combination example of water injection and an elbow part. The position of water injection was structurally inappropriate. The turbulent flow of the injected water stream accelerated the erosion and/or corrosion at the elbow part. In addition to the environmental affect, the rate of thickness reduction was at 4 mm/year. By analogy with this case, the accident occurred at Kansai Electric Power Company was supposed that the vent performed as water injection and the injection accelerated the erosion and/or corrosion at the orifice downstream.

Fig. 5 Damage from cold water Injection.

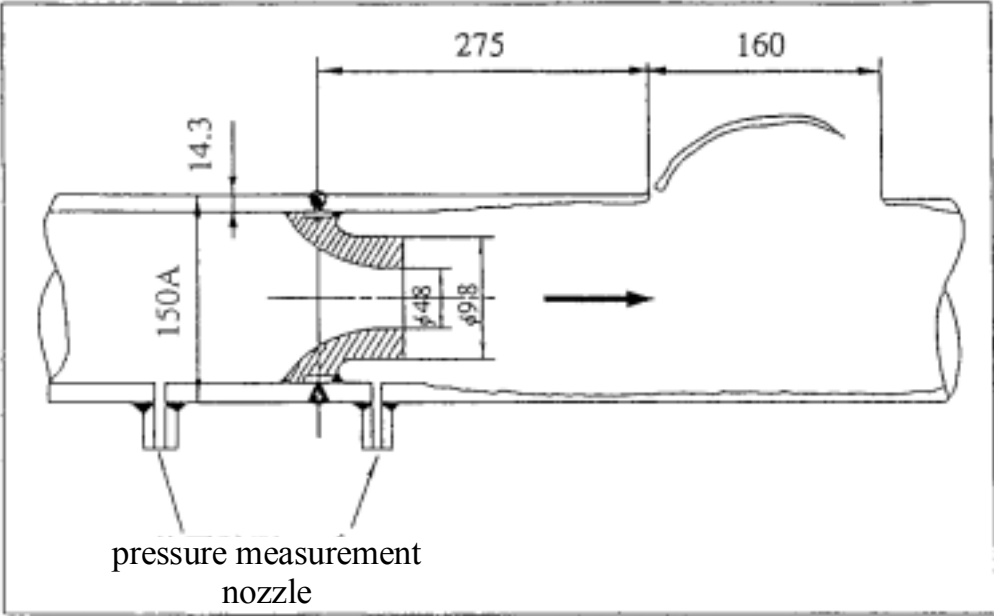
Figure 6 shows an example of hot flushing combined with an orifice. Under the condition that the hot water flushing (separation between liquid and gas phases) occurs, erosion and/or corrosion were accelerated at downstream of the orifice. Compared this example and the Kansai Electric Power Company accident, the opening appearance caused by the rupture and the thickness reduction at downstream orifice was analogous to each other.

Fig. 6 Damage from hot water flushing.
