Failed Launching of H- II A Rocket #6

Nov. 29th, 2003, Pacific Ocean, Off Tanegashima Island, Kagoshima

(Summary)

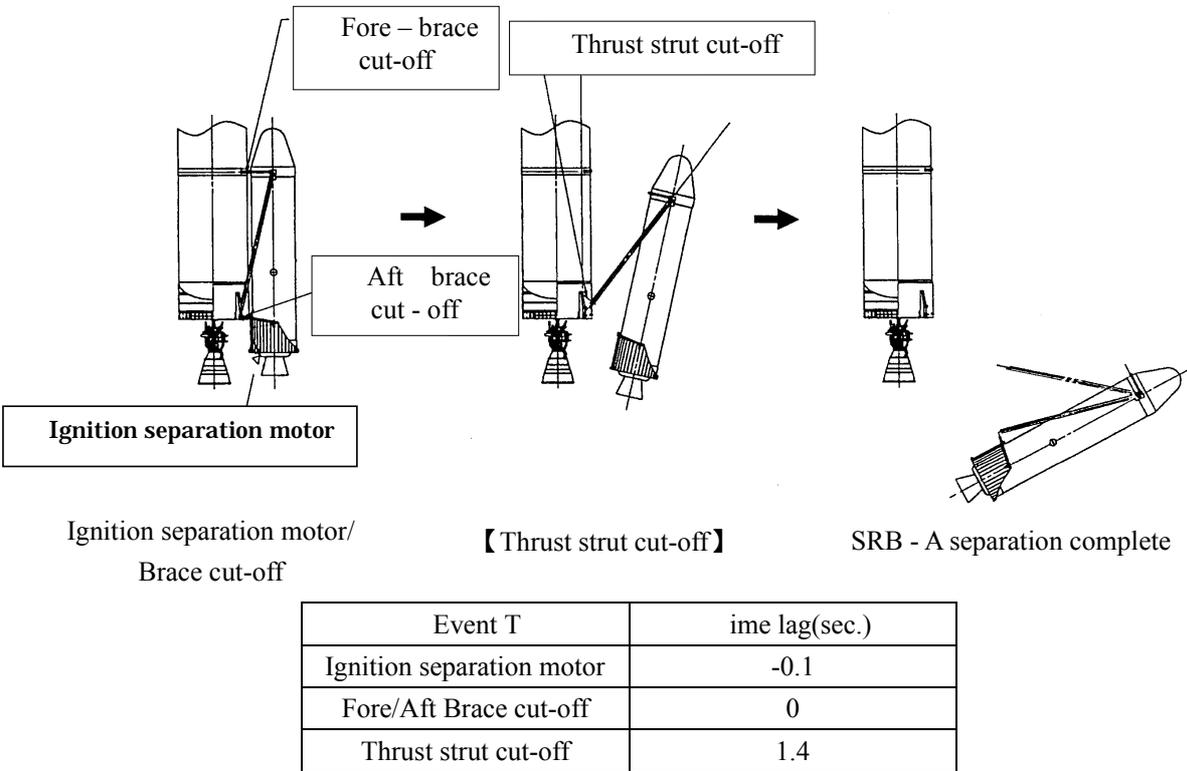
Fig. 4 Separation Concept of SRB-A.

The sequence of the SRB separation is shown in Fig.4. The SRB on the left hand side failed to separate because the forward brace connecting the fuselage and the SRB was not cut.

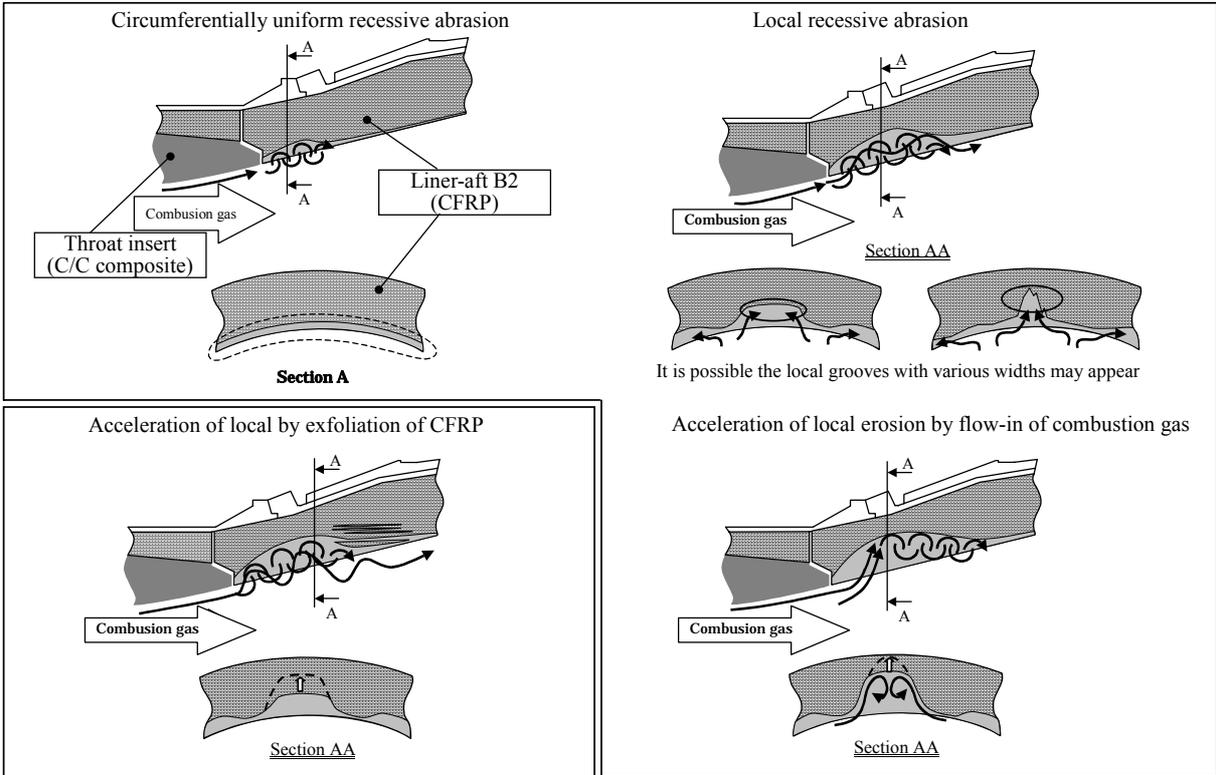
Fig. 5 Acceleration Process of Local Erosion.

The sequence of events leading to the failure is believed to have occurred as follows. (See Figure 5)

Because of the difference in the materials used for the nozzle throat and the liner aft, a step emerged along the front edge of the liner aft B2 on the inner side of the SRB-A nozzle during combusting.

This step caused a disturbance in the flow of the combustion gas, the heating rate became higher, and a thickness reduction was induced downstream of the flow.

Somewhere in this area of reduction in thickness, relatively deep grooves were formed by the deterioration of the binding properties of the carbonized layer.

As the grooves grew, the inter-laminate pressure and delamination increased, causing the exfoliation of the CFRP laminates. As a result of this phenomenon, local erosion was accelerated.

As a result of the increase of local erosion of the liner-aft B2, the combustion gas reached holder B, resulting the melting of the holder, which led finally to the leakage of the hot gas into the aft adapter. The combustion gas leaked into the aft adapter, heated the cable that carried the electric signals for the separation device causing the cable to fail so that the separation signal of SRB was not transmitted.

A bell-type nozzle with a higher angle at the nozzle mouth was adopted to more effectively prevent the delamination that accelerates the local erosion.

The thickness reduction of the liner-aft made of CFRP was found to be alleviated by extending the throat insert in the downstream direction of the exhaust gas flow.

A new design criterion was adopted to establish the reliability of nozzle. In accordance to this criterion, the thickness of the liner-aft was increased.
