Tank Explosion at the LP Gas Filling Station

Sept. 14th, 1964, Ibaraki, Osaka

AKATSUKA, Hirotaka (High Pressure Gas Safety Institute of Japan)

(Summary)

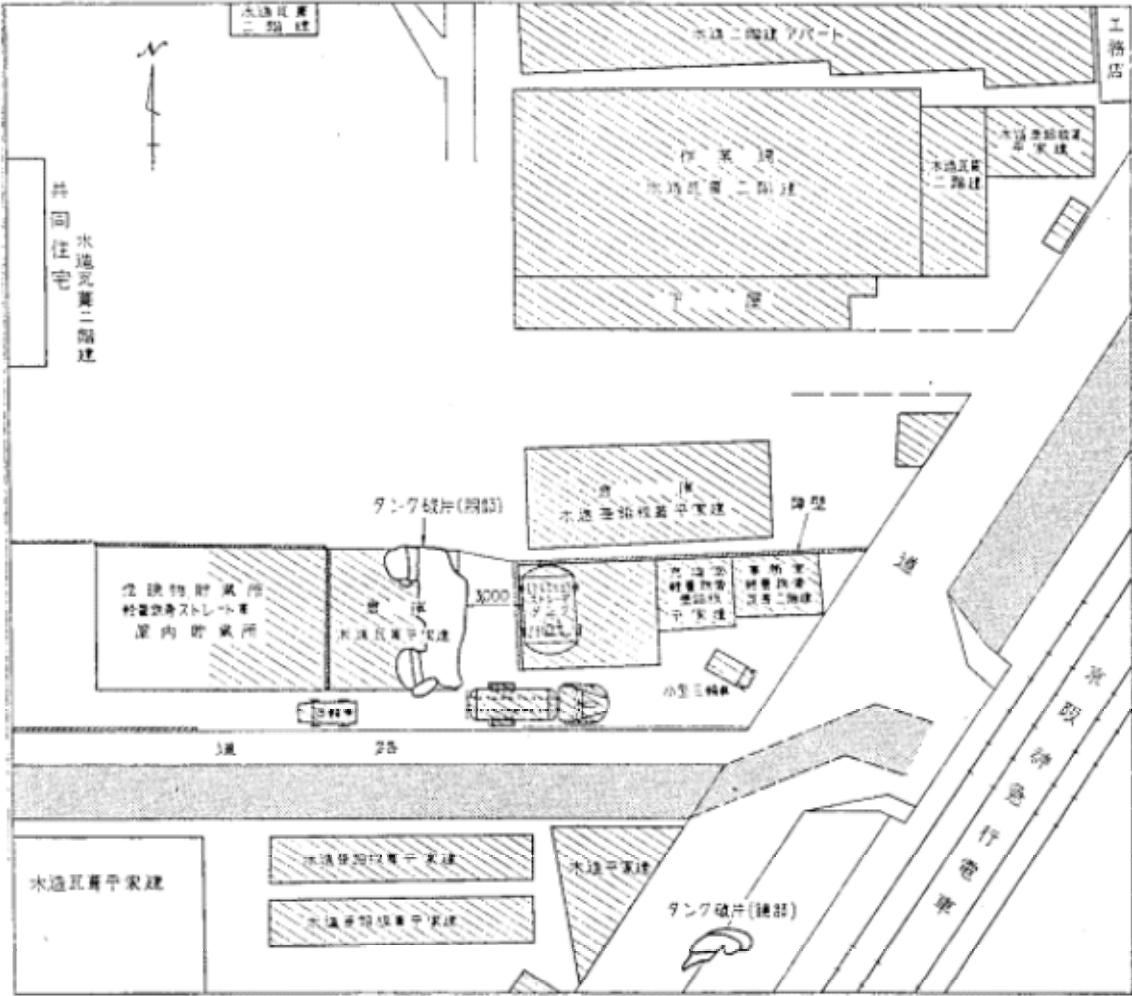
At the LP (Liquefied Petroleum) gas filling station, an attempt was made to fill a 10 kg container and a 50 kg container with LP gas using the pump of the tank truck instead of the compressor and pump of the station, which were out of order, but this attempt failed and was abandoned. (See Figs 1 and 2.)

Fig. 1 The scene of an accident.

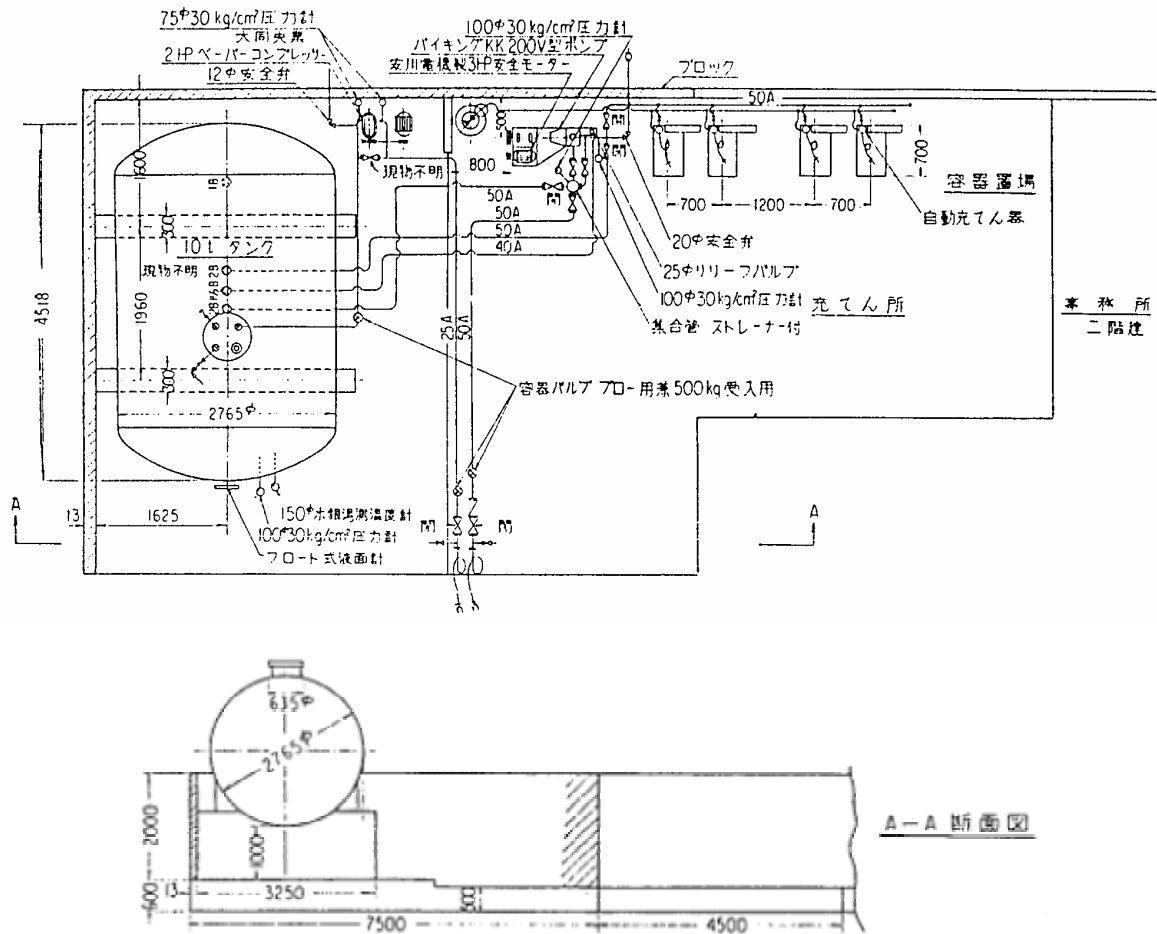
The post-accident investigation revealed no trace of any fracture from the main body of the tank truck through the pump to the hose joint and that the horizontal tank was not connected to the tank truck and the filling zone. (See Fig. 4.) Therefore, the origin of the blowout of the large amount of LP gas must have been somewhere in the connection hose, including the couplings, between the tank truck and the horizontal

Fig. 2 Arrangement machinery.

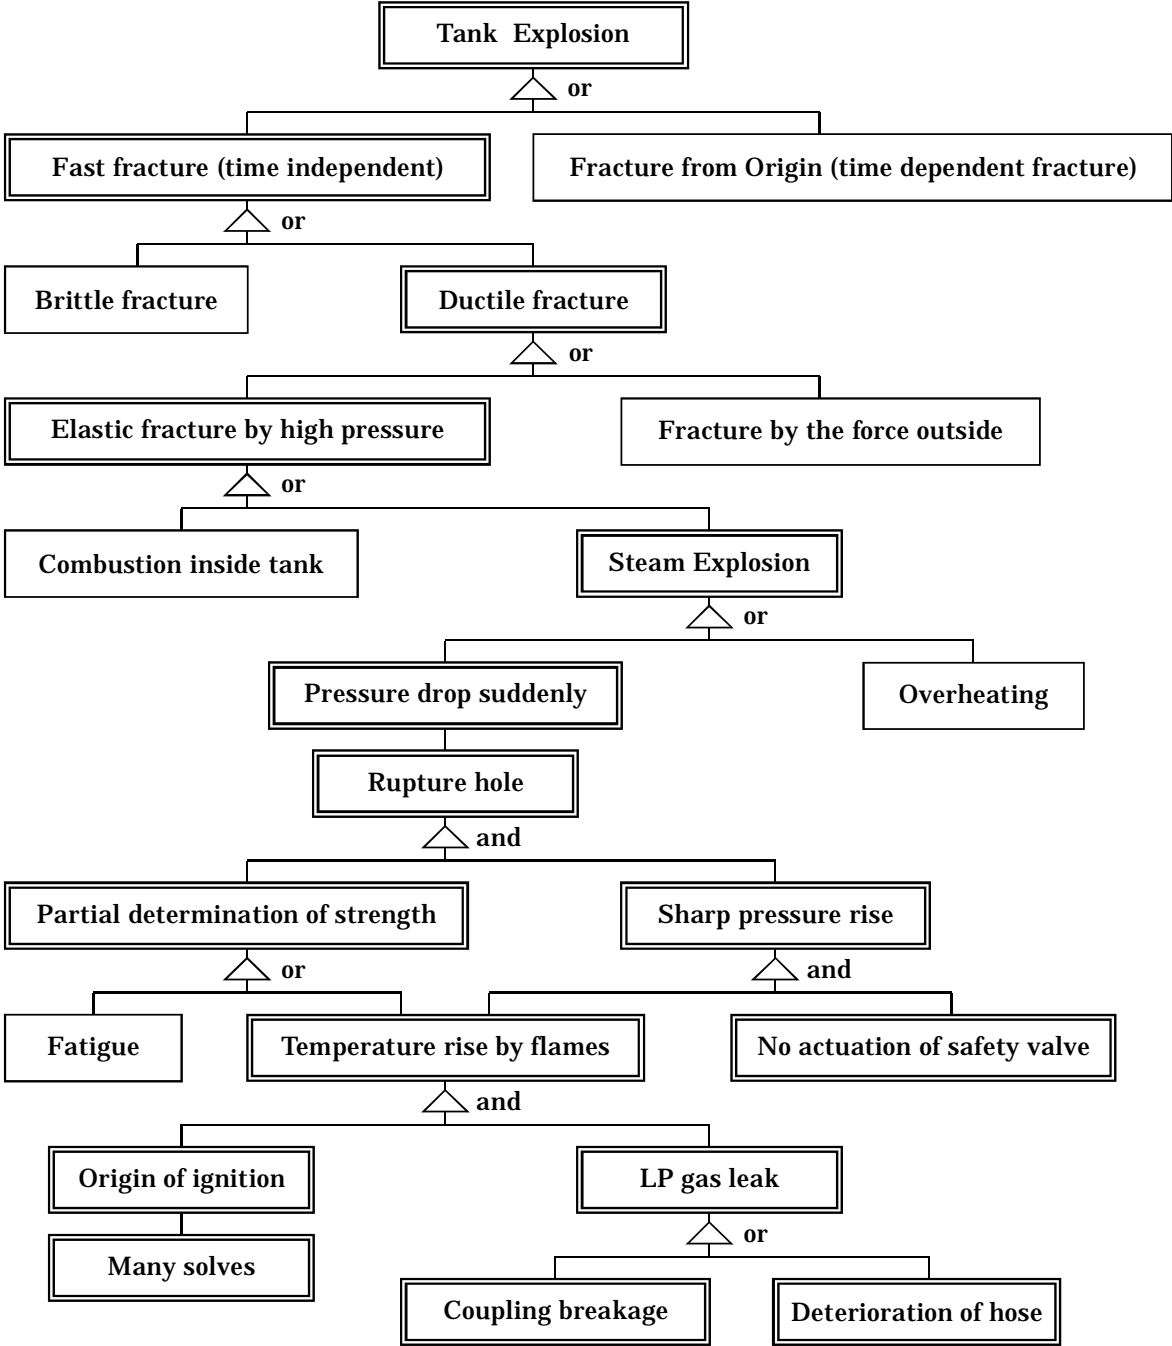
About 30 minutes after the attempt was suspended, white fumes suddenly spouted out with a hiss from somewhere in the line connecting the tank truck and the containers and completely filled the area. There then came, and the explosion occurred after that. Heated by the resulting flames, the LP gas containers and the horizontal tank burst one after other, resulting in a catastrophic explosion disaster with three deaths and 61 minor and serious injuries. According to the investigation carried out after the accident, LP gas was presumed to have blown out due to either the rupture of a deteriorated hose or the breakage of some coupling caused by the movement of the tank truck.

Fig. 3 Fault tree diagram with a focus on mode, mechanism, and process of fracture.

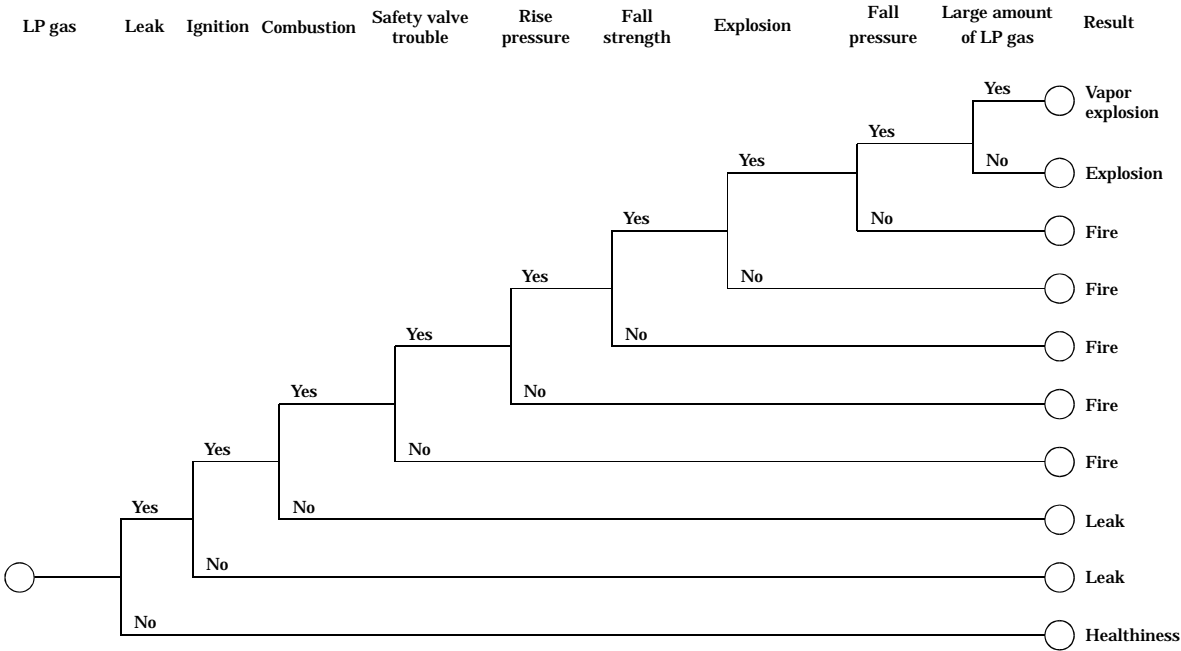
The horizontal tank ruptured due to a ductile fracture in the longitudinal direction of the barrel plate. The barrel plate (60 kg class high strength steel) was heated to the recrystallization temperature, and its pressure strength at 650°C was 20.7 kg/cm². The operating pressure of the safety valve was 29.8 kg/cm², which was higher than the pressure strength of the barrel plate. This suggests that a rupture hole had formed on the barrel plate due to a longitudinal ductile fracture before the safety valve could operate.

boundary surface of the gas liquid. From this fact, it is presumed that about six tons of liquid was contained in the horizontal tank immediately before the explosion. Furthermore, the safety valve had been operating normally until just before the explosion. These facts demonstrate that the LP gas in the horizontal tank was not above the critical temperature. As a result of the investigation, the explosion was believed to occur as follows. A large volume of LP gas was released from a rupture hole that had formed on the barrel plate due to a rise in the inner pressure, and so the inner pressure dropped suddenly. A quick drop in the inner pressure disturbs the gas-liquid equilibrium, causing the liquid to boil intensely in an overheated condition. As a consequence, a large volume of gas evaporated instantaneously, resulting in a powerful impact pressure exerted on the tank. This series of events -- known as a steam explosion -- caused the entire horizontal tank to break into pieces starting from the rupture hole formed on the barrel plate.

Fig. 4 Event tree diagram of horizontal tank explosion.
