Fire of Petroleum Tank, etc. by Niigata Earthquake

June 16th, 1964, Niigata, Niigata pref.

(Summary)

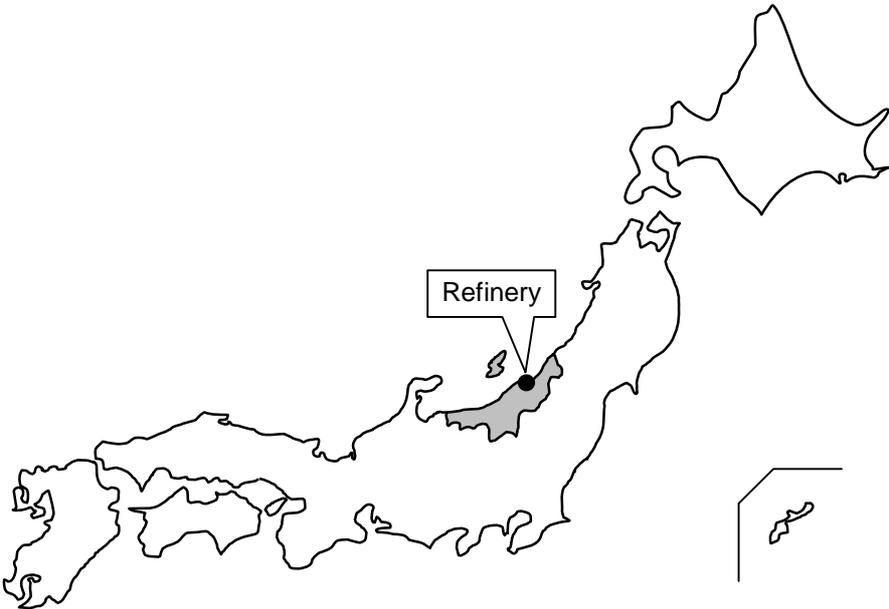
Each tank in the refinery was shaken by the earthquake in the north and south direction, coinciding with the direction to the seismic center (Figures 1 and 2). The floating roofs of five crude oil storage tanks shocked, and shaking motion of one of them was complicated by its inclination to the west, which was caused by subsidence of the ground that was associated with the soil liquefaction phenomenon. "Sloshing" is defined as the phenomenon of vibration induced on the free surface of a liquid contained in a vessel by the shaking of the vessel itself (Figure 3). In the sloshing of large vessels such as petroleum tanks, the force of impact to the top and the negative pressure to the side wall are serious problems. As a result of the shaking of the floating roof, the crude oil flowed out of the top of the tank, fell down along the side wall, and was ignited by the sparks generated by the collision between the floating roof and the side wall. The crude oil storage tank yard was located adjacent to the main plant area. That is, the tank was within 40m of the plant area, and 48m away from the nearest equipment. A part of the crude oil flowed into the main plant

Fig. 1 Site of refinery.

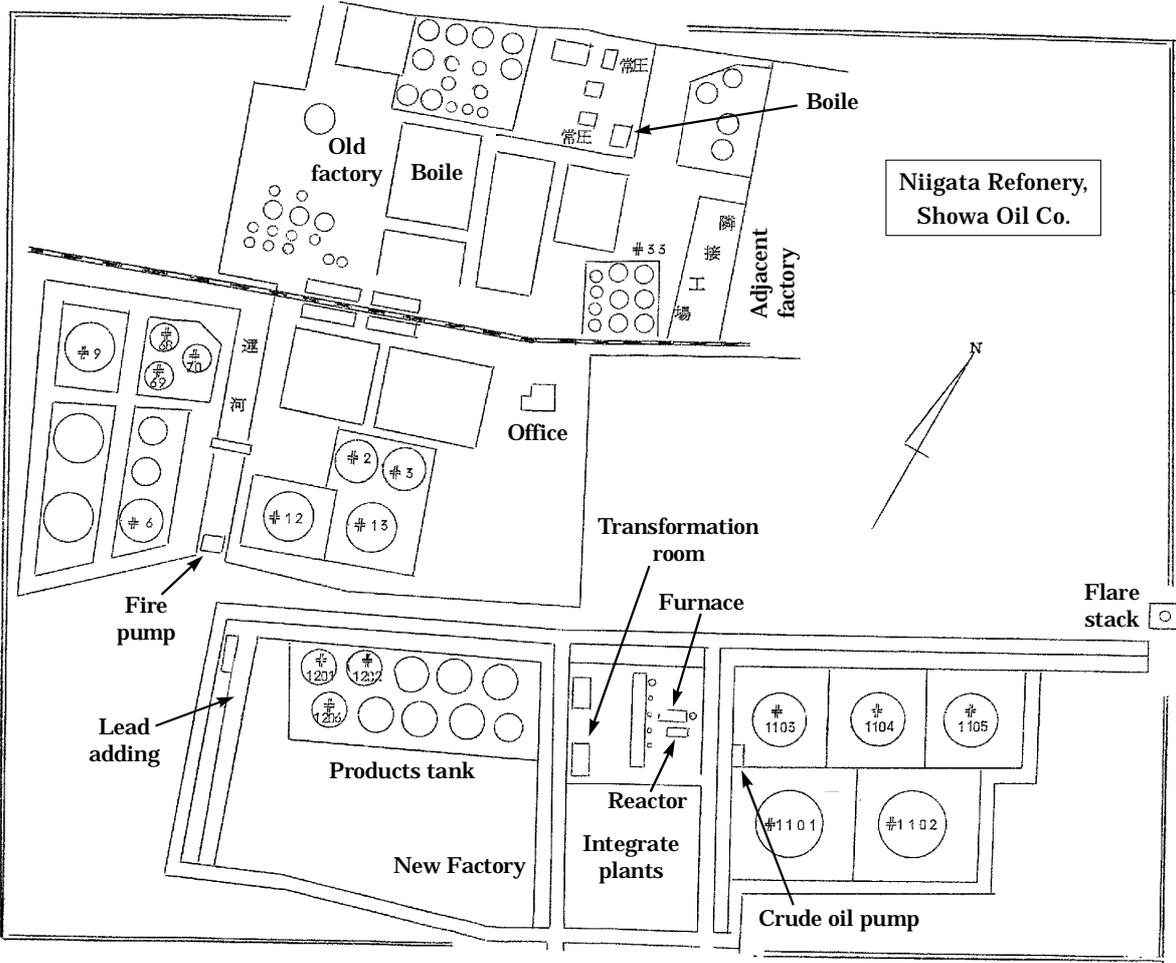
Fig. 2 Damaged part of refinery.

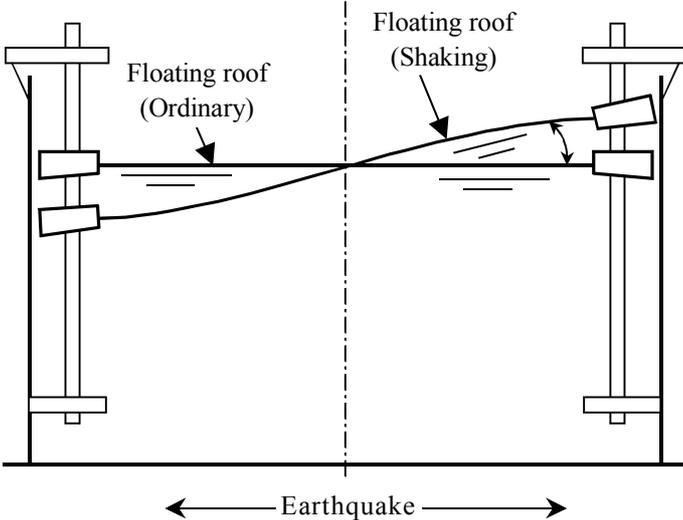
associated with the sloshing phenomenon is greater for the floating roof than for the cone roof. This disaster happened as a result of the following process; the floating roof was shaken vigorously by the earthquake together with the uneven settlement of the tank caused by the ground liquefaction, which resulted in ignition of the oil by sparks generated by the collision between the floating roof and the side wall. The sparks were generated by the metal touch sealing between the floating roof and the side wall. Recently, soft touch sealing composed of synthetic rubbers or urethane foams has been used instead of the metal touch sealing.

Fig. 3 Sloshing phenomenon.

The metallic seal mechanism was eliminated entirely and the side wall was heightened to prevent the outflow of oil.

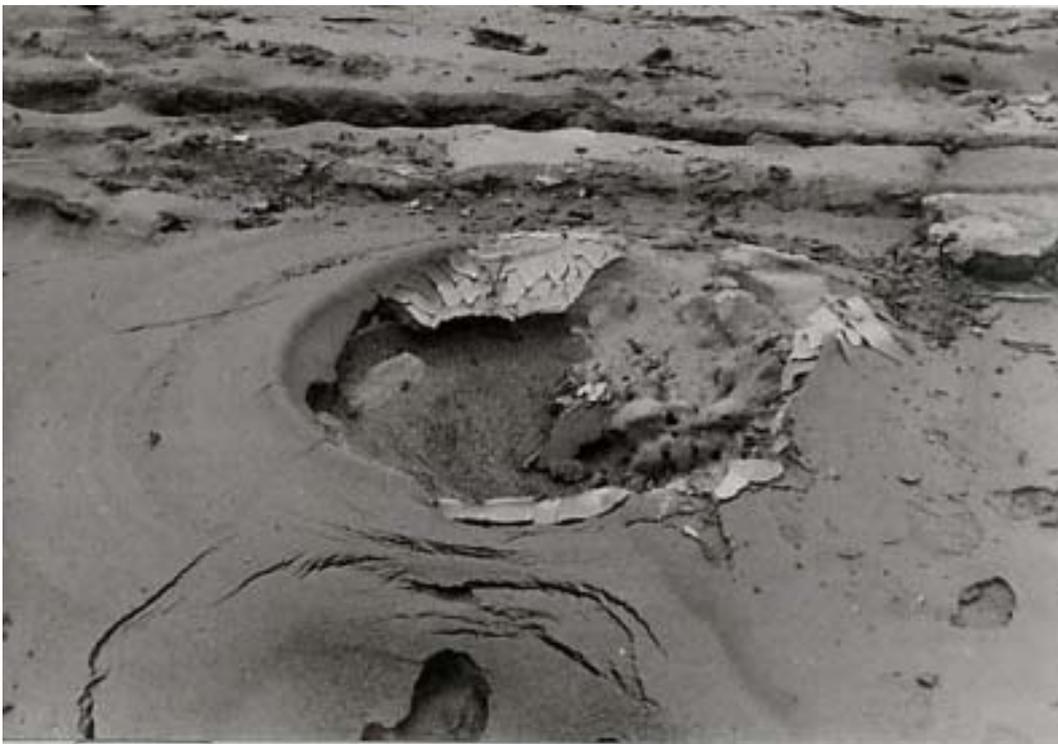
Various damages occurred as a result of the liquefaction of the ground. The "liquefaction of the ground" occurs when seismic vibration causes sandy ground saturated with underground water to become a liquid. Buildings that had been supported by the ground lose their support and become tilted or sink into the ground. On the other hand, structures that had been buried underground are lifted out of the ground (Figures 4 and 5). The ground liquefaction phenomenon caused uneven settlement to the tanks, which resulted in the deformation and failure of the pipes (Figure 6). The oil fence cracked to expose the reinforced steel bars, which in turn suffered from thermal expansion by the fire, causing the fence to lose its strength and collapse. Underground water rose up to the surface by the ground liquefaction, filling the campus together with the sea water that had come in with the earthquake induced tidal wave (Tsunami). Oil flowed out through cracks in the tanks and pipes and was spread by the flood water, causing the fire to spread at an accelerated rate.

Fig. 4 Liquefaction of ground (Kawagishi-cho).

The vibroflotation is a method for consolidating and tightening loose and soft ground as follows; the vibroflot (vibrator with water jet) is slowly lowered while vibrating to the bottom of soil layer, and then it gradually withdrawn while feeding sand into the area.

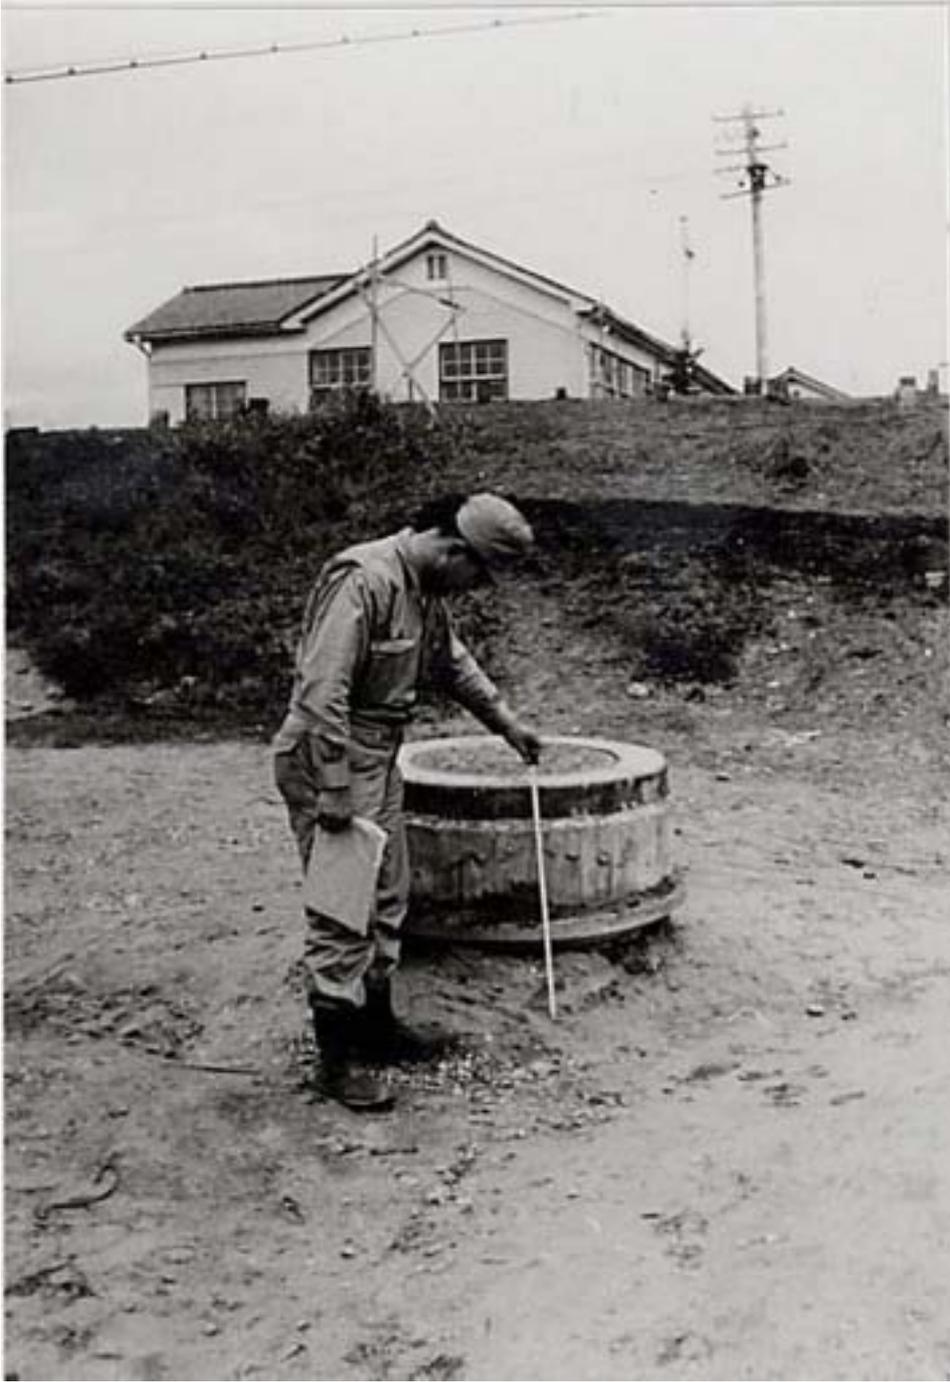
Fig. 5 Uplifted manhole by liquefaction (Near girder bridge of Echigo-line).

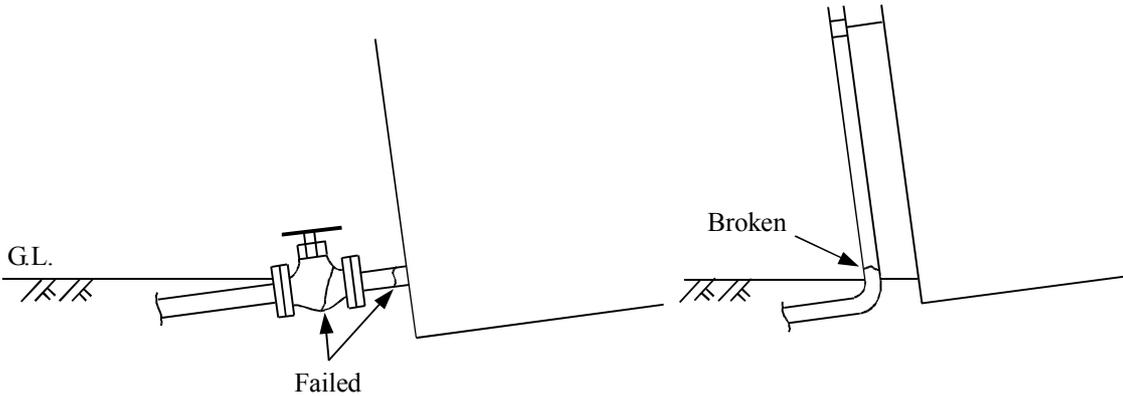
Insufficient improvement of the basic foundation for heavy structures as tanks and insufficient flexibility of the pipe line against the subsidence of the ground resulted in the amplification of the damages, especially in the areas of ground liquefaction and of zero ground level ground into which sea water could easily flow. In fact, some of tanks that were located on the improved basic foundation suffered little damages from the uneven settlement. At the initial stage, the oil fence helped to prevent expansion of the fire, however, later it collapsed because of insufficient earthquake-proof design.

Fig. 6 Damage of tank attachment piping.

Design such as the spring support and the flexible joint have been adopted depending on the kind of piping. Moving underground piping above ground has made it easier to find defective parts during ordinary operation and to take necessary actions quickly in the case of an emergency.
