LP Gas Explosion from the Overturning of a Tank Truck

Oct. 26, 1965, Nishinomiya, Hyogo

AKATSUKA, Hirotaka (High Pressure Gas Safety Institute of Japan)

KOBAYASHI, Hideo (Tokyo Institute of Technology)

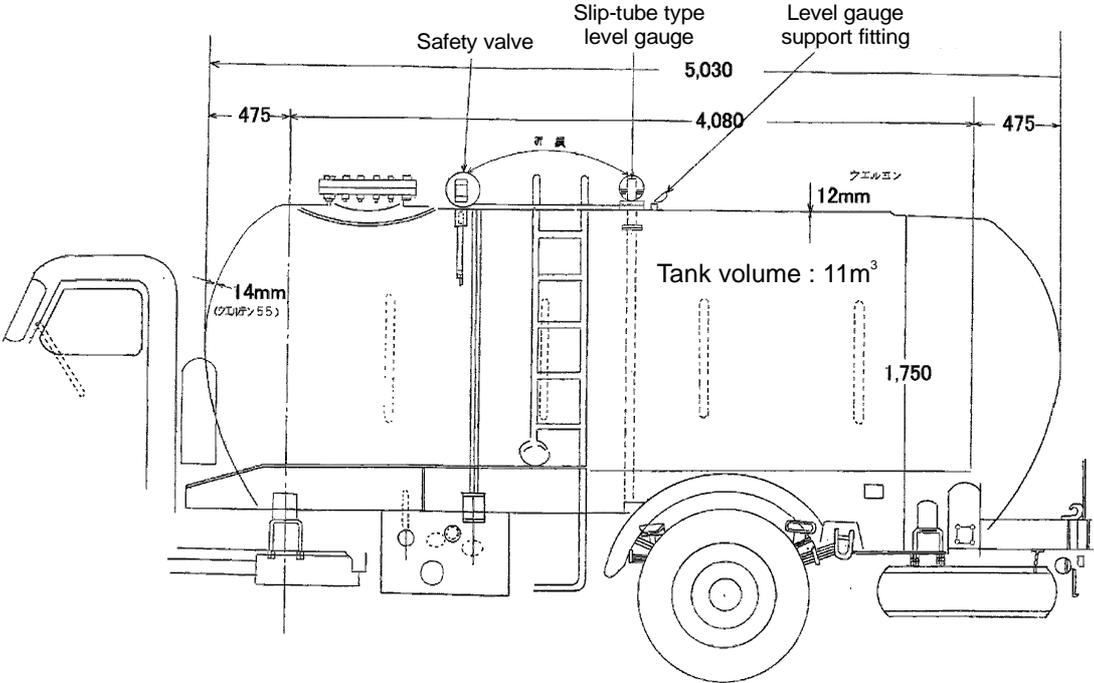
Five-ton tank truck (inside diameter: 1,750 mm, length: 5,030 mm, barrel thickness: 12 mm, material: 60 kg class high strength steel) (See Fig. 1)

Fig. 1 Tank lorry.

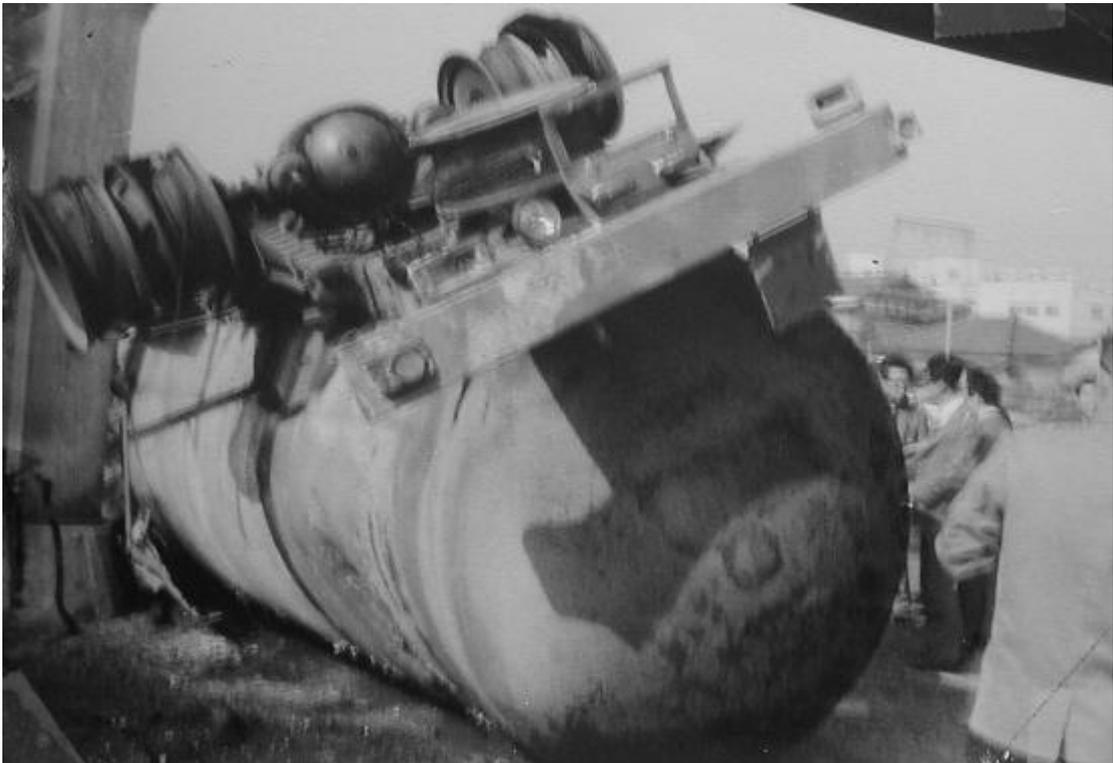
During the evening hours, a five-ton tank truck running on a national highway in Nishinomiya City, Hyogo was overturned due to the improper steering by the driver who fell into a doze while driving. (See Figs. 2 and 3) The tank truck, which was estimated to be running at a speed of 60 km/h or more, overturned just before the pedestrian overpass, slid away about 8 m, and crashed against the support of the overpass.

Sustaining a shock from the overturn, the protruded safety valve (size 50A) and slip tube level gauge were damaged. Given a shock such as this, a safety valve of any material would break down in this situation. The tank truck struck the curb, causing the right side of the truck (seen from the loading position) to be dented 110 mm deep, 1,200 mm long, and 600 mm wide. However, no areas were found where LP gas leaked, and no marked abnormalities were identified in the other fittings, either.

Fig. 2 Turned lorry on its side (Rear view).

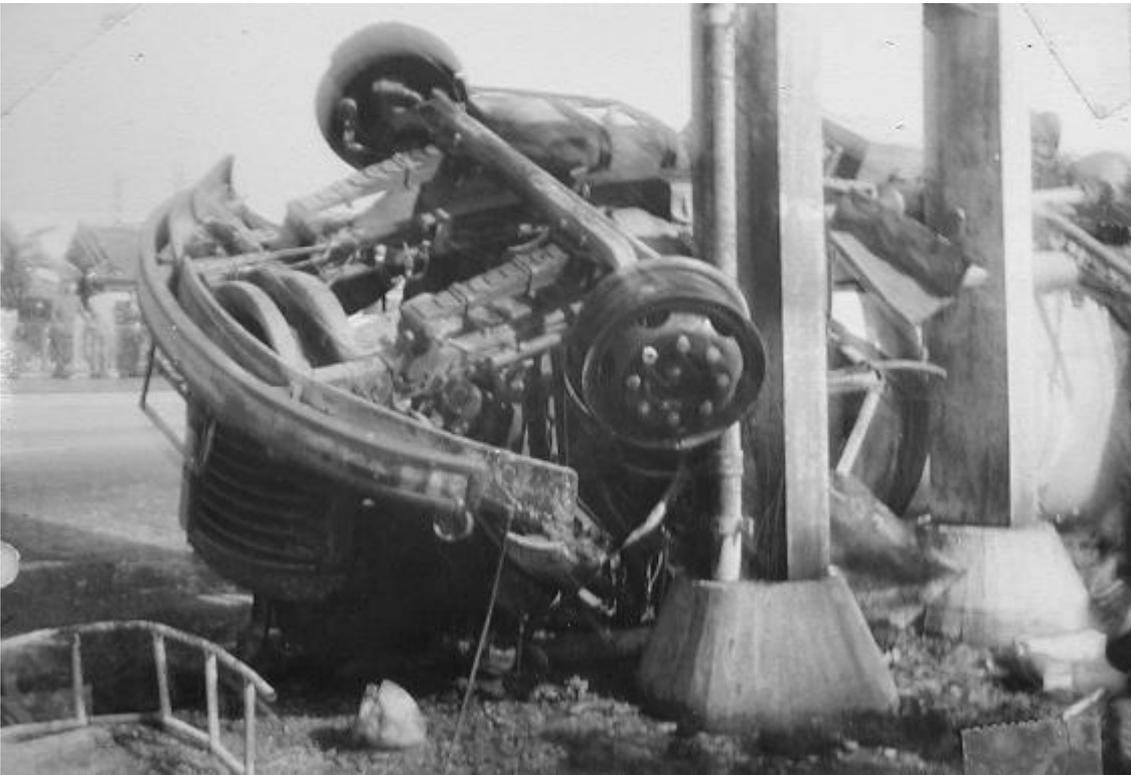
Fig. 3 Turned lorry on its side (Front view).

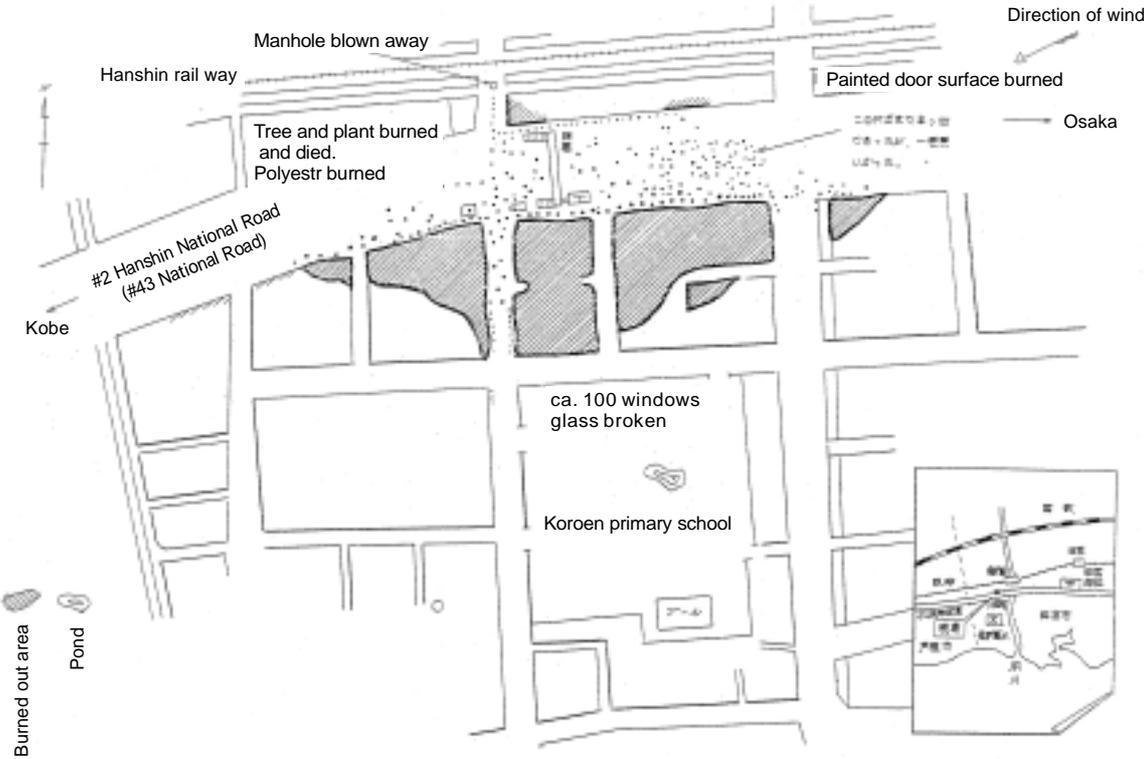
The gas blown out from a rupture ($50A/19.6\text{cm}^2$) kept spreading, ignited, and exploded about five minutes after the initial blowout. Assuming that the LP gas freely escaped from the hole, most of the LP gas escaped in about five minutes before the inflammation. The escaped LP gas developed into about 1 m thick white fumes, which crawled ahead across the range of 200 mm along the national highway. (See Fig. 4) Part of the fumes filled the southeast area of the overpass and went downwind beyond a wall (about 2

Fig. 4 Rough sketch of accident spot.
