# Explosion of air bottle by mixing oil

July 31st, 1995, Okegawa-city, Saitama Prefecture

KOBAYASHI, Hideo (Tokyo Institute of Technology)

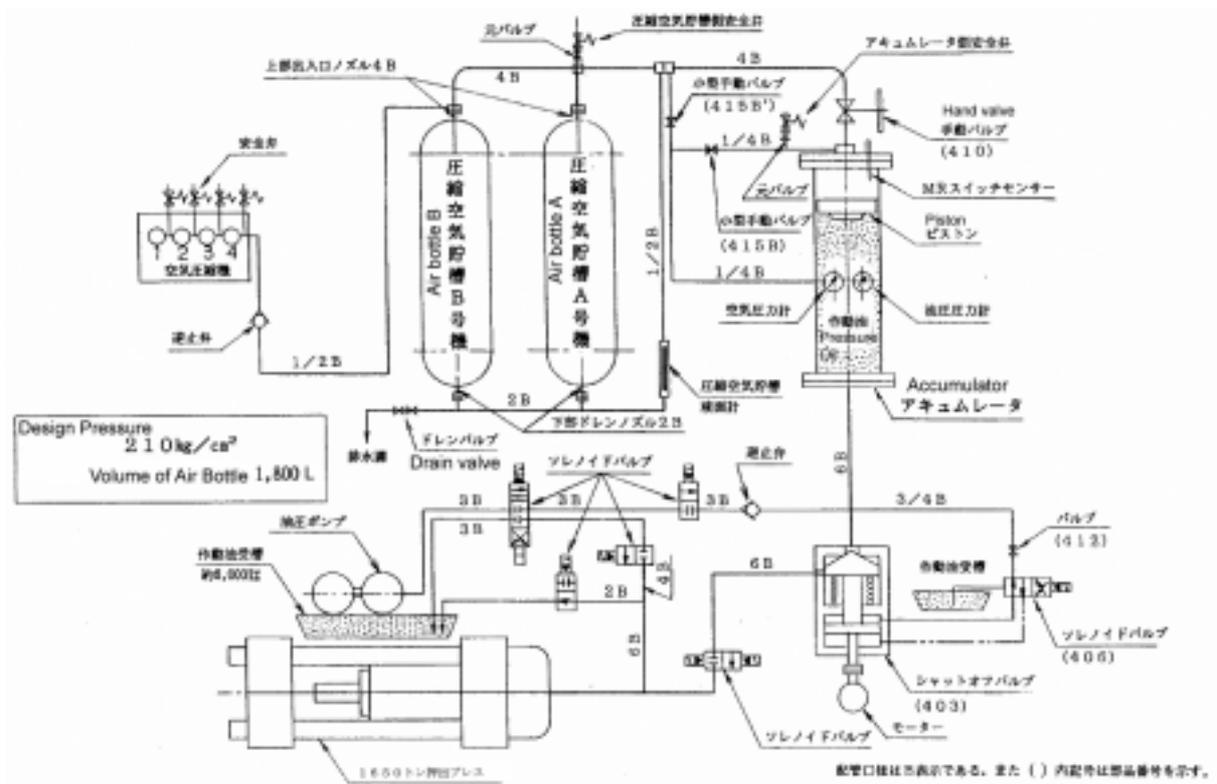
Fig. 1 Outline of Accumulator.

At 8:27 am on July 31st, 1995, in the Okegawa factory of Mitsubishi Materials Corporation in Saitama Prefecture, a worker opened a valve that was in the upper part of the accumulator in order to run the extrusion press equipment. Suddenly, the two air bottles exploded. The outline of the accumulator is shown in Fig.1.

The air part and the oil part were not completely isolated from each other because the accumulator uses a piston as a compartment. The oil leaks along the side of the piston into the air part. Through the investigation of the accident, it was determined that oil had collected in the hand valve, the inside of the connection tube and the lower part of the air bottle. Also, the operating oil of accumulator was leaking out because of the accident, so the piston was at its lowest position. Oil had accumulated on top of piston to a height of 42mm (about 14L). Although it is not clear whether the oil had accumulated before or after the accident, it is certain that there was oil in the air bottles and in the upper part of the piston before the accident.

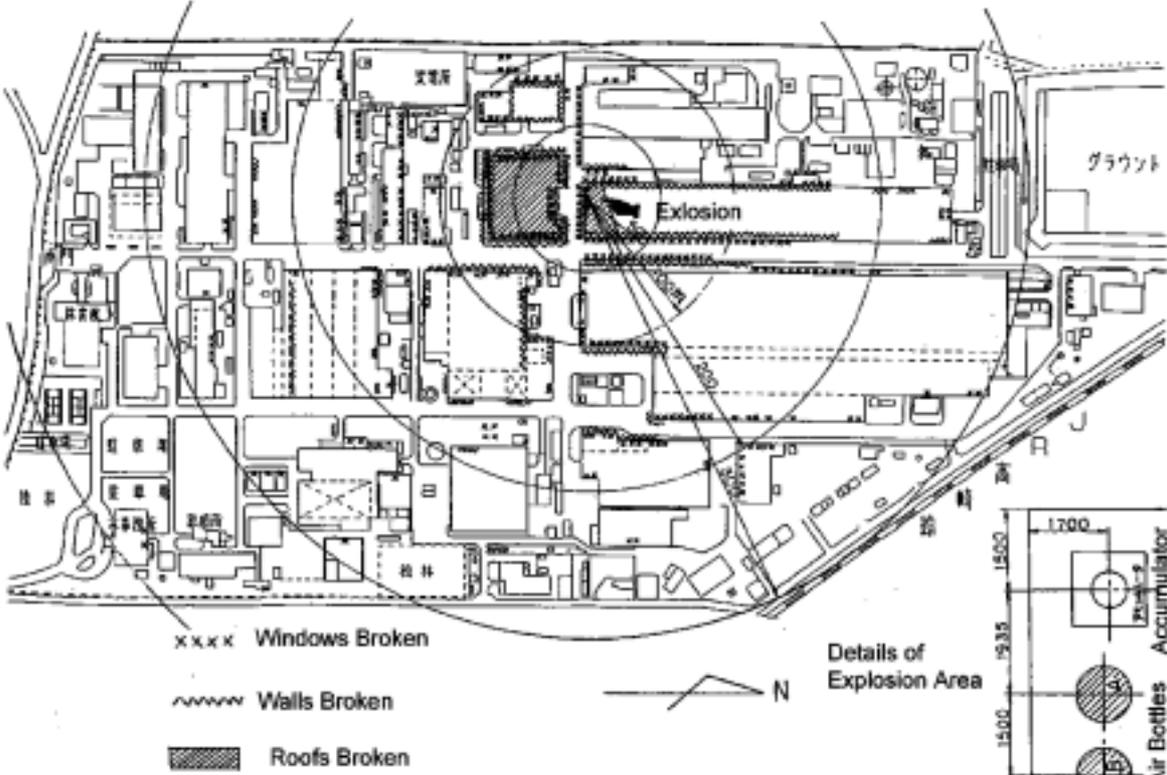
Fig. 2 Layout of Factory and Details of Damage.

Fig.2 shows the layout of the factory and the situation of this accident. The two air bottles broke into small parts that flew in to the neighboring areas and broke the buildings, roofs and walls of the buildings there. The A-type air bottle broke into thirteen parts, and the maximum flight length of the parts was 630m. The B-type broke into eleven parts, and the maximum flight length of the parts was 1200m.

The damage to the accumulator and other nearby parts of the extrusion press was not so bad. However, the wall, the roof and the center pillar of the building in which the press equipment was housed received greater damage. Furthermore, the windows, roofs and walls of neighboring houses that were not inside the factory but were less than 1500m from the air bottles, were seriously damaged. Eighteen people were injured, two of whom were the neighborhood of the factory. Thirteen days later, one of them died.

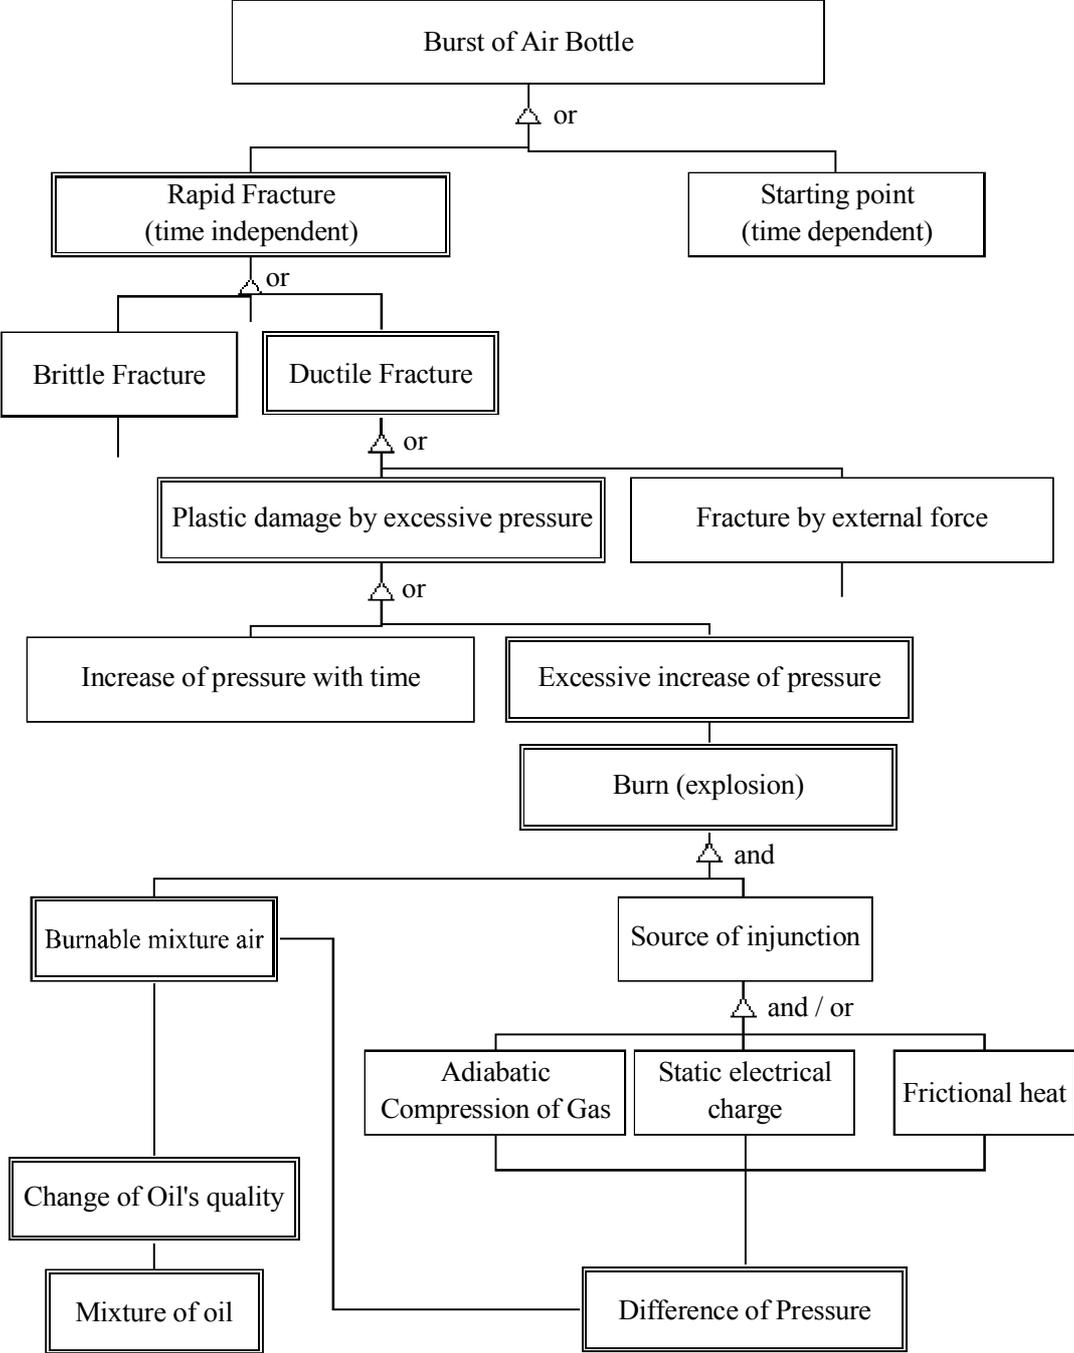
Fig. 3 Fault tree focused on fracture mechanics and process.

Considering the fact that the two air bottles had exploded at the same time, and from knowledge of fracture mechanics, the ignition was hypothesized to have occurred in the inside of the accumulator and the connection pipes. The possible causes of the ignition are shown below, but which actually occurred could not be determined.

In summary, first ignition occurred in the accumulator. Next, the flame propagated through the inside of the pipes and reached the two air bottles at the same time. Suddenly, an explosion occurred in both bottles by the air-oil mixture and the old oil.

Fig. 3 shows the fault tree describing the fracture mechanics and process. The event tree of air bottles' explosion is shown in Fig. 4.
