Fusion and Explosion of Oxygen Gas Containers in The Filling Process

Mar. 25th, 1996, Kasuya, Fukuoka

AKATSUKA, Hirota (High Pressure Gas Safety Institute of Japan)

KOBAYASHI, Hideo (Tokyo Institute of Technology)

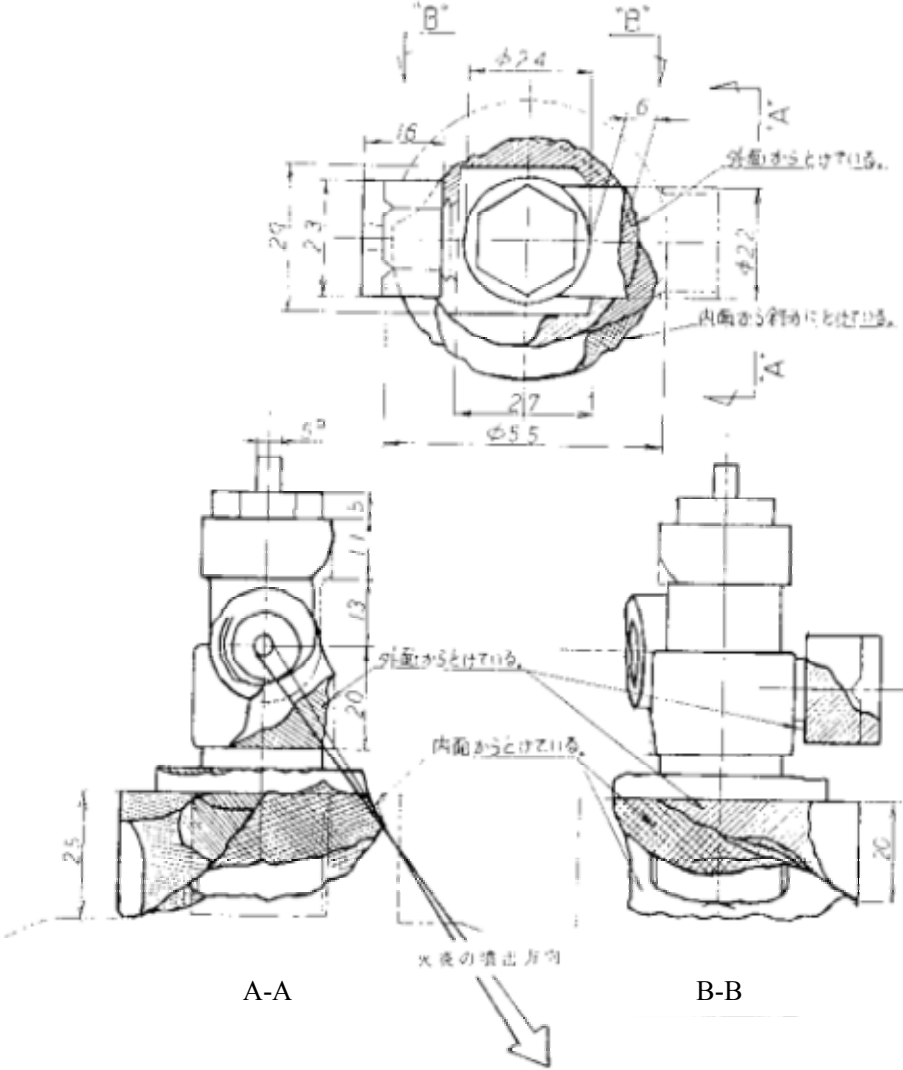
One of the aluminum alloy containers that had been filled with oxygen gas, suddenly fused somewhere between the valve-fitting and the shoulder section, causing flames to spout out. (See Fig. 1) According to the results of the investigation, the origin of inflammation was in the end section of the container valve where the branch tube for filling was inserted. The flames then shot the main body of the valve and directly hit against the outer surface of the aluminum container to melt an opening. The fused area of the main body looked as if it had been irradiated with an electron beam.

In the meantime, the flames melted the surface of the valve sheet and penetrated into the container while propagating through the inlet of the container valve. The oxygen gas ignited in the check valve cartridge in the container valve. The resulting flames fused down the foot part of the valve body toward the filling side, and then directly hit and fused the outer surface of the container at an angle of 135° (seen clockwise with the top face as 0°). (See Fig. 2) Furthermore, the flames penetrated through the mouth of the valve into the confined space on the valve sheet surface, fused the surfaces of the valve sheet (brass) and the seat padding (nylon 66), and then reached the inner depth of the container while propagating through the inlet of the container valve. Both the fusion face caused by the irradiation of flames and the knife-edged fusion face caused by the spout of flames were observed on the fractured area of the opening on the container.

Fig. 1 Valve.
