Oil Spill by Mizushima's Tank Damage

Dec. 18th, 1974, Kurashiki City, Okayama Prefecture

(Summary)

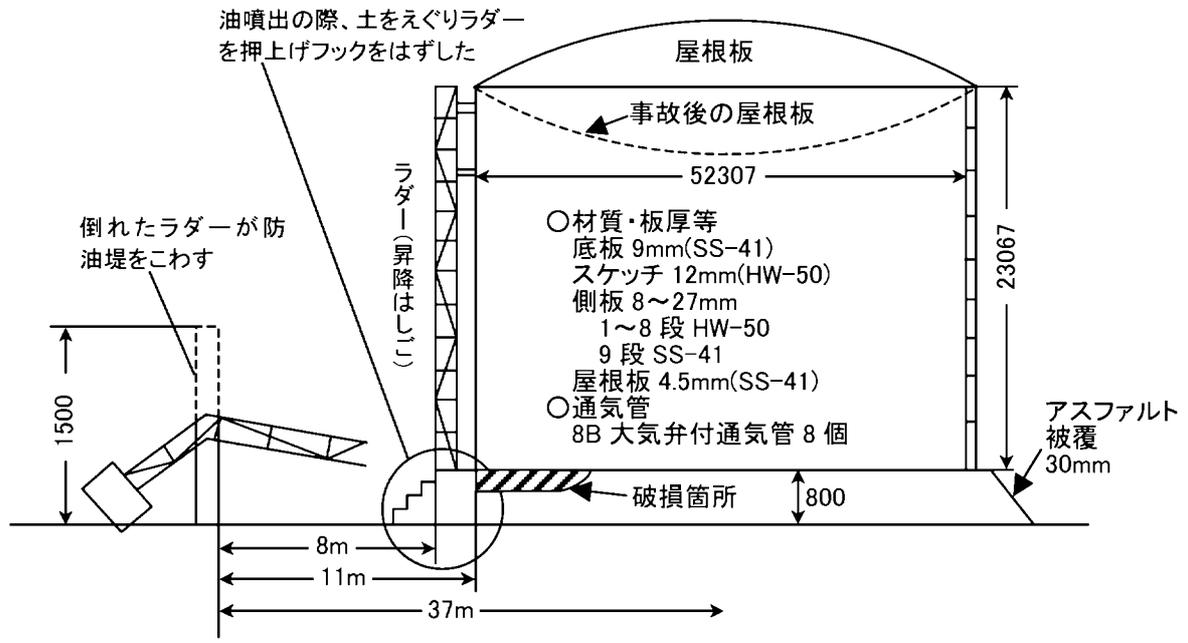
(a) Outline of Damaged Tank

Only nine months have passed in the accident tank (52.3m in diameter, 23.67m in height, and 27mm thickness of 60 kg/cm³ class high tensile strength steels in the lower) since use began. The occurrence part of destruction is a bottom of the tank where the vertical stairs were set up. The crack occurred at the fillet welded joint of the shell plate in the lower and the annular plate (12mm in thickness of 60 kg/cm³ class high tensile strength steels). This crack has reached about 13m in the direction of the circumference at the fillet welded joint even by the annular plate (9mm in thickness of SS400 steel) and about 3m from the fillet welded joint toward the tank center. Moreover, the dome roof tank becomes the state of vacuum by a rapid outflow of oil and has been broken two exact halves through the sinking center.

After a while, the foundation in the vicinity of the vertical stairs sank, the vertical stairs fell, and the dike was destroyed. Therefore, oil besides the dike flowed out, and 7500-9500 liters in that flowed out to the sea.

It is presumed to be a cause of the crack that the installation construction of the vertical stairs is done during the hydraulic test of the tank, and the basic ground has subsided locally because the consolidation of the foundation was insufficient, and an excessive stress acted on the main body of the tank.

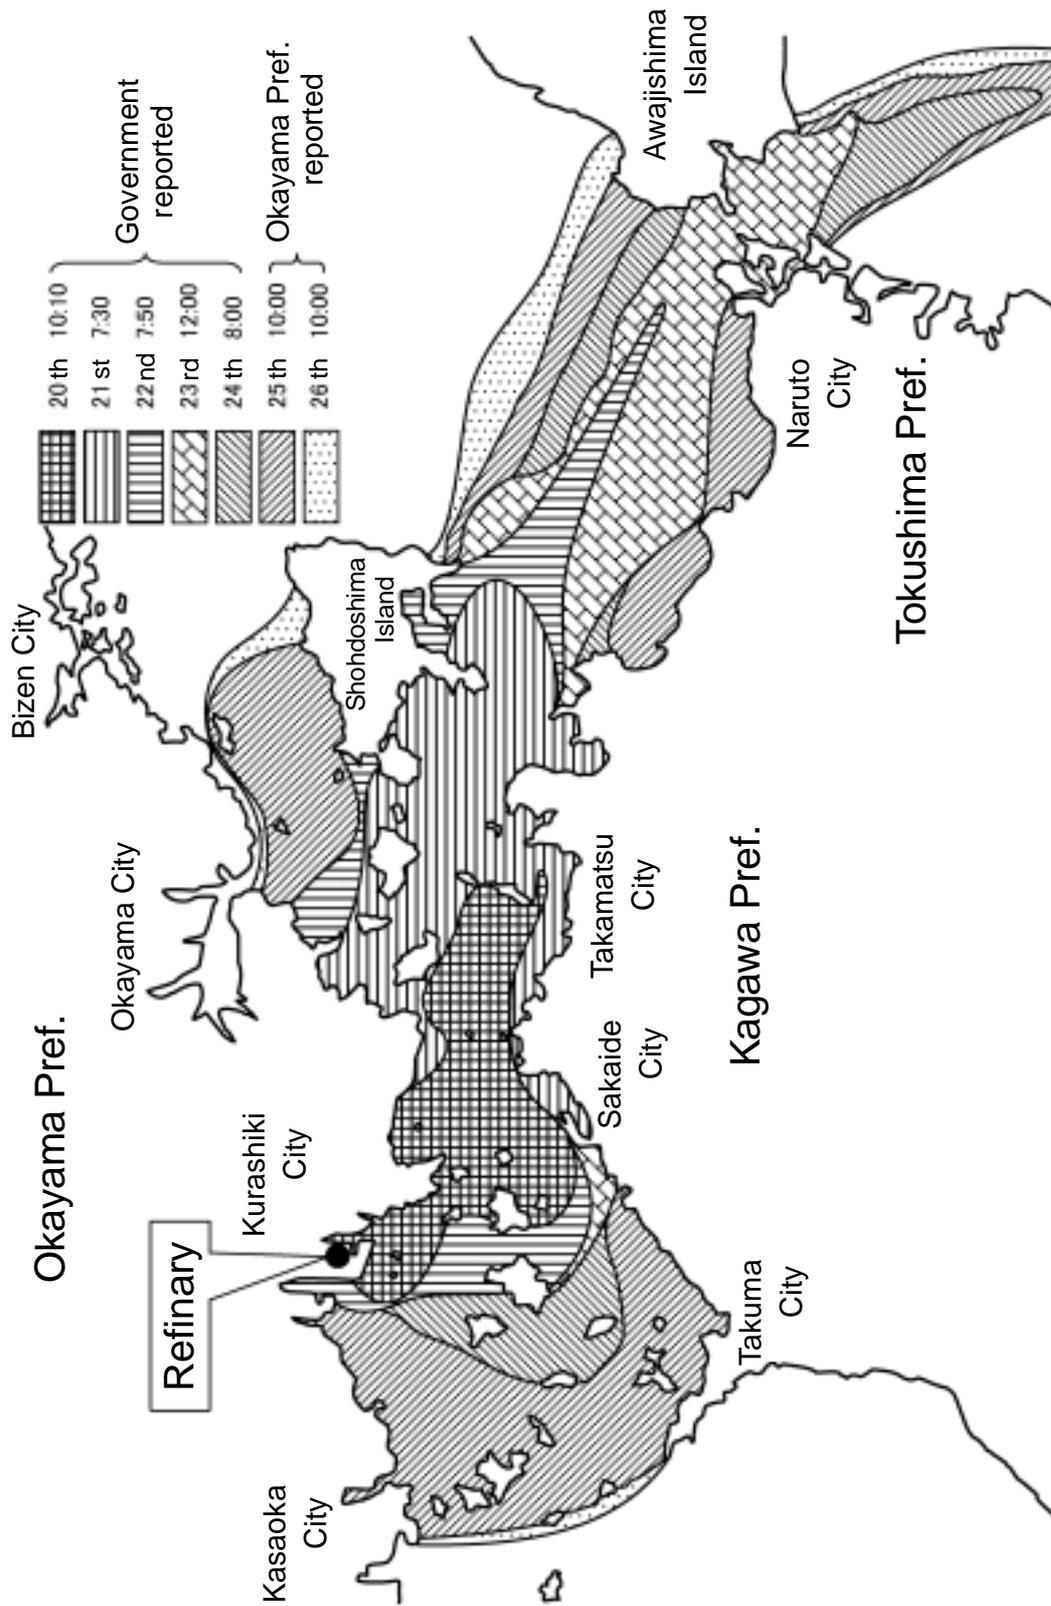
The oil fence was set up around the Mizushima port entrance to prevent spreading of oil upon the sea. However, it flows out outside the Mizushima port on the evening of the 19th, and it has extended widely with the time passage.

Fig. 5 Diffusion situation of spilled oil (20th - 26th in December).
