Burst of Steam Turbine Rotor in Fossil Power Plant

June 19th, 1974, Gallatin, Tennessee, USA

(Summary)

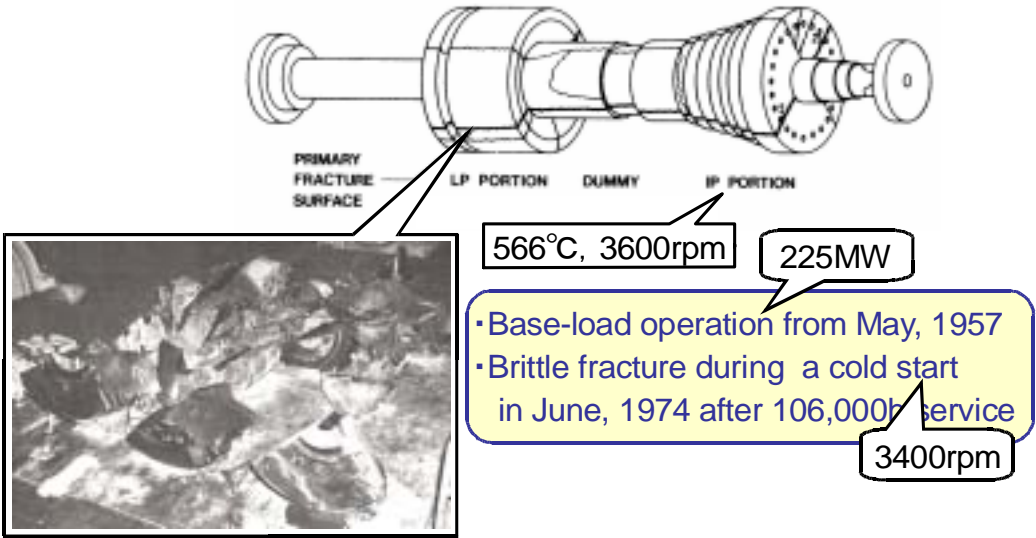
On June 19th, 1974 during a cold start after a long shutdown for repairing the TVA Gallatin No.2 unit, the IP-LP rotor burst at approximately 3,400rpm. The rotor had been in operation for 106,000 hours from its operational start in May 1957 (see Fig. 1).

The burst rotor forged from an air melted ingot in the 1950's had a MnS segregation zone near its bore. At that time, the pre-service boresonic inspection was required only for the steam turbine rotors made of a Cr-Mo-V steel that had been austenitized at 1100 °C. Because the austenitization temperature of the rotor was only 955 °C, the pre-service boresonic inspection was not conducted. Consequently, the service operation of the rotor was continued for over 100,000 hours prior to the burst accident without noticing the existence of the MnS segregation zone (Fig. 5). As shown in Fig.6, a crack grew due to creep-fatigue interaction during the operation period. Also, the rotor material was degraded by the temper embrittlement that occurred during the long period of operation. Consequently, the brittle fracture of the rotor during a cold start was caused by the superposition of mechanical damage and material degradation. Finally, the rotor fractured into thirty large pieces, and some of the pieces flew off to a hit boiler building.

Fig. 1 Overview of the burst TVA Gallatin No.2 IP-LP turbine rotor.

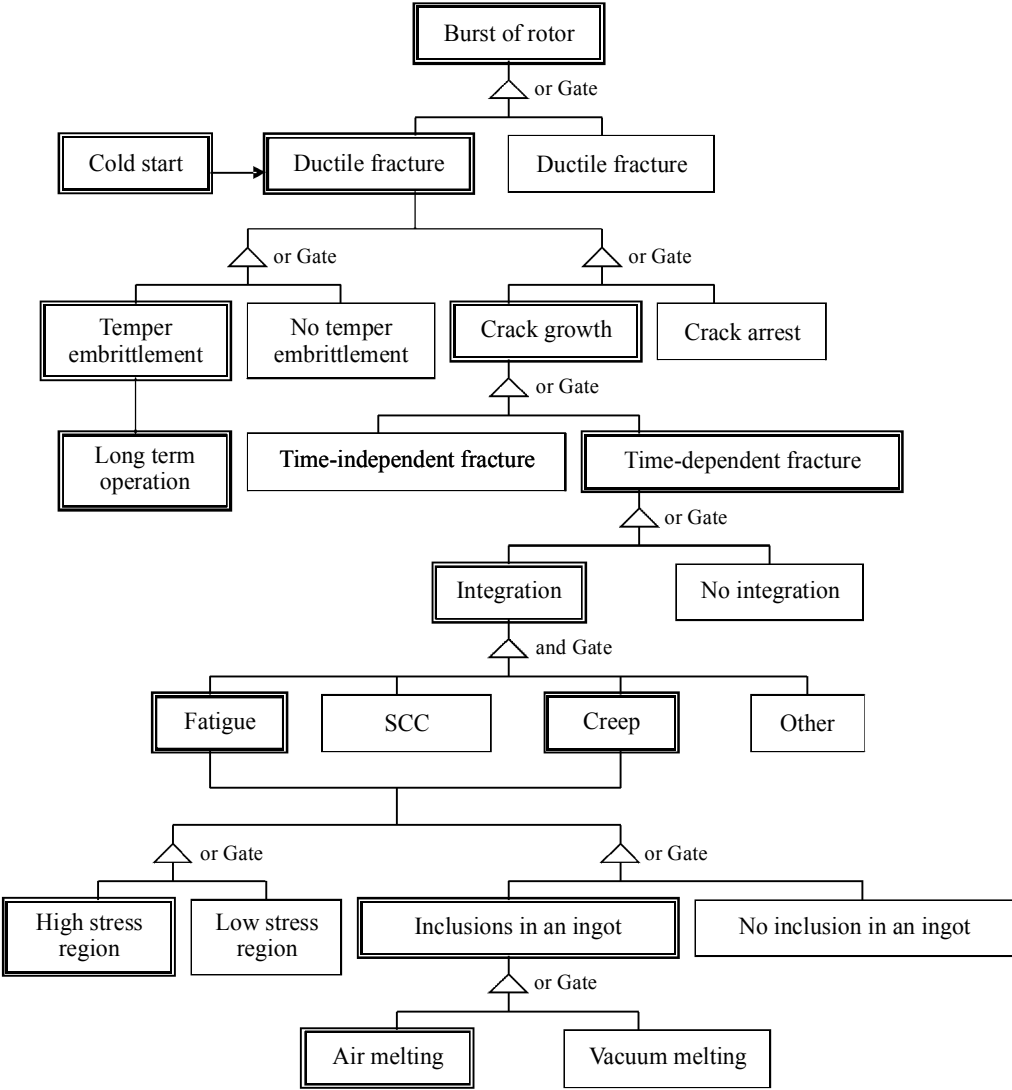
(1) Fault tree diagram for mode, mechanism and process of fracture (Fig.2)

The burst rotor forged from an air melted ingot in the 1950's had a MnS segregation zone near its bore.

However, at that time, the pre-service boresonic inspection was not required for the rotors austenitized at 955 °C. Thus, its service operation was continued for over 100,000 hours without noticing the existence of the MnS segregation zone, which resulted in crack growth due to creep-fatigue interaction. Also, temper embrittlement occurred over the long period of operation. Therefore, the rotor burst by brittle fracture during a cold start after a long shutdown for repair.

Fig. 2 Fault tree diagram for mode, mechanism and process of fracture.

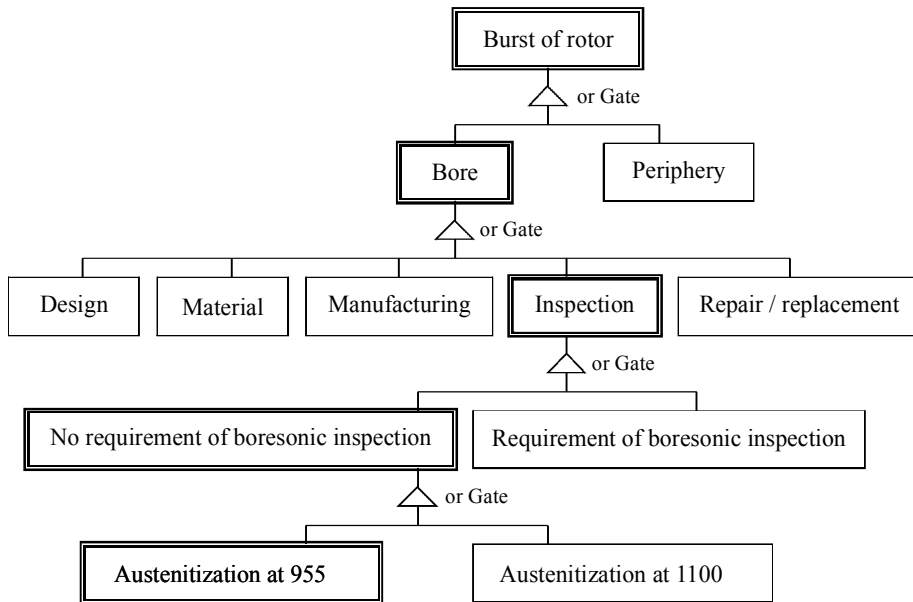
(2) Fault tree diagram for design and manufacturing errors (Fig. 3)

At that time, the pre-service boresonic inspection was required only for the steam turbine rotors made of a Cr-Mo-V steel that had been austenitized at 1100 °C. Because the austenitization temperature of the rotor was 955 °C, the pre-service boresonic inspection was not conducted. As a result, the rotor was operated for a long period without noticing the existence of a large MnS cluster that had become segregated near the bore during ingot manufacturing. This MnS cluster caused the burst accident.

Fig. 3 Fault tree diagram for design and manufacturing errors.

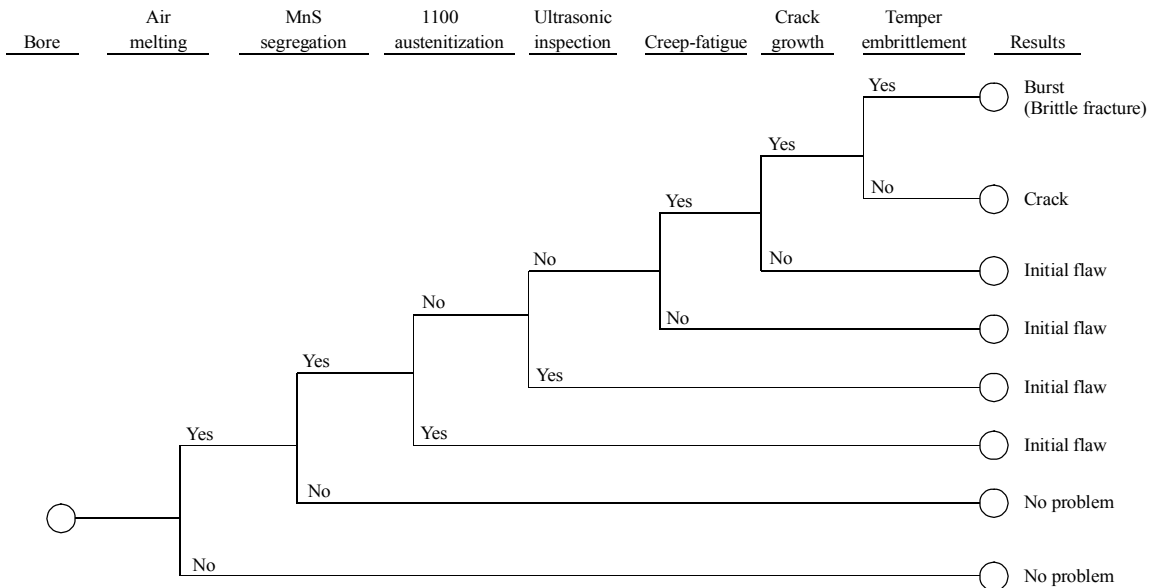
(3) Event tree diagram for the steam turbine rotor burst attributed to the lack of the requirement for the pre-service boresonic inspection (Fig. 4)

The existence of a MnS segregation zone near the bore of the rotor forged from an air melted ingot of a Cr-Mo-V steel was not detected because the pre-service boresonic inspection was not required for rotors that were austenitized at 955 °C. The long-term operation of the rotor having a big flaw of MnS inclusions near its bore resulted in creep-fatigue crack initiation and propagation from the flaw. Finally, a brittle fracture during a cold start was caused by the crack growth in combination with the temper embrittlement that had resulted from the long period of operation.

Fig. 4 Event tree diagram for the steam turbine rotor burst attributed to not requiring the pre-service bore sonic inspection.

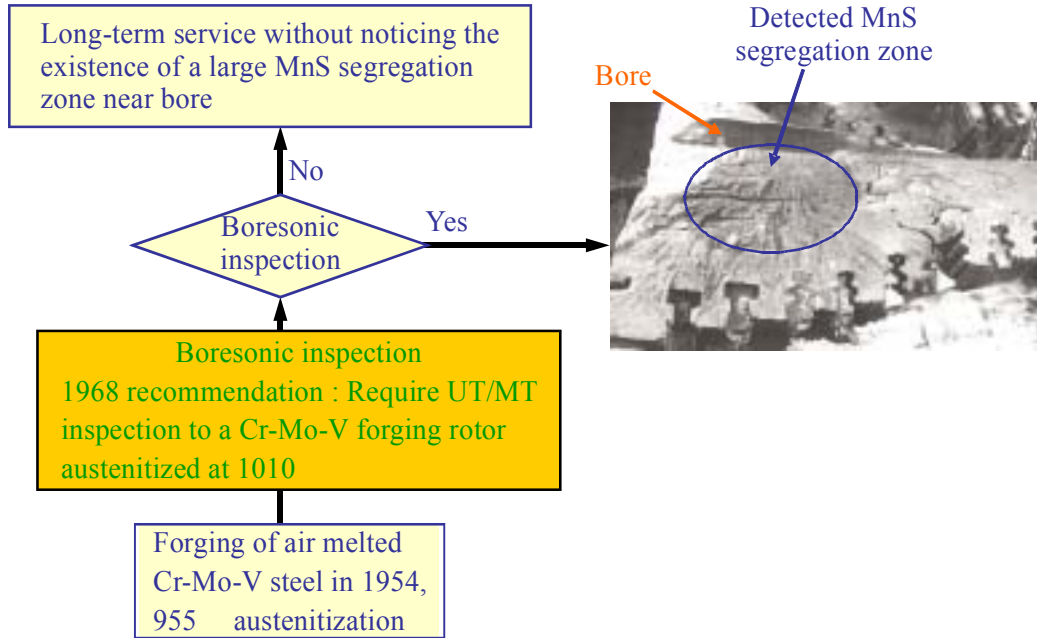
Fig. 5 MnS segregation zone existing near bore.

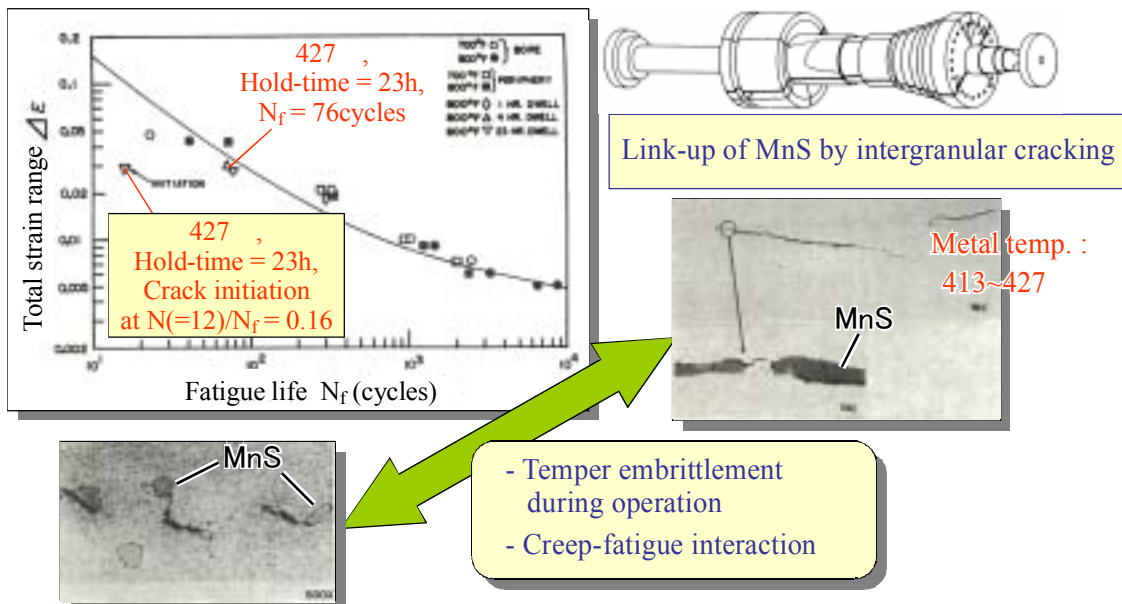
Fig. 6 Crack growth by creep-fatigue interaction from MnSs.

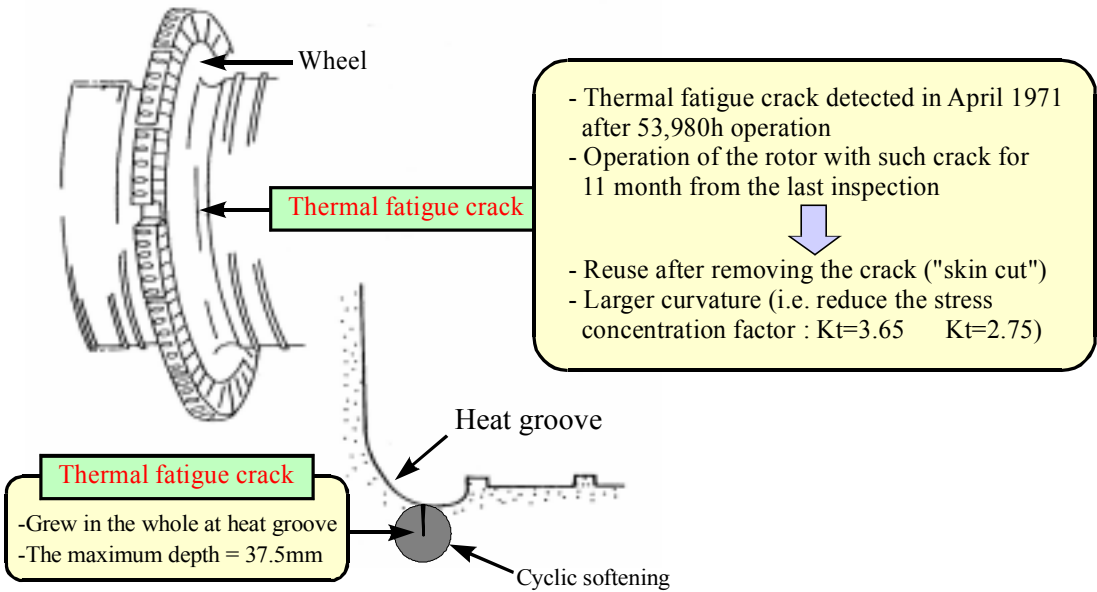
In Japan, a power plant is maintained based on the concept of preventive maintenance. Particularly, in the case of a high speed rotating component such as a steam turbine rotor, a component with a crack-like flaw is removed immediately after the flaw is detected. Figure 7(3) shows an example of a high-pressure turbine rotor in which a thermal fatigue crack grew throughout the entire heat groove. In this case, the

Fig. 7 Thermal fatigue crack initiating at the heat groove of HP turbine rotor.

cracked portion was removed (called a "skin cut") and the curvature of the heat groove was increased by machining in order to reduce stress concentration at that part. Also, this example shows the importance of assessing the lifetime to crack initiation caused by thermal fatigue. The amount of thermal fatigue life consumption, which is called the Low Cycle Fatigue Index (LCFI), has been usually controlled to limit the rate of temperature variation during transient operations such as startup and shutdown. In this case, the crack initiation life is defined as the length of time from fabrication to the point when the LCFI reaches 100%. However, the value of LCFI was only 23% when the thermal fatigue crack shown in Fig.7 was detected and caused the accident(4). This shows that a more accurate assessment of thermal fatigue life is necessary for operating a rotor reliably. As an aside, the SAFER code was introduced to Japan in the middle of the 1980's. However, the original function of the code for crack growth analyses was not used, and another function of damage analyses was added to the code to assess the crack initiation life. Thus, preventive maintenance has been applied in Japan while the break down maintenance approach is used in the USA. In other words, the difference of culture between nations appears on the concept of maintenance.
