Burst of Steam Turbine Rotor in Nuclear Power Plant

Sep. 19th, 1969, Somerset, England, UK

NITTA, Akito (Central Research Institute of Electric Power Industries)

KOBAYASHI, Hideo (Tokyo Institute of Technology)

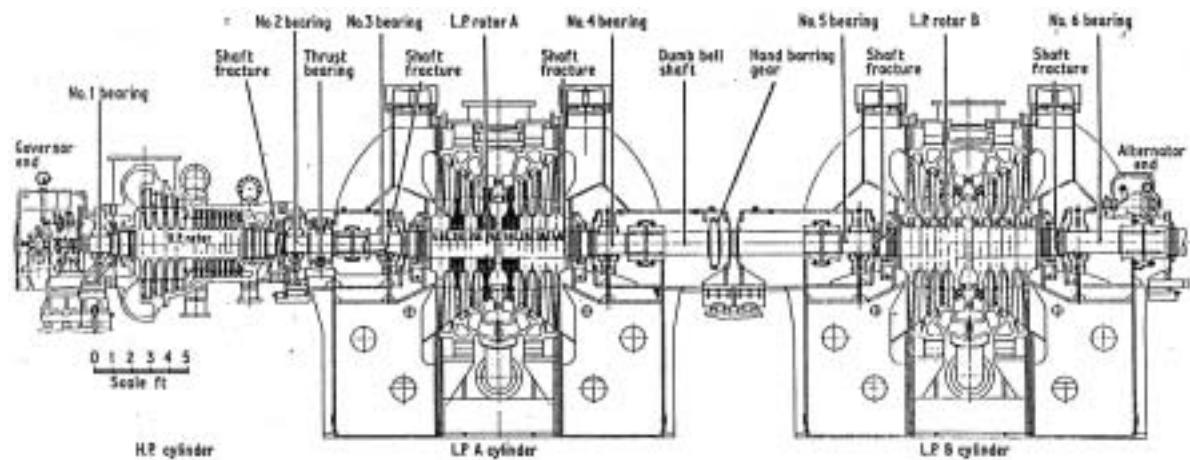
Fig. 1 Overview of the burst TVA Gallatin No.2 IP-LP turbine rotor.

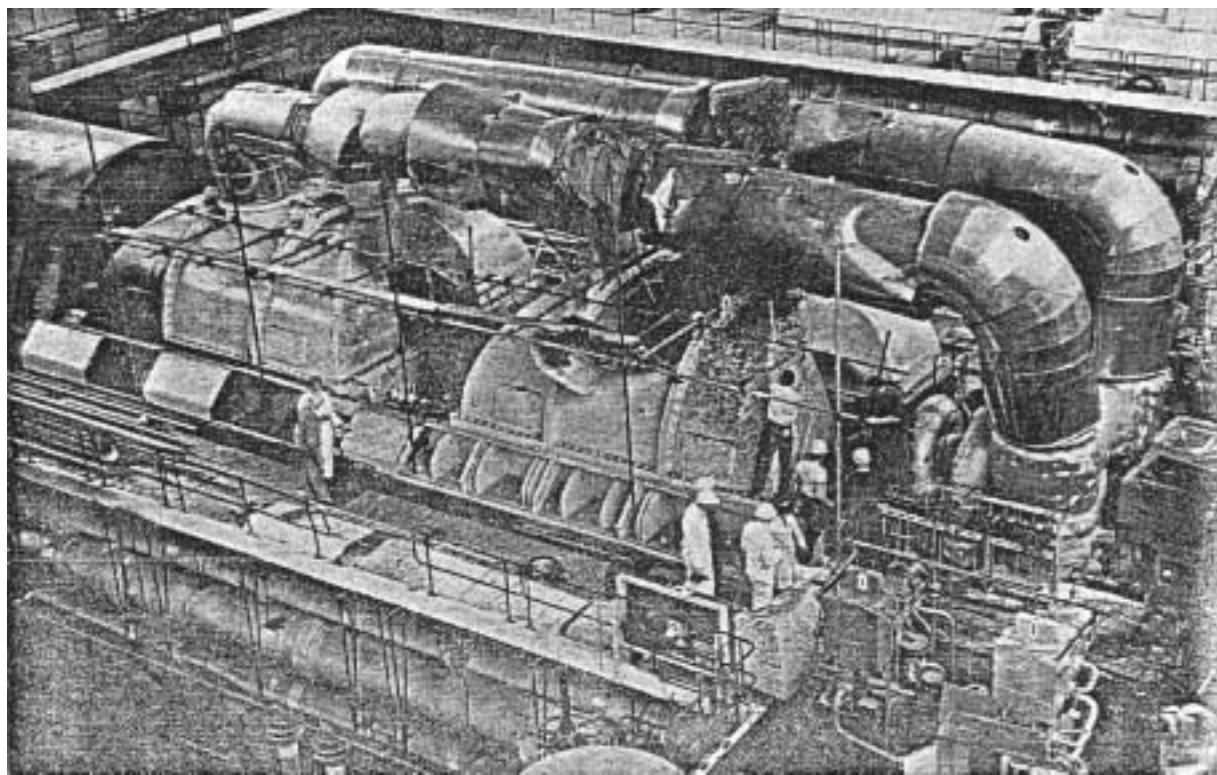
Fig. 2 Appearance of the No.5 unit after the failure.

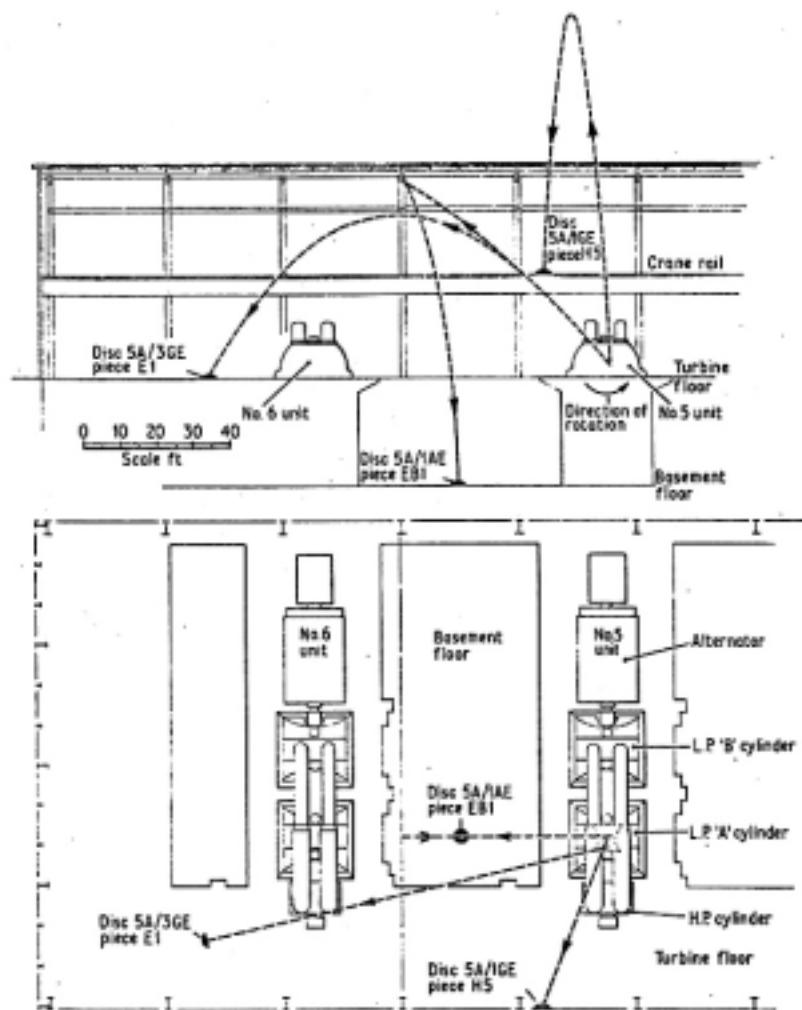
Fig. 3 Flying-off paths of three large disc fragments.

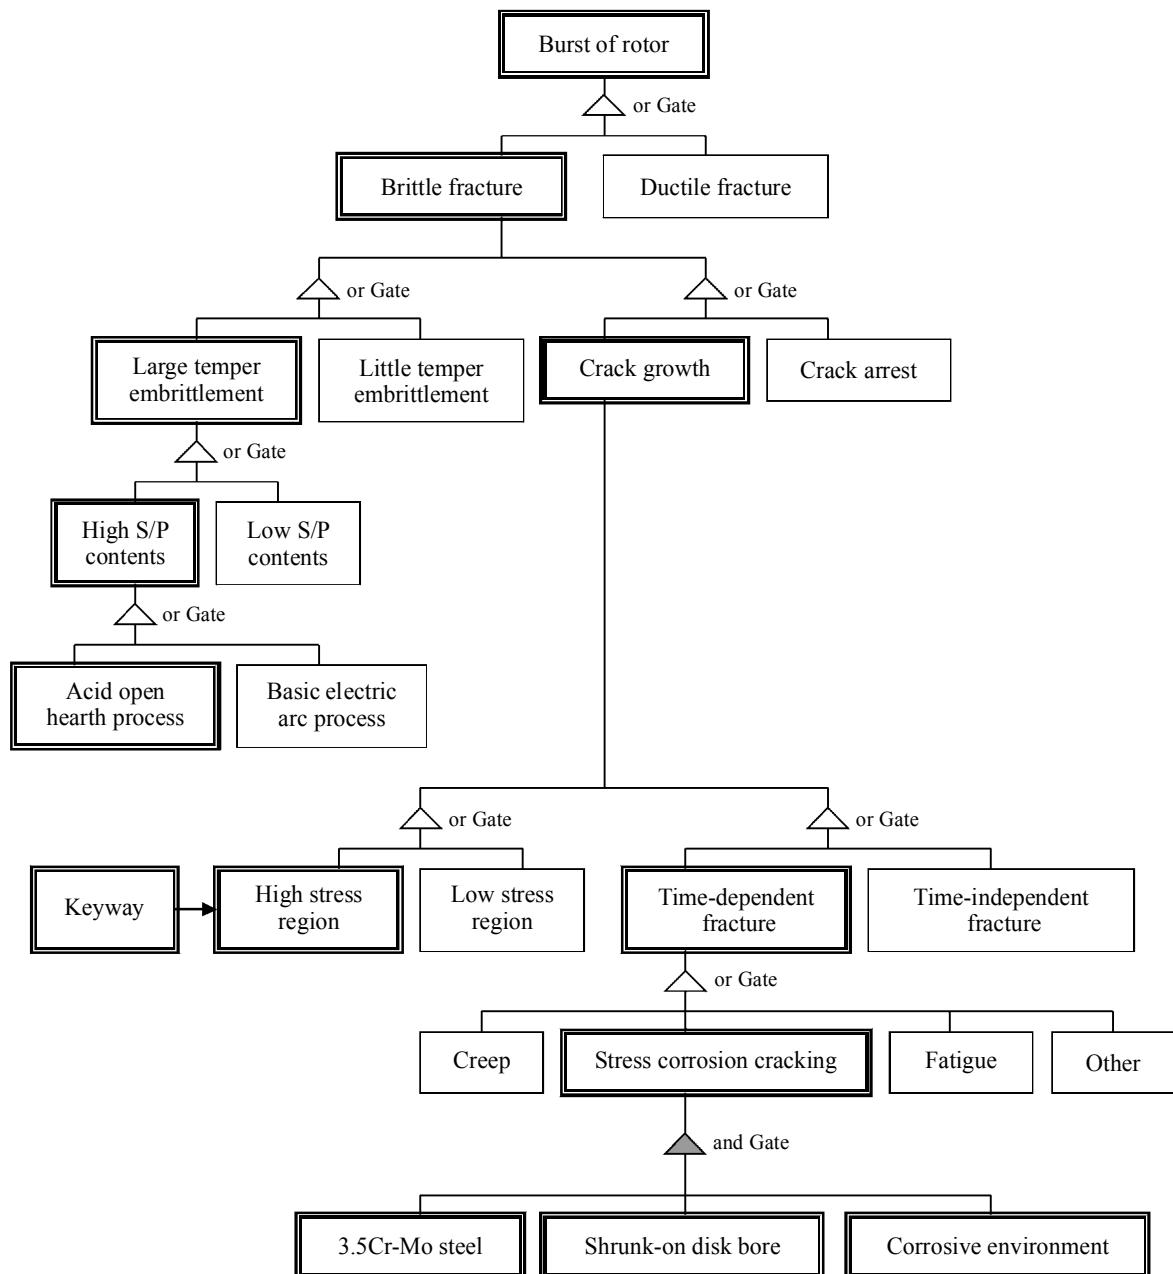
Fig. 4 Fault tree diagram for mode, mechanism and process of fracture.

(1) Fault tree diagram for mode, mechanism and process of fracture (Fig. 4)

The low-pressure turbine disc, which was the site of the fracture, was made of a 3 Cr-0.5Mo steel by acid open hearth process. Also, the disc was found from chemical analyses to have a high sulfur and phosphorus content, although the levels were within the specifications. Thus, the material was apt to have a lower fracture toughness as a result of the temper embrittlement caused during heat treatment process. Furthermore, in order to shrink the disc onto the shaft, the disc had a semicircular keyway that acted as a stress concentration reservoir. Under such conditions, the stress corrosion cracking (SCC) related to environmental factors such as NaOH in the steam can occur, although it was very difficult to identify the true cause of the SCC. Finally, when the crack reached only 1.6mm in depth, the brittle fracture of the disc occurred.

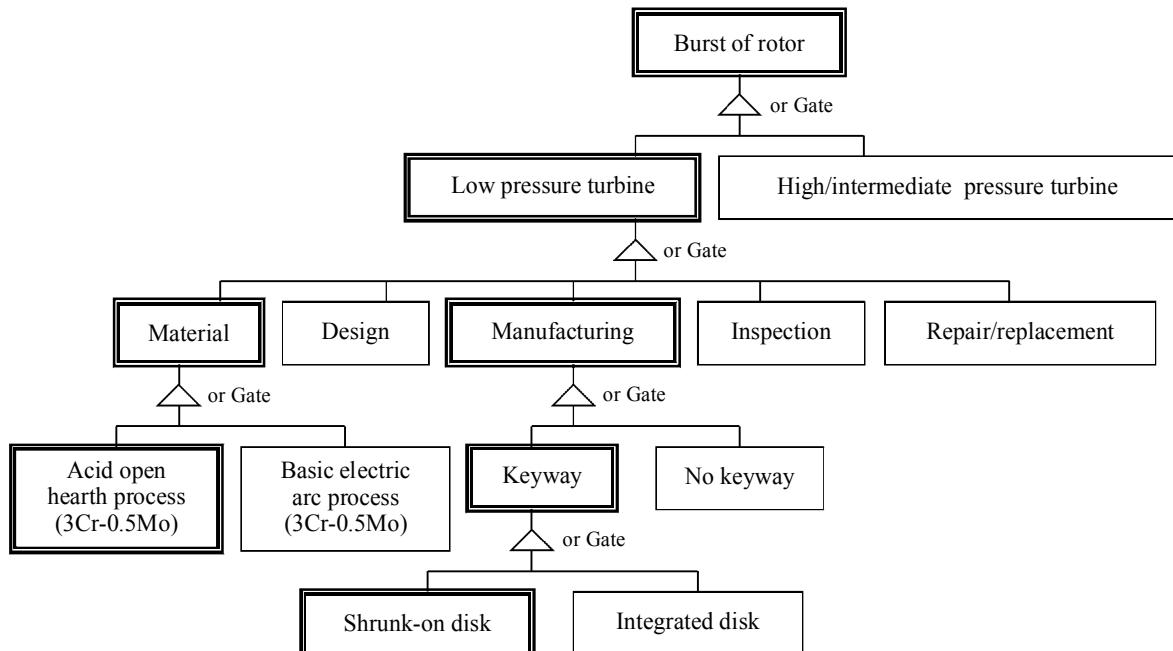
Fig. 5 Fault tree diagram for design and manufacturing errors.

(2) Fault tree diagram for design and manufacturing errors (Fig. 5)

No problems were found in either the forging and heat treatment processes at the time of the disc manufacture or in the results of nondestructive (i.e., magnetic and ultrasonic) and tensile acceptance tests. Furthermore, review of the design stressing of the main rotating components and investigation of the possible modes of the failure by additional or abnormal stressing did not find any problems in the design. Therefore, the following tests were carried out to identify the root cause of the failure: the detailed fractographic observation of the fractured discs, and chemical analyses, tensile tests, fatigue and crack propagation tests, Charpy impact tests, fracture toughness tests and SCC tests by using the test pieces taken from the discs. From these results, the brittle fracture of the low-pressure turbine was thought to be caused by the initiation and growth of SCC related to environmental factors in the low-pressure steam at the key way (i.e., stress concentrated portion) of the shrunk-on disc, together with the low fracture toughness of the 3Cr-0.5Mo steel made by acid open hearth process.

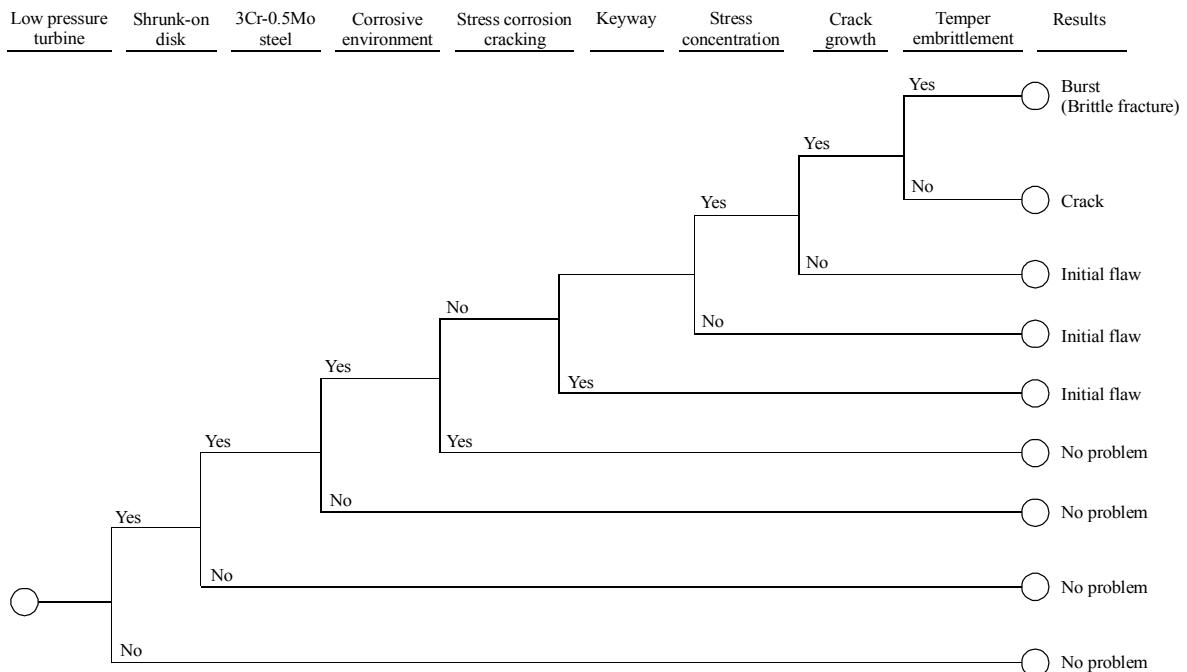
Fig. 6 Event tree diagram for the low-pressure steam turbine rotor burst attributed to stress concentration in a shrunk-on disc keyway and the low toughness of a disc material.

(3) Event tree diagram for the low-pressure steam turbine rotor burst attributed to the stress concentration in a shrunk-on disc keyway and the low toughness of a disc material (Fig. 6)

The SCC, which was thought to be related to environmental factors in the low-pressure steam, occurred on the bore surface of a shrunk-on disc of 3Cr-0.5Mo steel made by acid open hearth process. The disc keyway was a stress concentration reservoir, and the toughness of the material of the disc was lowered by temper embrittlement during its heat treatment process. The compound effect of these two factors resulted in the brittle fracture of the low-pressure turbine rotor.
