The guillotine breaking of the secondary piping in nuclear power plant

Dec. 9th, 1986, Virginia State United States

MURAKAMI, Hiroshiyo (Japan Atomic Power Company)

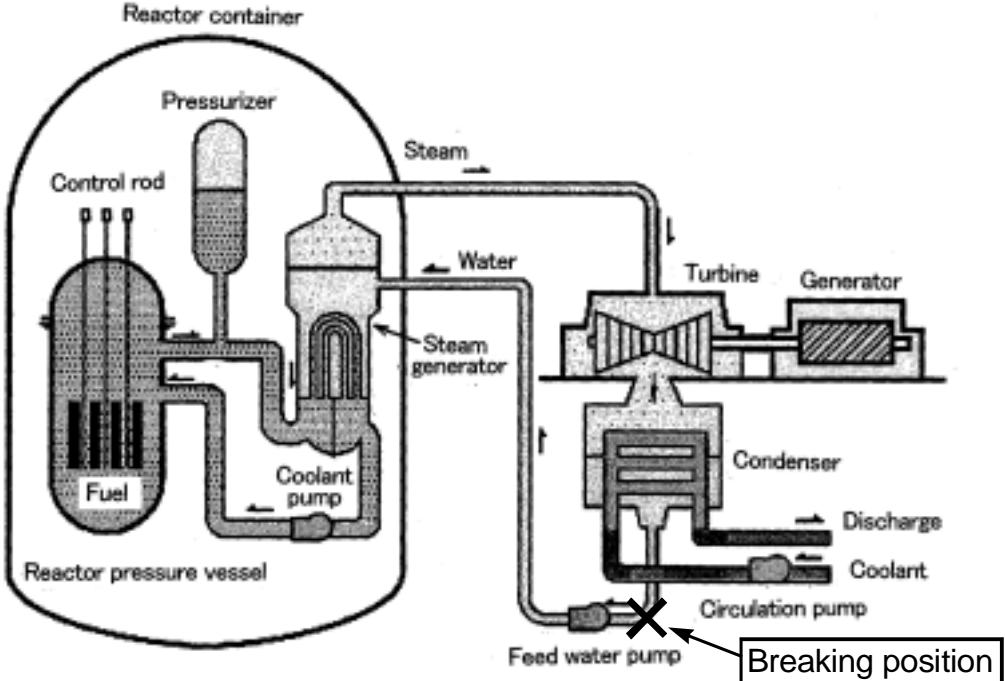
Fig. 1 Primary and Secondary Systems of Pressurized Water Reactor and Braking Portion.

At 14:21 on December 9th, 1986, the guillotine breaking accident shown in Fig. 1 occurred at the secondary system piping in Surry Nuclear Power Plant Unit No.2. The Surry Unit No.2 was owned and operated by the Virginia Electric Power Company in Newport News, Surry County in the state of Virginia, the USA. The commercial operation started in May 1973 and continued for a total operating time of 76,600 hours prior to the accident. The pipe failed in a 90°elbow located in the 18 inch (457mm) feedwater suction line that feeds water to the feedwater pump as shown in Fig. 2. The material of the broken piping is carbon steel (ASTM A234) with a wall thickness of 0.5 inches (12.7mm). The cause of the failure is wall thinning due to erosion-corrosion. Four persons who were replacing thermal insulation nearby the line were killed and two persons were injured.

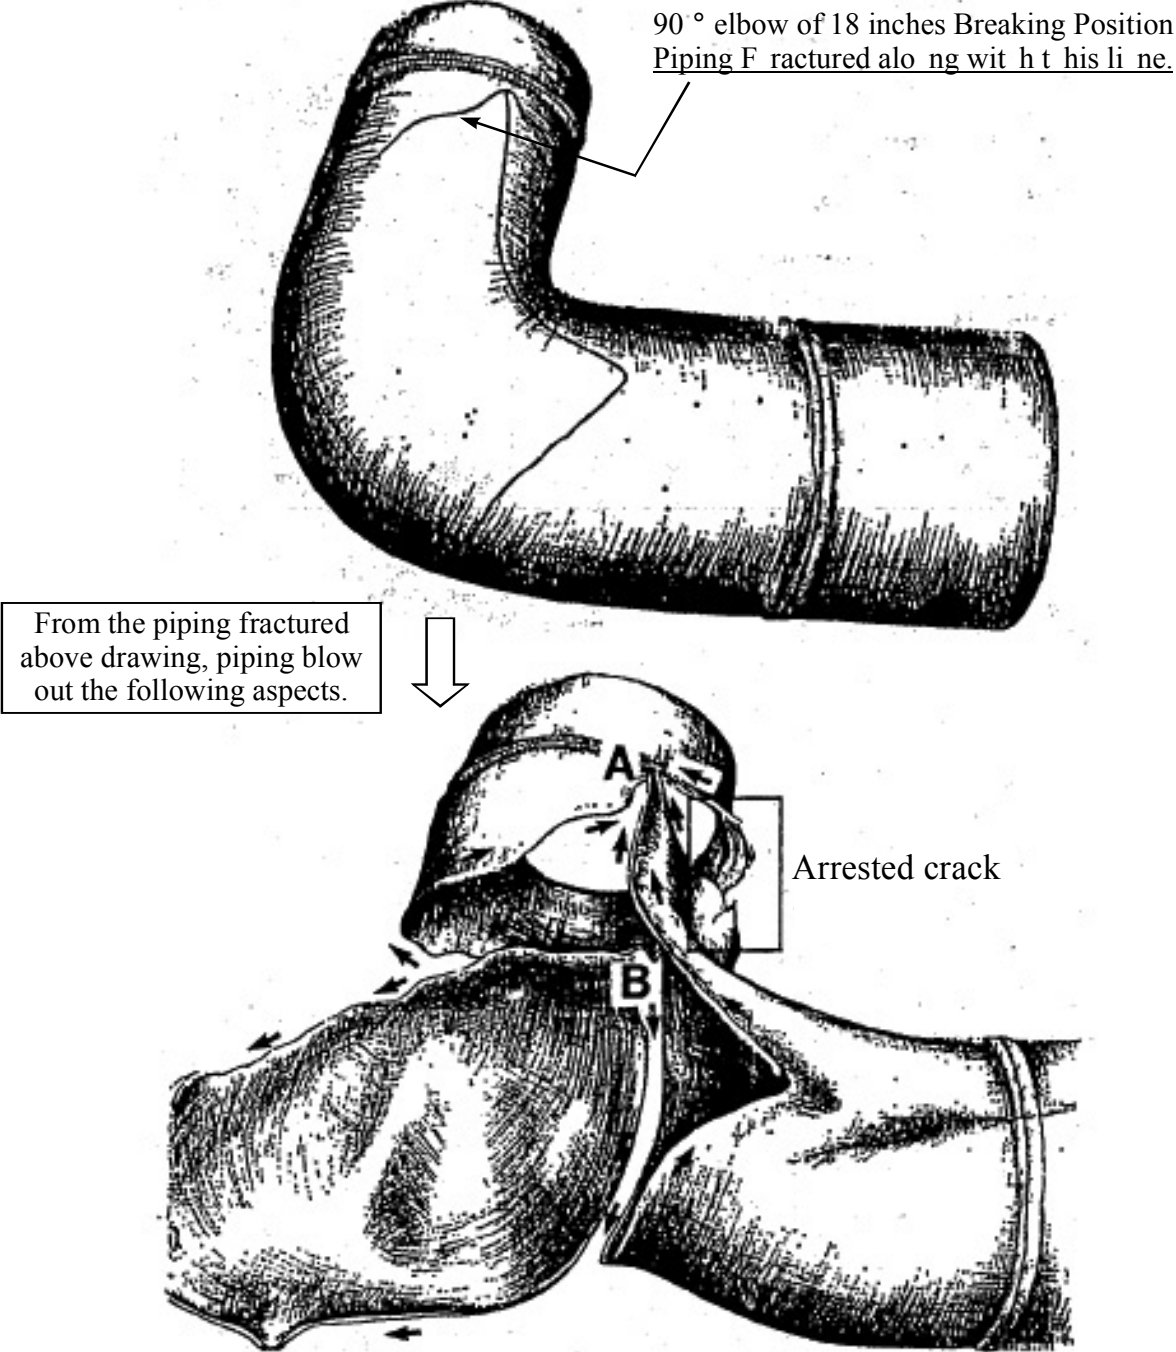
Fig. 2 Detail Drawing of the Breaking Portion.

- (3) Since the feedwater pump was working even though the main water supply control valve was closed, the pressure in front of and behind the feedwater pump rose. As a result, about 5 seconds after the main water supply control valve was closed, there was faint steam discharge sound, and the 90°elbow part of the 450mm piping that branches from a 600mm header piping at a feedwater pump suction line broke. Six of eight persons who were replacing thermal insulation nearby the fractured elbow part received serious burns. Four of them died, and two of them survived with serious burns.

The part in which the break occurred was carbon steel that was exposed to the secondary water chemistry environment of a pressurized water reactor. In the combination of the secondary system water chemistry (pH 8.8 - 9.2) by AVT (All Volatile Treatment), and carbon steel, it was not necessarily the water chemistry for maintaining the corrosion protection of carbon steel. Since a copper alloy was used in the system, proper corrosion protection of the carbon steel could not be maintained under the higher pH. Moreover, because the part that broke was not designated as an object of the in-service inspection, no inspection of the position where the break occurred had ever been conducted. In addition, the 90° elbow where the break occurred had been installed as a result of an improper piping layout. For this reason, a turbulent flow occurred in the elbow part resulting in the progression of severe wall thinning by erosion-corrosion. The break occurred after the scram of the nuclear reactor.

- (1) An inspection of the wall thinning in the piping of the secondary system at the Surry Unit No.2 that caused the accident was performed. The piping in the part where the generation of wall thinning had been observed was replaced.
- (2) The piping was replaced according to the following conditions. (a) Adoption of stainless steel that has a higher erosion-corrosion resistance than carbon steel, for which the corrosion resistance under the water chemistry environment and flow velocity conditions was difficult to maintain, and (b) adoption of larger diameter piping in order to reduce erosion-corrosion and to improve the piping layout by decreasing the flow velocity.

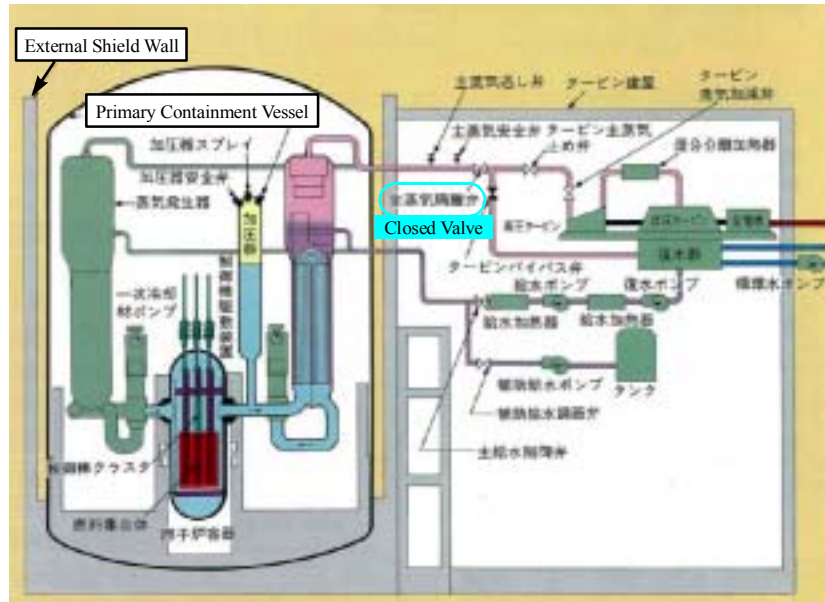
Fig. 3 Schematically System Drawing of Pressurized Water Reactor.

- (1) The main steam isolation valve failed to close while operating at 100% power on December 9th, 1986. Therefore, the nuclear reactor tripped and the auxiliary feedwater pump started as shown in the outline of the system given in Fig. 3.
