# Brittle Fracture of Hydrodesulfurization Reactor during Pressure Test

April 1st, 1980: Tokuyama-city, Yamaguchi Prefecture

## (Summary)

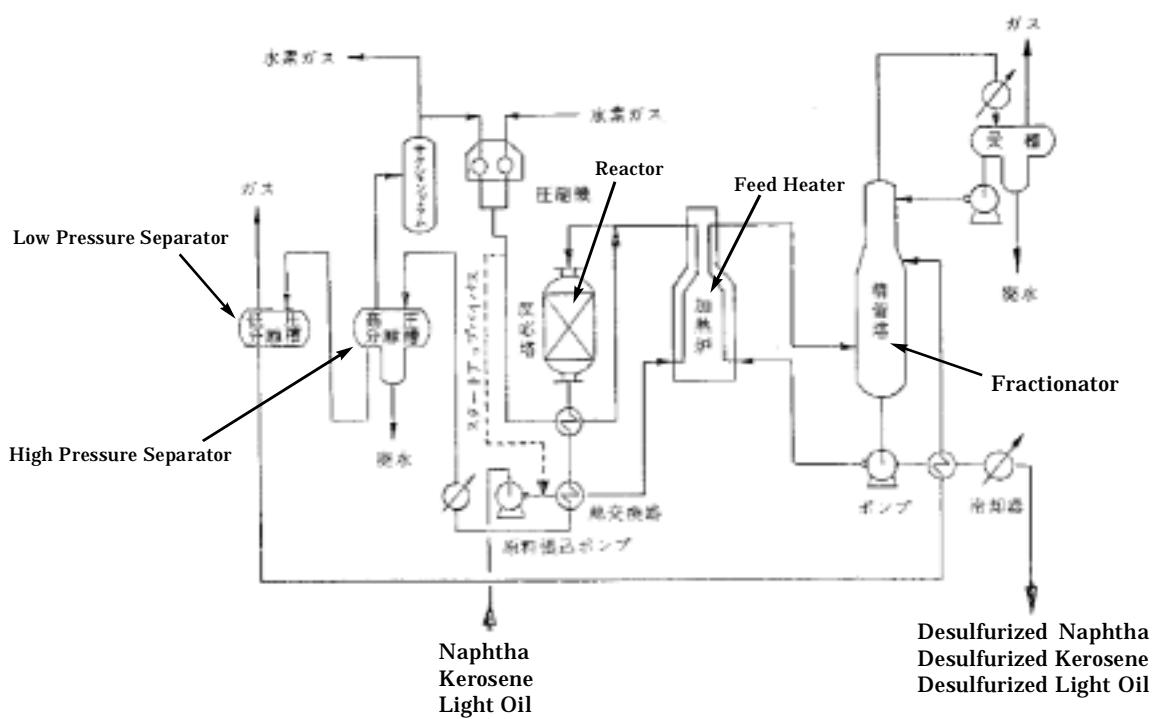
Fig. 1 Flow Sheet of Hydrodesulfurization Plant.

The reactor of the hydrodesulfurization plant for light oil, naphtha and kerosene failed during the hydrostatic test using N<sub>2</sub> before the restart-up after scheduled shutdown inspection(Fig. 1, 9,000BPD).

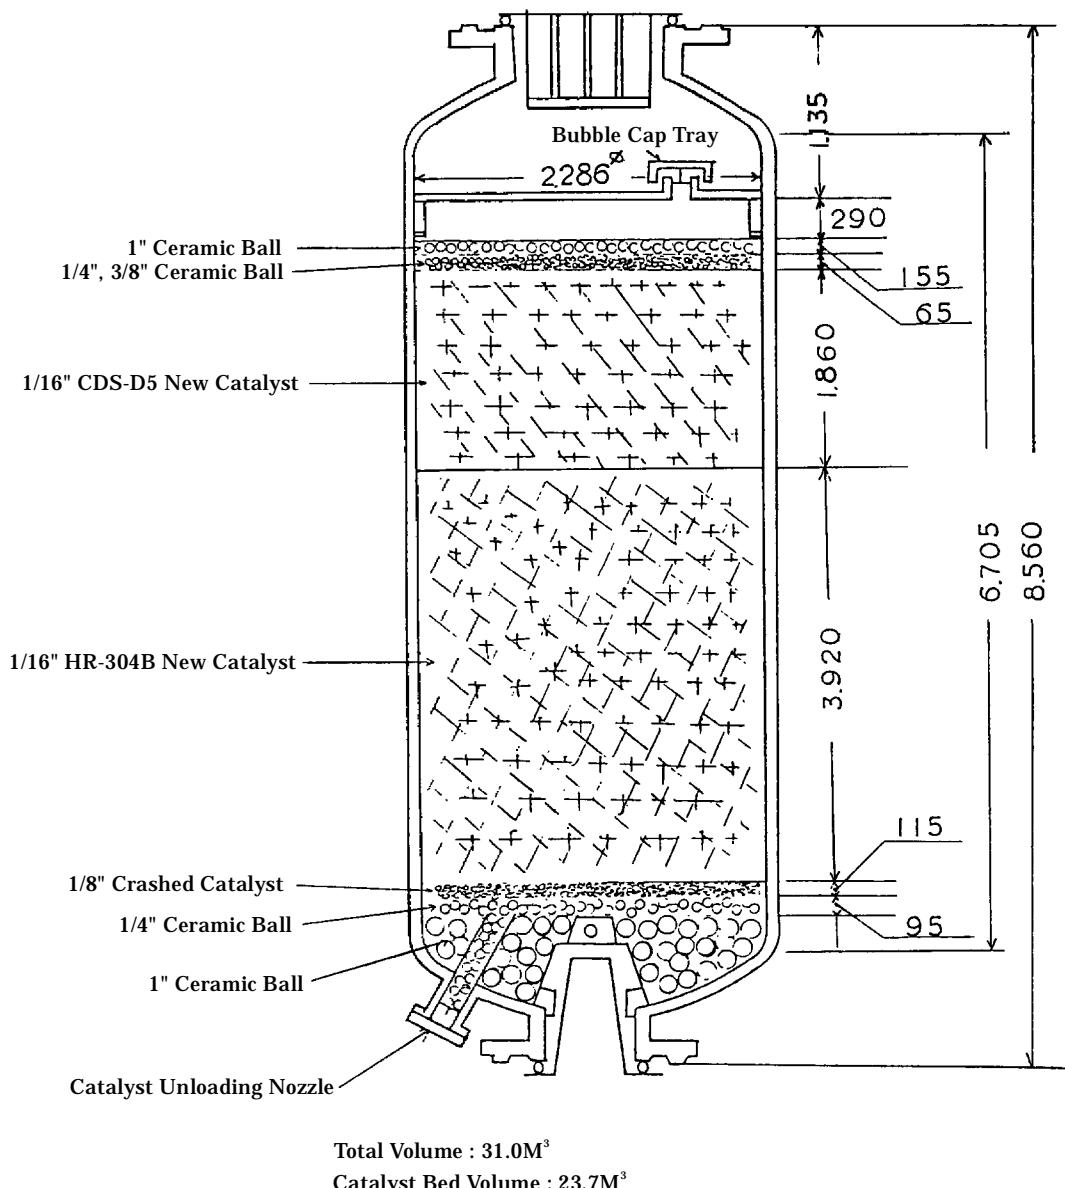
Fig. 2 Structural Sketch of Hydrodesulfurization Reactor.

Reactor of desulfurization process(Fig. 2, 89t pressure wall of SB46M + 3.5t clad of SUS405)

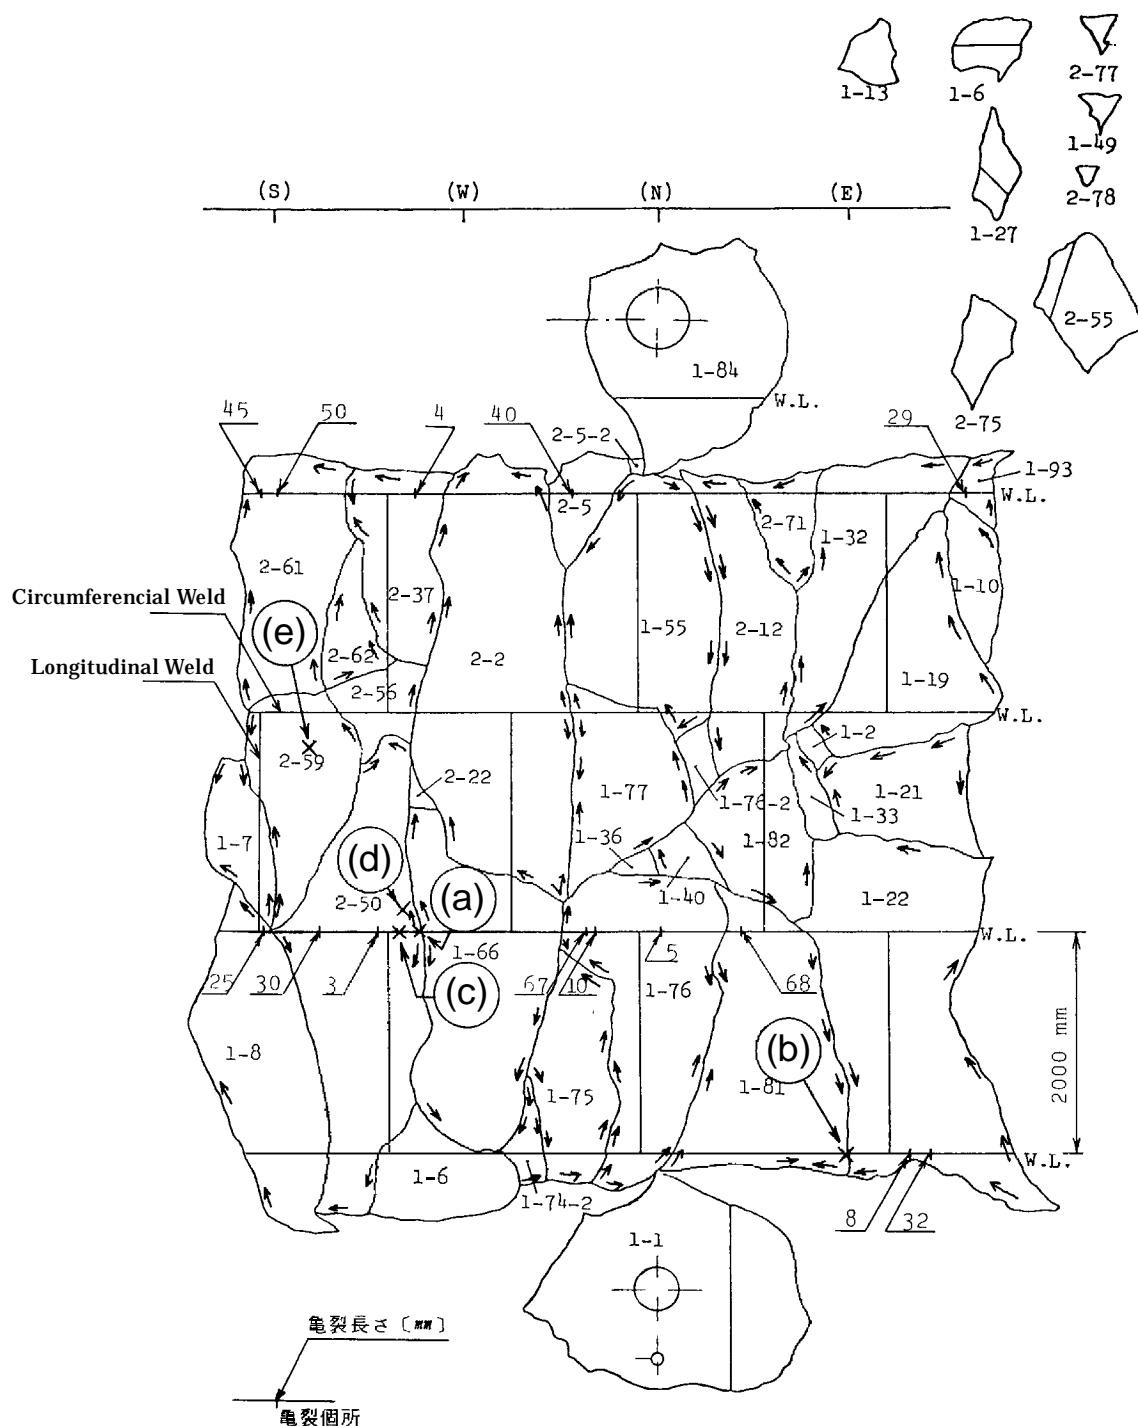
The 44 pieces of the fractured reactor were collected and the map of fracture-pieces was made as shown in Fig. 3 where the arrows indicate the crack propagation directions. Based on the analysis results of Fig. 3 and the distribution of the catalyst blown out of the reactor, the starting point of fracture was presumed at (a) in Fig. 3.

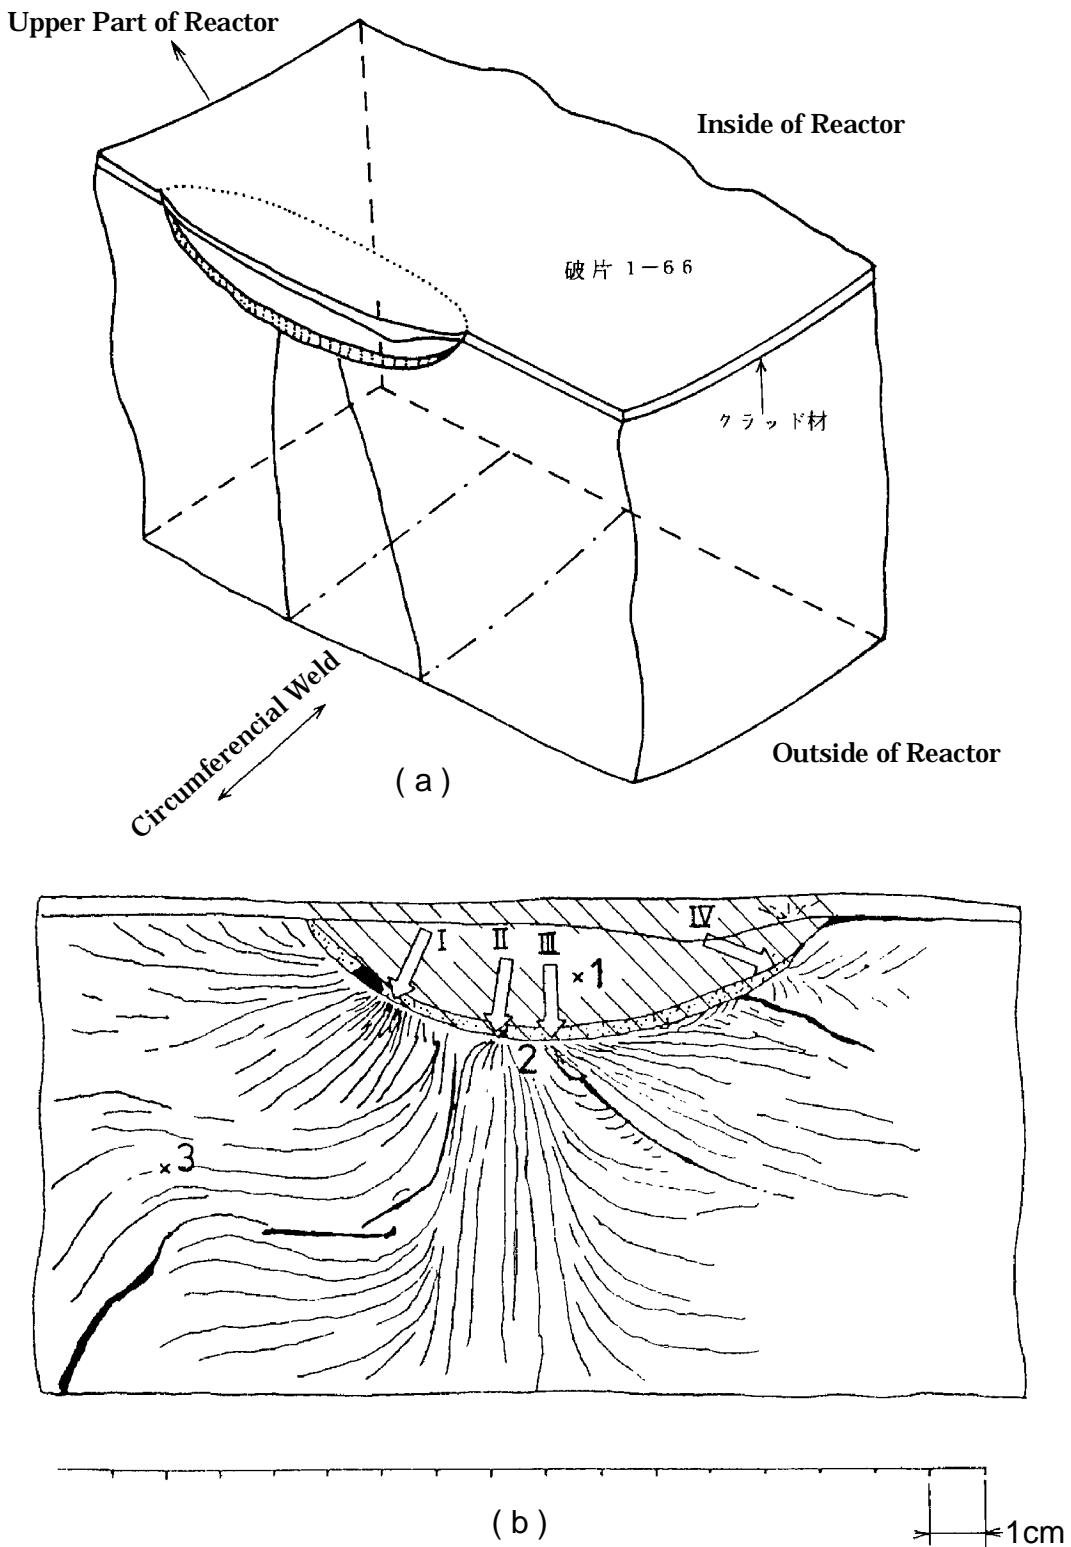
Fig. 4 Schematic Representation of Fractured part weld repaired at shop.

Examination of fracture surface, microstructure analysis, electron probe micro analysis (EPMA), chemical analysis of (a) were carried out and it was concluded that the starting point was within the weld repaired part applied during fabrication of the reactor at shop.

The story of the repair work at shop was supposed as follows; In the nondestructive inspection of weld lines after completion of welding, found were defects in the circumferential weld line of the reactor. The defects were ground off and repair welding with D309 was applied. Finally, the inner surface of the repaired part was weld over laid with CR40Cb for matching the SUS405 clad (Fig. 4, 5).

Due to the repetition of plant startup and shutdown for many years, disbonding at the boundary of C-0.5Mo steel and D309(Dissimilar weld joint) occurred and worked as the starting point of crack(Fig. 4 I ~ IV). After the crack propagated and reached the inner surface of the reactor(Fig. 5 (A)), hydrogen attack of base metal occurred at the disbonded area and propagated toward the external surface of the reactor(Fig. 5 (B)). When the stress intensity factor of the crack tip reached the fracture toughness of the base metal under the hydrostatic test condition(wall temperature; 13 °C, pressure; 55kgf/cm<sup>2</sup>), the accident occurred.

It is the general way to apply austenitic weld metal like 309 so as to avert PWHT when we carry out repair welding of equipments of C-0.5Mo steel. In case that the equipment repaired by this way is used under the conditions having hydrogen attack possibility, the practices of their periodic inspections should be discussed in detail and understood by all members concerned. A lot of inspection methods using ultrasonic techniques have been developed for detecting hydrogen attack of pressure vessels.
