# Burst by Hydrogen attack of Residue Hydrodesulfurization Unit Piping

March 31st, 1982, Kashima city, Ibaraki Prefecture

HASHIMOTO, Tetsunosuke (Chiyoda co., OB)

KOBAYASHI, Hideo (Tokyo Institute of Technology)

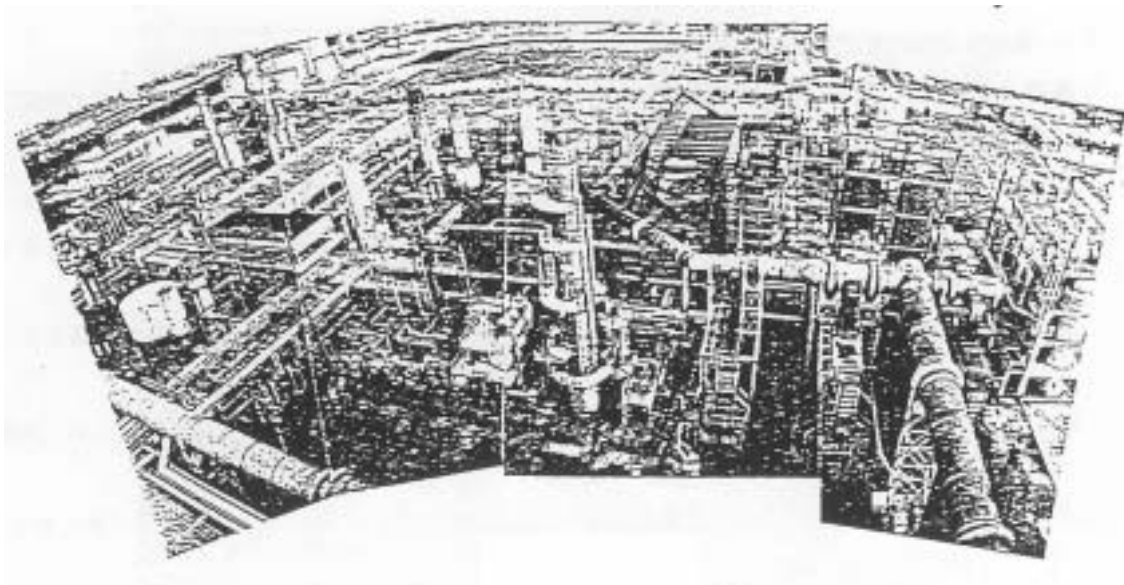
Fig. 1 Accident site.

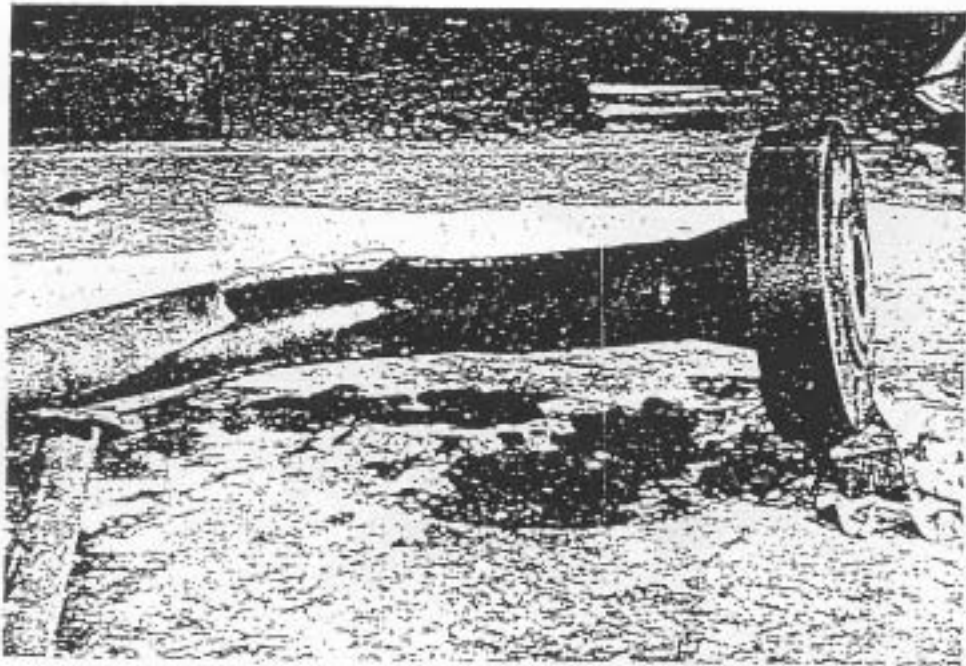
The burst happened in the direction of the tube axis from a distance of 36mm from the flange welding line to a distance of about 1.2m.

Fig. 2 Burst part of the safety valve downstream piping.

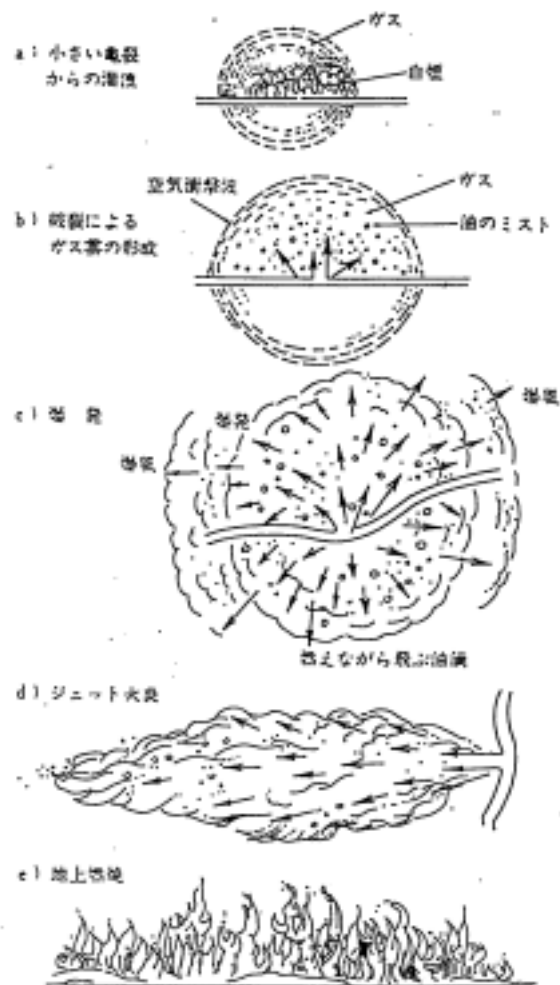
After having detected the pressure abnormality, eight people who were in the operation room gathered to the leakage site for the purpose of the site confirmation. The explosion occurred just 4-5 minutes after the leakage was discovered, resulting in extensive damage, five deaths, and three serious injuries.

Fig. 3 Passage of a fire and explosion.

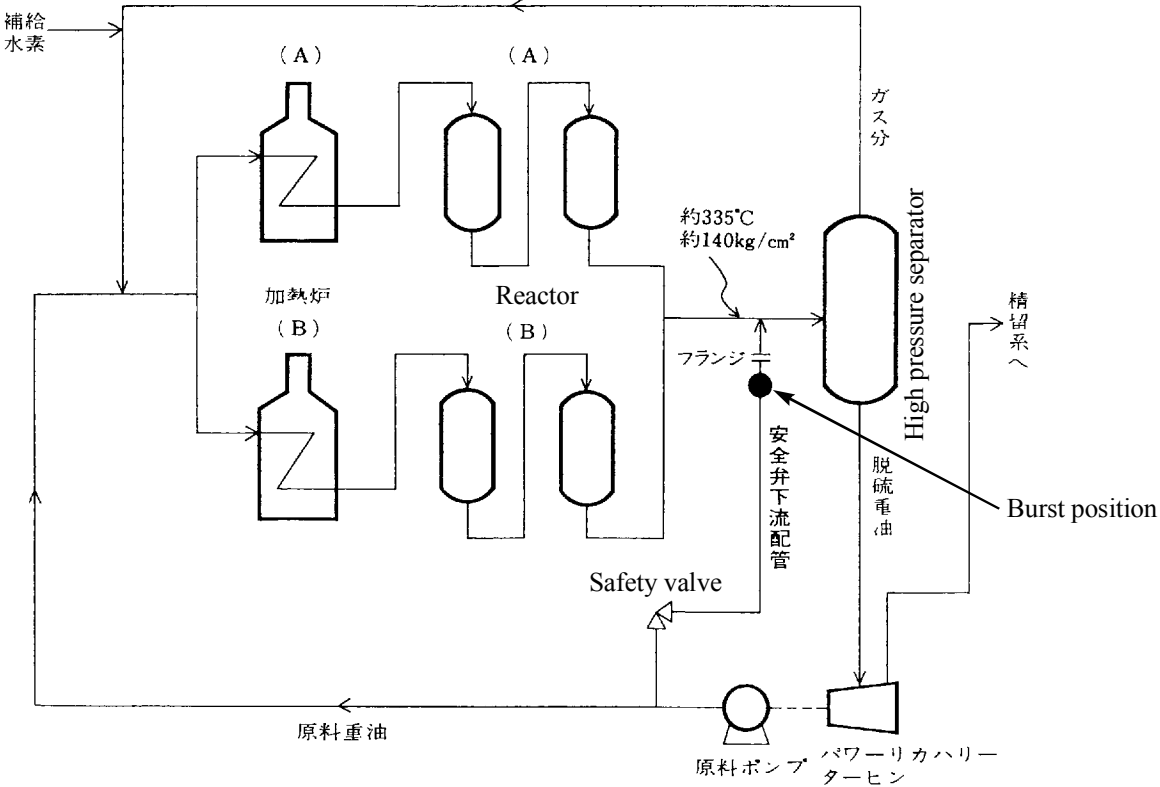
The process fluid, including high temperature high pressure hydrogen, flows to the main piping from the reactor exit to the separator. Stainless steels (20B, SUS321) were used for this main piping. Branch piping 1,300mm in length of same material (6B, SUS321) had been installed horizontally in the main piping. The damaged carbon steel by-pass piping (6B, STPT38) of the safety valve downstream was connected with the stainless steel branch piping (6B, SUS321) by a flanged connection (Refer to Figure 4). During regular operation, the fluid does not flow through the pipe. Therefore, the system had been designed based on the assumption that the temperature of the carbon steel by-pass piping would not rise.

Fig. 4 Hydrodesulfurization process flow seat and burst position.

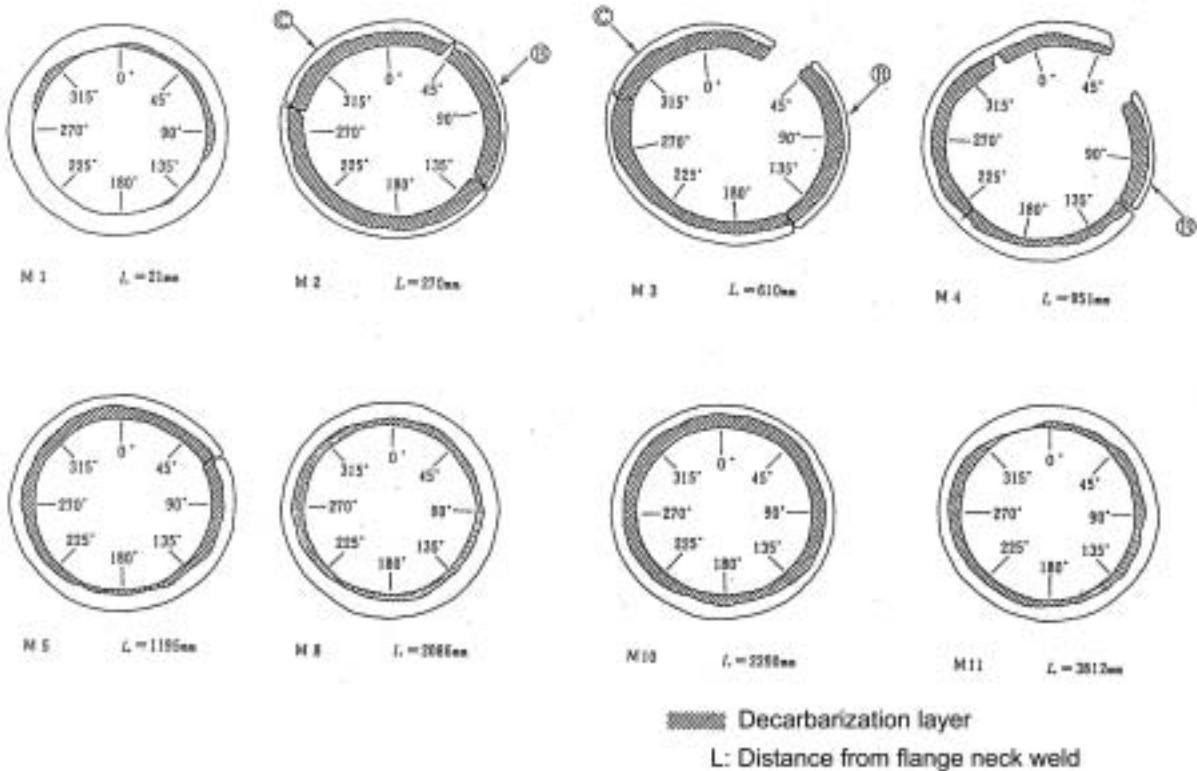
As a result of studies including microscopic examination, it was concluded that the hydrogen attack had occurred on the inner side of the piping, and that the decarburization had occurred in the flange weld of the carbon steel piping resulting in micro intercrystalline cracks in a part of the piping about 5.5 m in length.

Micro cracks extended throughout the whole area of the tube section in the vicinity of the part of the piping that had burst as shown in Figure 5, and it is thought that the first leakage had occurred through a micro crack. (Refer to Figure 6). Judging from the Nelson chart (API 941) that shows the boundary of safety from the hydrogen attack, the damaged part was presumed to have been kept at a temperature of 230 or more for a long time. However, although the interaction between the carbon steel branch piping and the stainless steel piping of the high temperature driving condition (335 and hydrogen partial pressure 120kgf/cm<sup>2</sup>) was examined, the temperature rise mechanism of this carbon steel piping was not determined conclusively. The mechanism of the heat-pipe phenomenon was presumed as a strong inference of the possibility. That is, when the steam was added to promote the hydrosulfurization reaction, it condensed in the carbon steel piping of the line in the part where the fluid did not flow during operation. The condensed water flowed backward to the main piping, causing the inflow of the high temperature fluid to the damaged part, which raised the temperature of the carbon steel piping.

Fig. 5 Distribution of decarburization part of tube section.

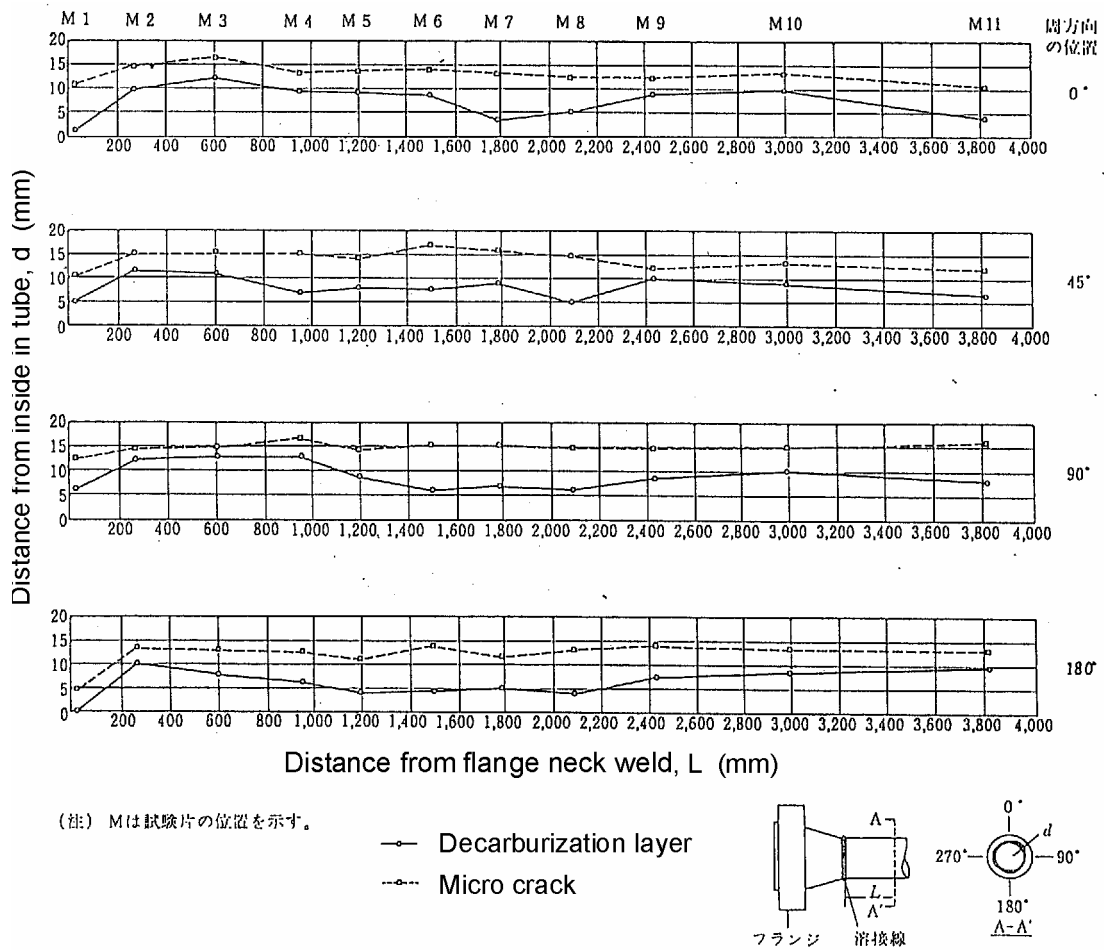
Fig. 6 Distribution of direction of tube axis of decarburized layer and micro crack.
