Disaster of Chemical Plant at Flixborough

June 1st. 1974, Flixborough UK

(Summary)

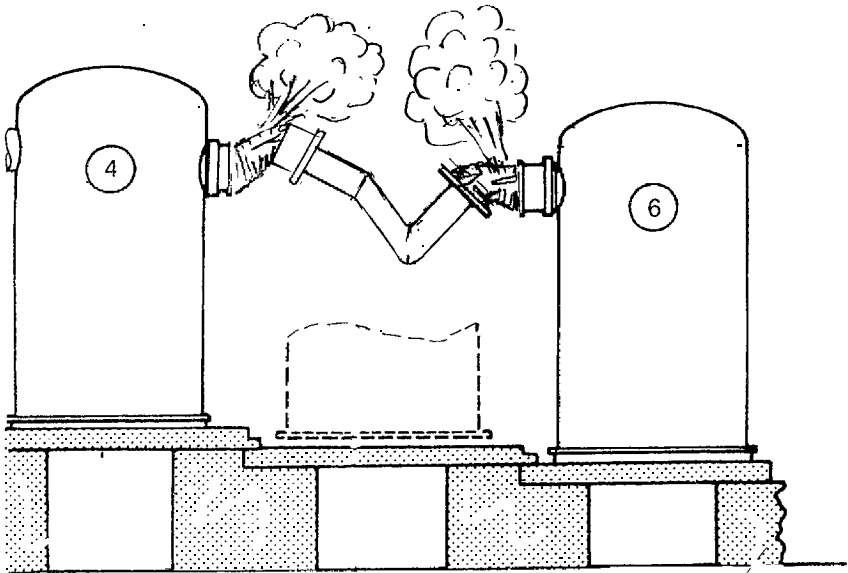
As a result of the rupture of the bellows, a great amount of cyclohexane escaped from the holes in the bellows and formed a cloud of cyclohexane vapour, which subsequently caused the explosion (Fig. 1).

An initial investigation at the site found a "S" shape 20in. (508 mm) pipe assembly lying on the concrete

plinth below its original position. It had jack-knifed completely at the lower mitre joint and apparently collided violently with the plinth after being projected forcibly downwards.

Both of the bellows had torn away from the temporary pipe. They had also been torn off the reactor nozzles. Each of the bellows had disintegrated into a few large pieces, all of which were found in the vicinity of the failed pipe.

The temporary pipe was deformed in a "V" shape by bending stress at only slightly above operating pressure, and the bellows, the weak link in the chain, were torn away by shear stress. As a result, a massive vapor cloud was formed by the escape of cyclohexane from the holes of the ruptured 28 in. (711 mm) diameter bellows, and subsequent ignition caused the explosion to occur.

The reason for why the bellows fractured by shear stress, was that the temporary pipe was installed without examining what the effect of a slight pressure rise on the bellows would be.

The support of the temporary pipe was a scaffolding structure upon which the pipe rested, without being fastened down. Therefore, the support structure could not provide enough strength to withstand against bending stress.

Fig. 1 View of fractured temporary pipe.

Especially in plants that are treating hazardous materials, even relatively easy repairs or improvements of facilities should be made with thorough reference to the standards, and the design should be entrusted to professional engineers.
