# Capsize of Offshore Oil Drilling Platform

March 27th, 1980, Ekofisk oilfield in the North Sea

KITSUNAI, Yoshio (Japan Crane Association)

KOBAYASHI, Hideo (Tokyo Institute of Technology)

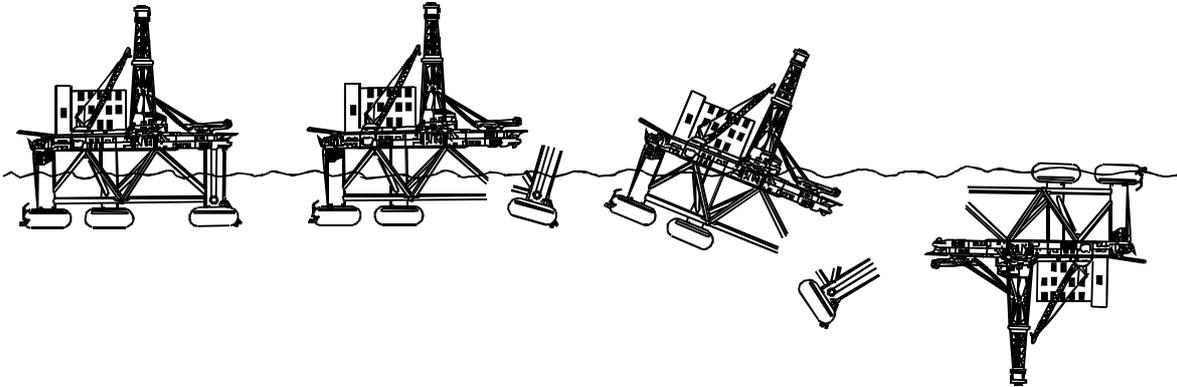
At around 6.30 pm on March 27th, 1980, the semi-submersible oil drilling platform "Alexander Kielland" capsized near the Norwegian Ekofisk oil field located at a latitude 56 degrees 28 minutes north and a longitude of 3 degrees 7 minutes (Fig. 2), in a storm with wind velocities from 16 to 20 m/s, temperatures of 4 to 6 C, and wave heights of 6 to 10 m, because the platform's columns broke off. Within seconds, the platform tilted between 35 and 45 degrees. After 30 minutes, the platform turned upside down (Fig. 3).

Fig. 3 Process of capsizing of Alexander L. Kielland.

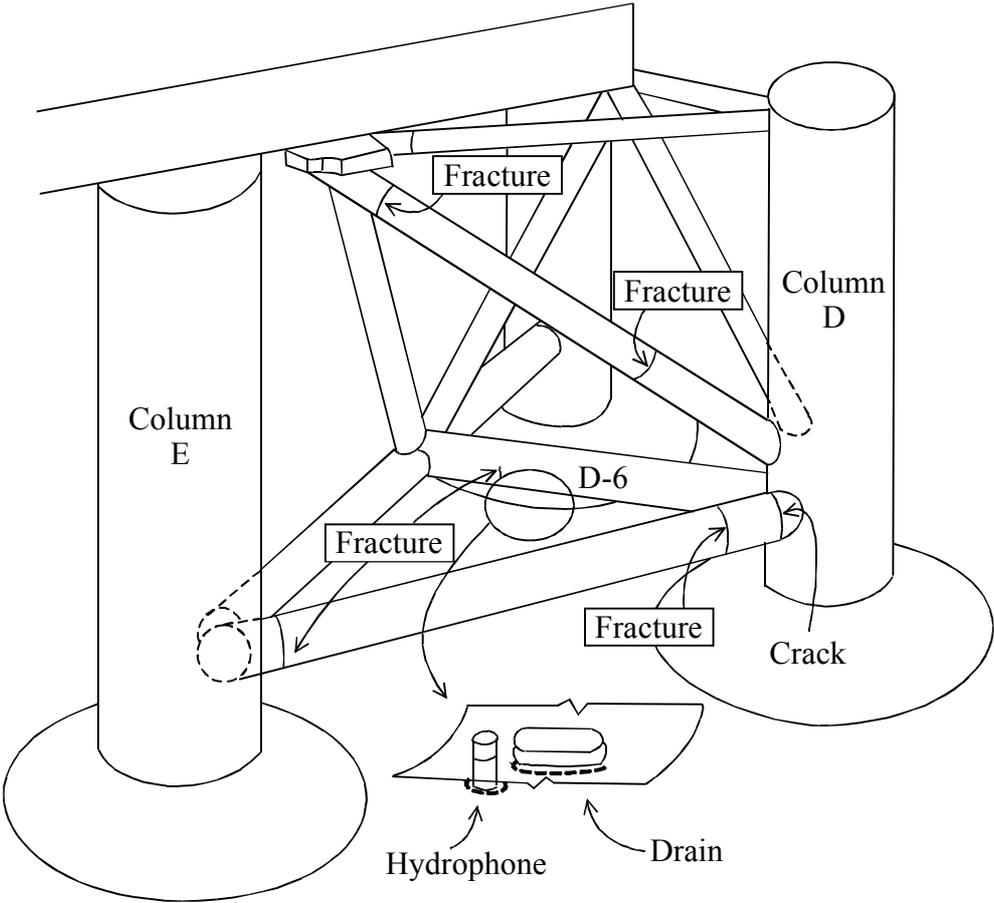
A circular hole was introduced to the underside of the D6 bracing, and a pipe, which is called a hydrophone, was mounted into the circular hole by welding (Fig. 4). The hydrophone was 325 mm in diameter with a 26 mm wall thickness. The hydrophone was welded using a double fillet weld with a weld throat thickness of 6 mm. A drain of the bracing D6 had to be installed at a location 270 mm away from the hydrophone (Fig. 5).

Fig. 4 Position of hydrophone and bracings connected columns1)2)

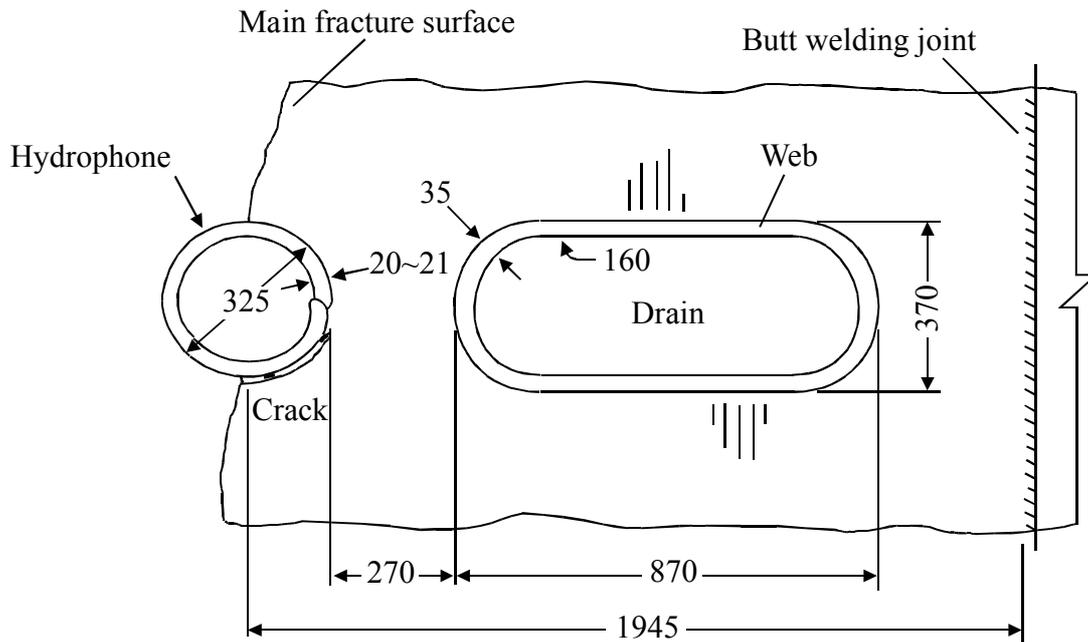
As a result of examination of the welds of the D6 bracing, some cracks related to lamellar tearing were found in the heat affected zone (HAZ) of the weld around the hydrophone. However, no weld defects were found at any other location. Traces of paint coinciding with the paint used on the platform were recognized on the fracture surface of the fillet weld around the hydrophone in the bracing D6. These paint traces show that the cracks were already formed before the D6 bracing was painted. Examination of the fracture surface also showed that the fatigue cracks propagated from two initiation sites near the fillet weld of the hydrophone to the direction circumferential to the D6 bracing. Moreover, the fatigue fracture surface occupied more than 60% of the circumference of the D6 bracing (Fig. 6), and beach marks were formed on the fracture surface, which was about 60 to 100 mm away from the hydrophone. Striations with spacing of 0.25E-3 to 1.0 E-3 mm were observed in patches on the fracture surface of the D6 bracing.

Fig. 5 Main fracture surface near hydrophone1)2).

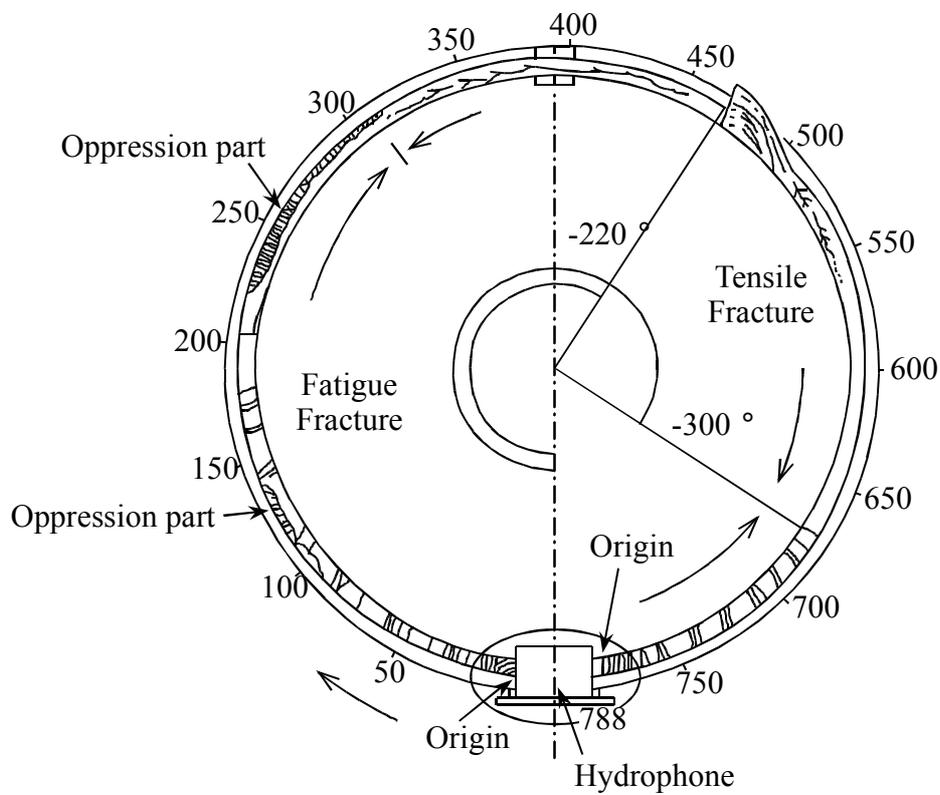
Fig. 6 Fracture feature of D6 bracing2).
