# Leakage of primary coolant at Mihama Unit 2 due to failure of SG tube

February 9th, 1991, Mihama in Fukui Prefecture

## (Summary)

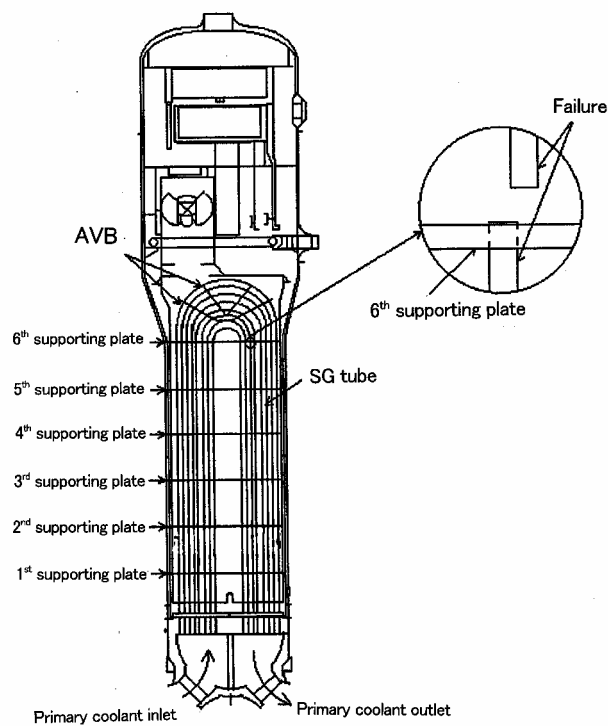
After the accident, investigation of the steam generator was carried out using a fiber scope and some other inspection instruments. As a result, the failure of a SG tube was found near the sixth supporting plate for the SG tubes.

Fig. 2 Steam generator and location of failure of SG tube.

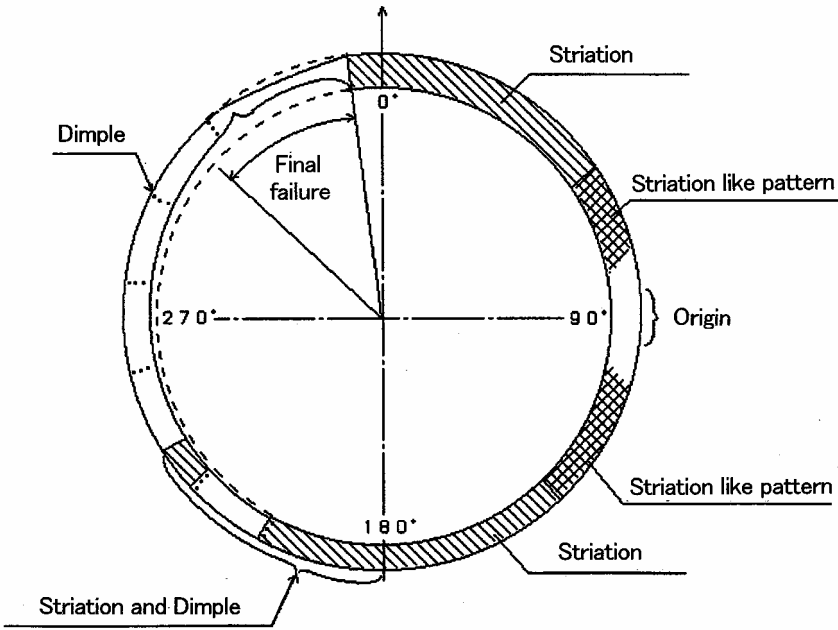
The failed tube was removed from the heat exchanger, and the fracture surface was examined by a scanning electron microscope. Striations, which are a characteristic of fatigue failure, were observed on large portions of the fracture surface, and dimples showing tensile fracture were also observed. However, few traces of stress corrosion cracking and corrosion were found on the fracture surface of the tube. The failure of the tube was, therefore, hypothesized to be due to cyclic loading. Figure 3 shows the morphology of the fracture surface of the SG tube. Figure 4 shows a typical example of the striations formed on the fracture surface of the SG tube. Examination of the other SG tubes near the failed tube showed traces of wearing formed by fretting due to contact between the tubes and the anti-vibration bars on the outer surfaces of the tubes. Stress amplitude of the failed tube estimated based on the striation spacing was found to be in the range of around 51 to 60 MPa.

Fig. 3 Morphology of fracture surface of the SG tube.

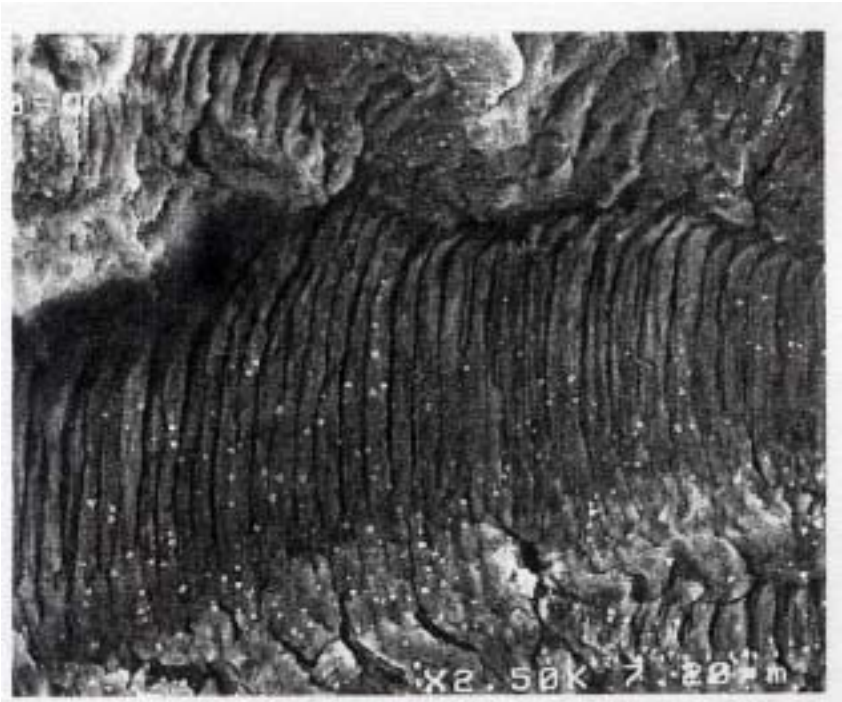
Fig. 4 Striation formed on the fracture surface of the SG tube.

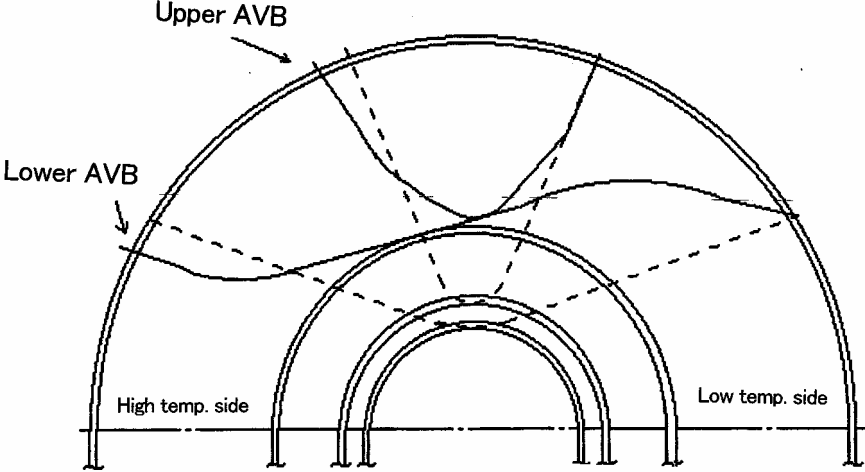
Occurrence of cyclic loading in the SG tube that had failed was related to the insertion depth of the anti-vibration bar, AVB. The SG tubes were subjected to vibrations due to the flow of secondary coolant outside of the SG tubes. In order to prevent the flow-induced vibration, V-shaped AVBs were installed onto the opposite U-bent SG tubes near the upper part of the steam generator. However, the insertion depth of the AVB for the SG tubes was not enough, because the engineers who installed the AVB did not fully understand the importance of the AVB. In fact, no damage was found in the SG tubes into which the AVB were inserted to sufficient depth as shown by the design guidelines. Figure 5 shows the insertion position of the AVB on the SG tubes by solid lines. Accordingly, the SG tubes were subjected to flow-induced vibration and strongly contacted with the sixth supporting plate, so that the SG tubes incurred damage by fretting fatigue. Inspection of the AVB had not been carried out since installation. Figure 6 shows a schematic illustration of the fatigue failure of the SG tube due to flow-induced vibration.

Solid lines show the location of AVB when accident occurred.  
Dotted lines show normal position of the AVB.

Fig. 5 Location of AVB on the SG tubes.

After the accident, a detailed examination of the AVB for the SG tubes in the steam generators of all reactors in the Kansai Electric Company was carried out. As a result, lack of sufficient insertion depth of the AVB was found in some heat exchangers. These AVBs were replaced with new ones and installed at the designated depth in the steam generators. Moreover, the steam generator of the No.2 pressurized water reactor was also replaced with a new one, because many of the SG tubes were removed from the generator for failure analysis.

- (1) Inspection of the installation of the AVB for the SG tubes and of the mounting position of the AVB before operation.
- (2) Execution of regular inspections of the AVB.
- (3) Inspection for distortion and damage of the supporting plate for the SG tubes.
- (4) Development of a new detecting system that can quickly and accurately detect signs of damages of the SG tubes in a steam generator.
- (5) Development of a new type of AVB with high performance and easy installation.
- (6) Employers should make sure that the engineers who are engaged in fabrication or maintenance of the devices and equipment in nuclear reactors understand the function of those devices and equipment.

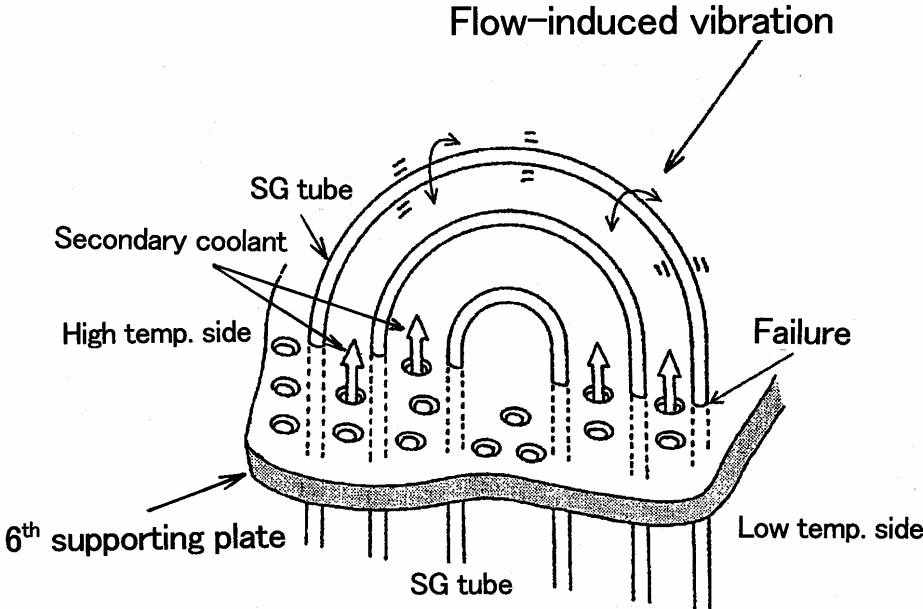
Fig. 6 Schematic illustration of fatigue failure of the SG tube due to flow-induced vibration.
