# Crash of Japan Airlines B-747 at Mt. Osutaka

Dec. 8th, 1985, near the ridge of Mt. Osutaka, Ueno, Gunma Prefecture

## (Summary)

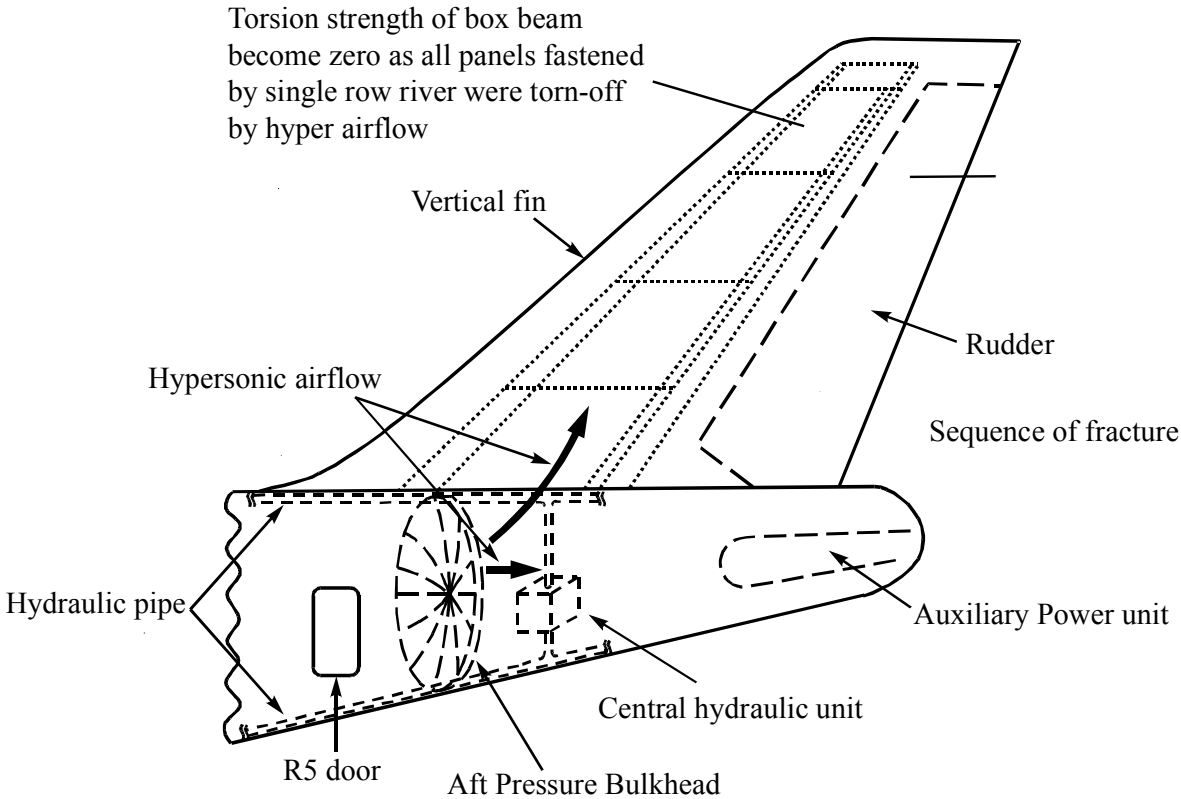
Fig. 1 Structure near the Empennage.

The direct cause of the accident was the fatigue failure of the aft bulkhead as shown in Fig. 1. The central hydraulic controlling system and APU located at the back of bulkhead as well as the box-beam structure of the vertical fin were blown off by the large mass of air moving a hypersonic velocity that was induced by this breakage.

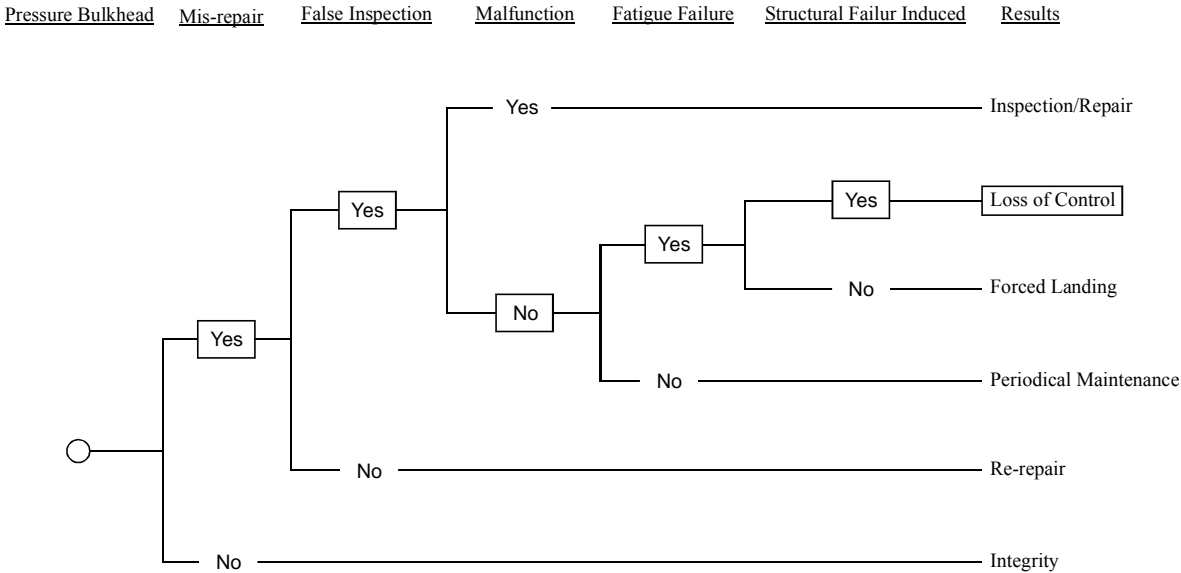
Fig. 2 Event Tree Analysis of JAL Accident Caused by Miss-repair of AFT Pressure.

The aircraft had received large-scale repairs at the maintenance field at Haneda in June 1978, after it experienced a tail hit landing at Osaka International Airport. Fatigue failure of the aft bulkhead was due to a mistake during the repairs at that time. Figures 1~3 show the details of the riveted joint that was incorrectly repaired by the engineering staff from Boeing. The repair was not conducted in accordance to the company procedure. The repair was made using two separate splice plates instead of single plate. As a result, the entire load was transmitted through the center rivet row only, and multiple site fatigue cracks initiated from the rivet holes of the center row soon after the repair. These cracks propagated by the cyclic pressurization of the aircraft and finally caused the unstable fracture of the whole structure after a total of 12,319 cycles. The repair mistake extended across two bays, which is about one-meter in length. As this was longer than the critical length necessary for the unstable failure of the structure, the crack propagated by the interlinking of adjacent small cracks without being arrested.

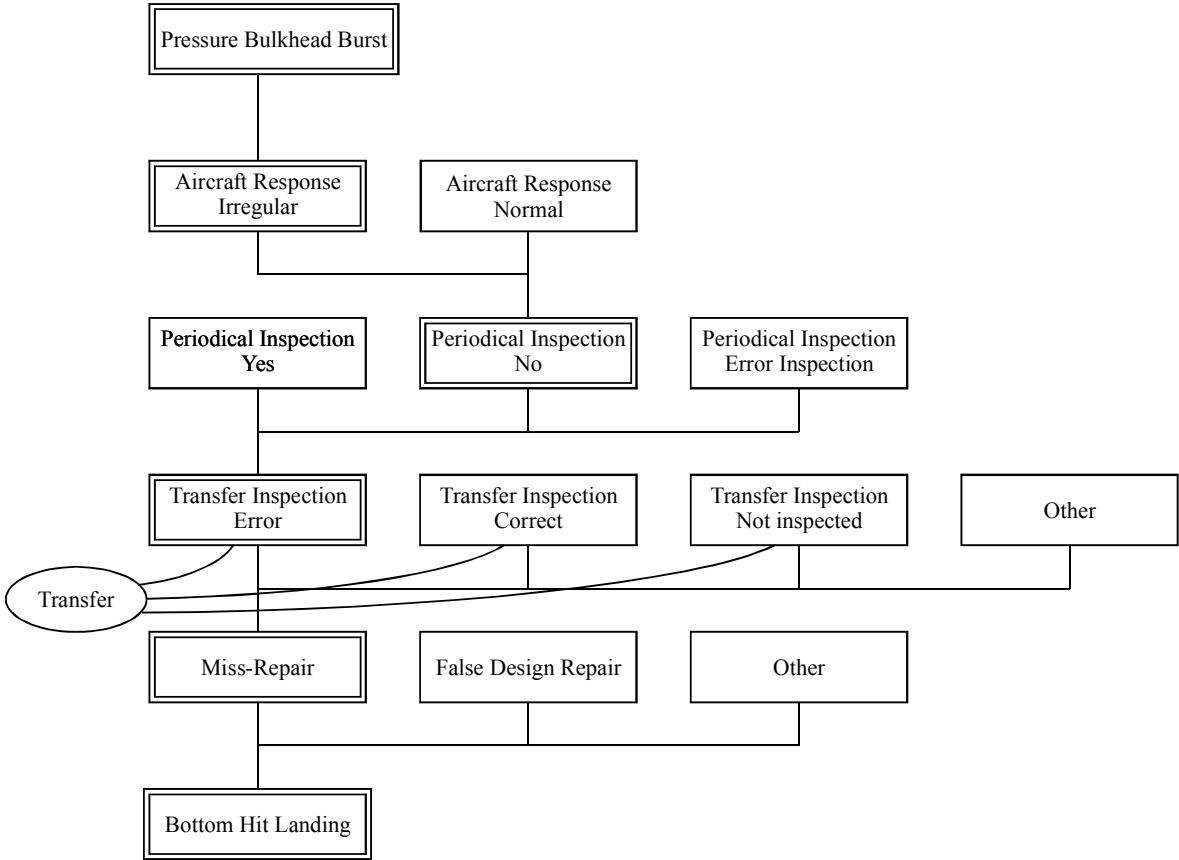
Fig. 3 Fault Tree Analysis of JAL Accident Caused by Miss-repair of Aft Pressure.

As is shown in Fig. 3, as a result of the mistake in the repair, the entire membrane stress induced by internal pressure was transmitted through just the center row fastener. Therefore, it can be judged that the fundamental mechanism of load transmission was not understood at all by the maintenance engineers.

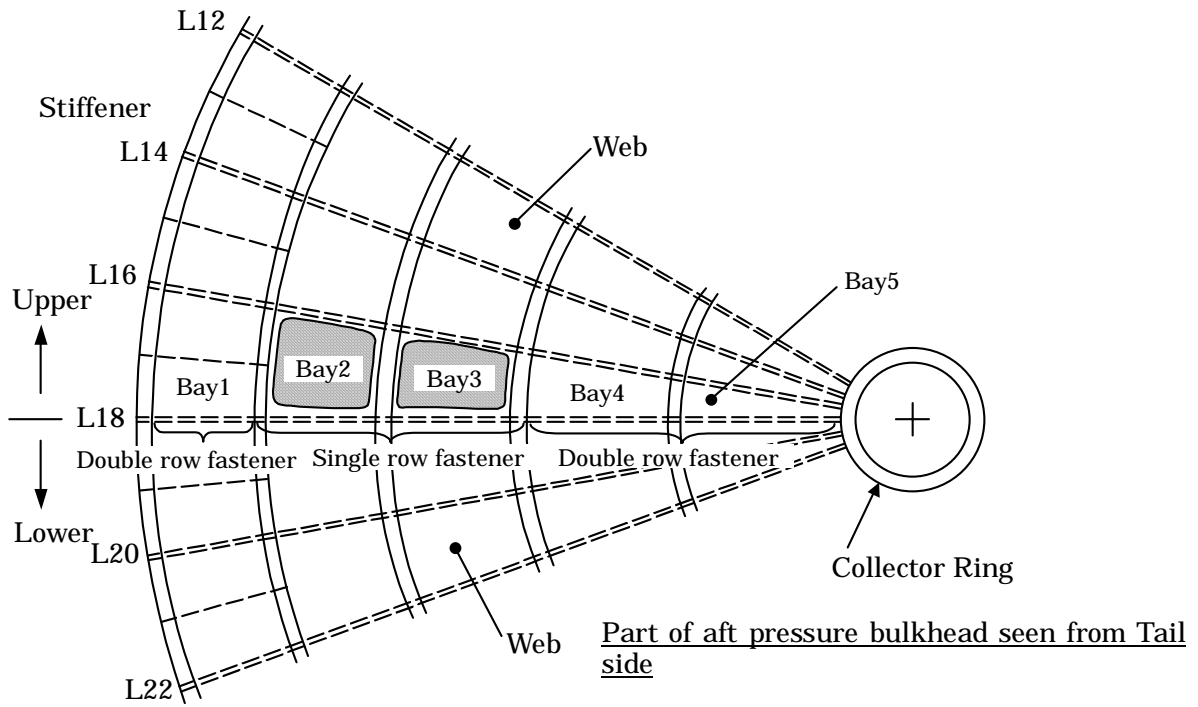
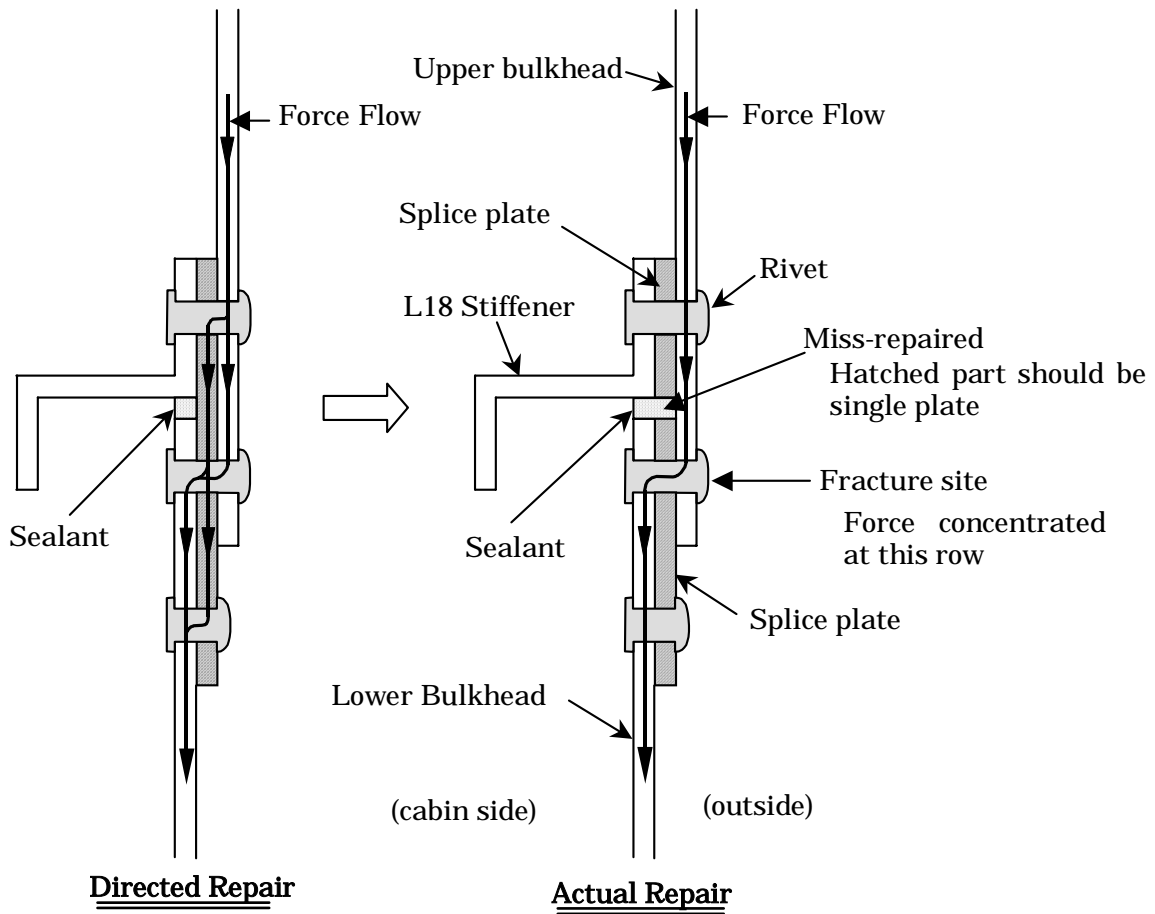
Fig. 4 The Aspect of Aft Bulkhead Repair.

One reason why multiple-site cracks occurred is that the old rivet holes were used again at the repair without resizing the holes. The JAL accident showed the potential danger of multiple-site cracks.
