Decompression of B-737 of Aloha Airlines by Separation of Upper Fuselage

April 28th, 1988, near Maui Island, Hawaii

KOBAYASHI, Hideo (Yokohama National University) TERADA, Hiroyuki (Japan Aerospace Technology Foundation)

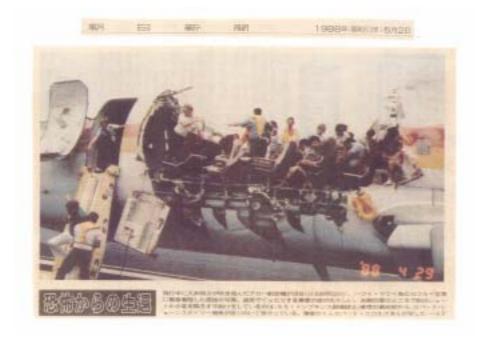
A part of the cabin structure measuring several meters in length was torn off. One cabin attendant was sucked out of the aircraft and was not found, but the aircraft succeeded in making an emergency landing at the airport in Maui, because fortunately one hydraulic controlling system had survived.

Fig. 1 B-737 Made an Emergency Landing with Large-scale Peeling of Fuselage.

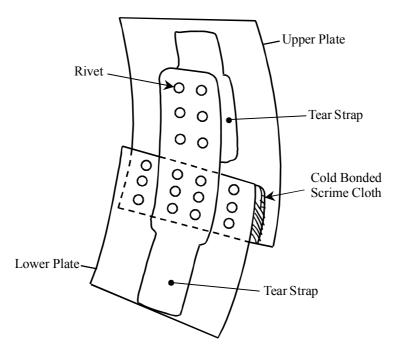
The a ircraft was fabrica ted in 1969 and had been in service for alm ost nineteen y ears. It had experienced 89,600 flight cycles before the accident. The single lap joint of the fuselage panel structures was manufactured by cold-bond process using scrim cloth and rivets. It was known that the cold-bonded joints have not enough durability in thermal and humid cycle condition. As a matter of course, fastener joints received heavy corrosion damage during 19-years operations. Under the thermal and humidity cycle conditions due to operation, the fuselage structure was subjected to Wide-spread Fatigue Damage (WFD),

Unstable propagation of m ultiple site cracks induced by corrosion fatigue took place at the fuse lage panel structure. Because the single lap joint had been manufactured using scrim cloth by the cold bonding process, the scrim cloth and adhesives absorbed water and became brittle over the years of operation.

Fig. 2 Bonded and Riveted Lap Joint of B-737 Fuselage.

- (1) In ord er t o prevent the wa ter a bsorption of the b onded joints, which is the main cause of joint degradation, the bonding process was changed from cold bonding to hot bonding.
- (2) The Fe deral Aviation A dministration (FAA) dir ected Aloha Airl ines t o observe the m aintenance manuals strictly in order to maintain the airworthiness of the aircraft.
