Mid-air Explosion of Comet I over the Mediterranean Sea

Jan. 10th, 1954, Over the Mediterranean Sea (near Rome)

KOBAYASHI, Hideo (Yokohama National University)

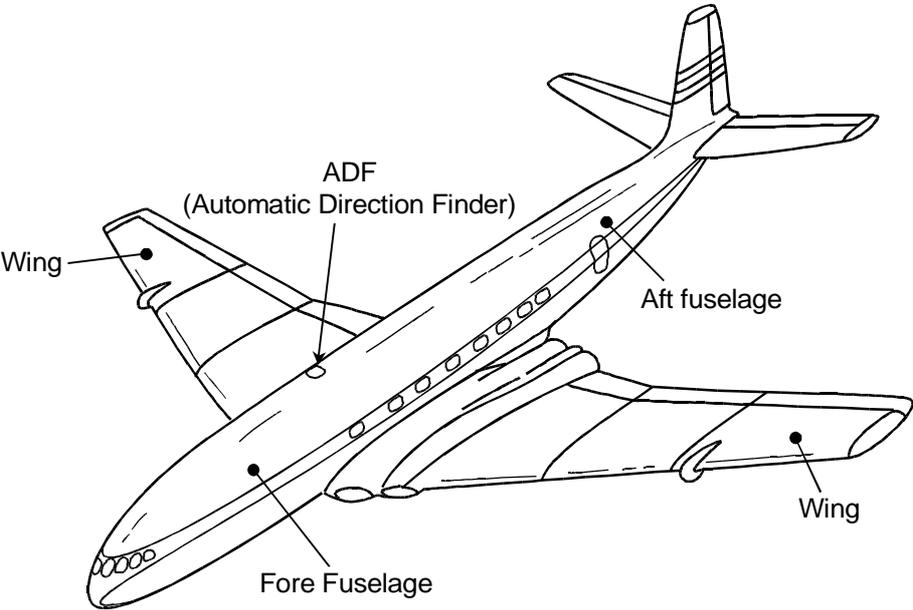
Figure 1 shows the Comet 1 air transport. Figure 2 shows the parts of the aircraft that were retrieved from the Mediterranean Sea by the salvage operation.

Fig. 1 Comet-1 (G-ALYP).

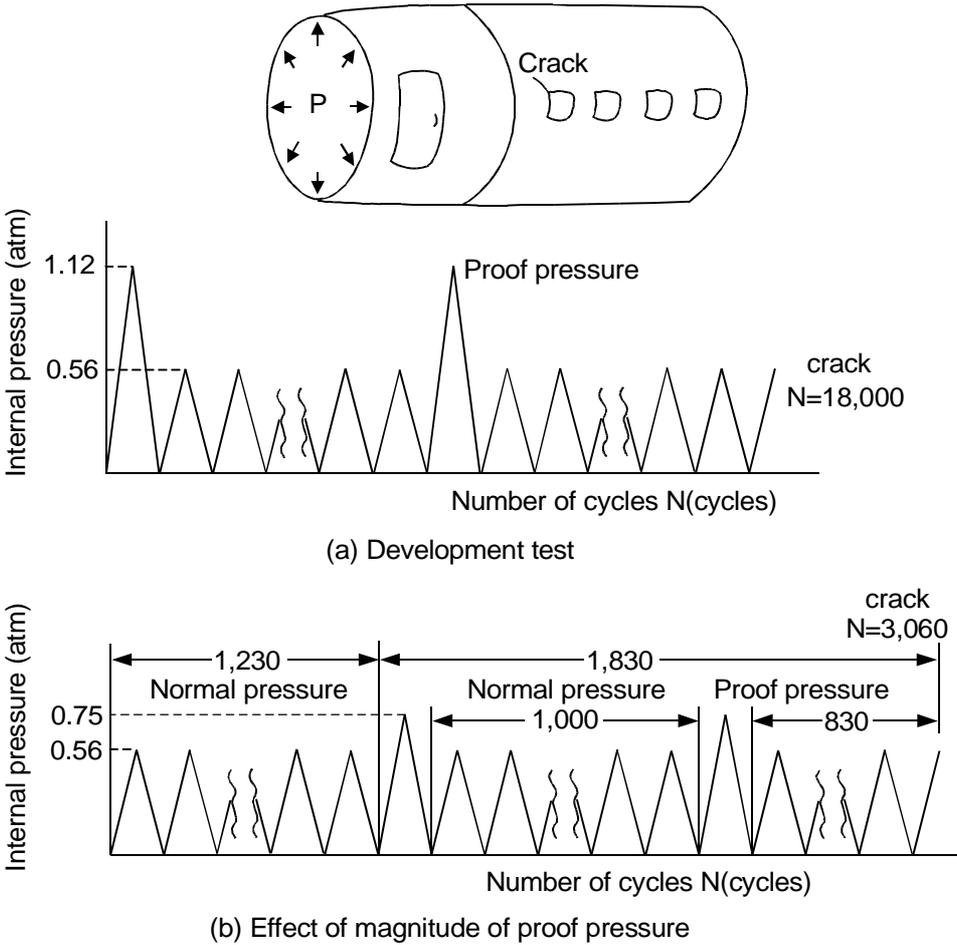
However, the accident occurred after far fewer flight cycles than this design life. The pressure pattern applied for the fatigue test using the actual fuselage structure is shown in Fig. 1. In the fatigue test, the pressure difference inside and outside of the cabin was assumed to be 0.56 atm. However, in the fatigue test conducted on the ground, a proof pressure load corresponding to 1.12 atm, that is twice that of actual pressure difference, was applied every 1,000 pressure cycles for safety purposes. As a result of this test, the fatigue crack initiation life was determined to be 18,000 pressure cycles.

Fig. 3 Pressurizing Pattern of Comet

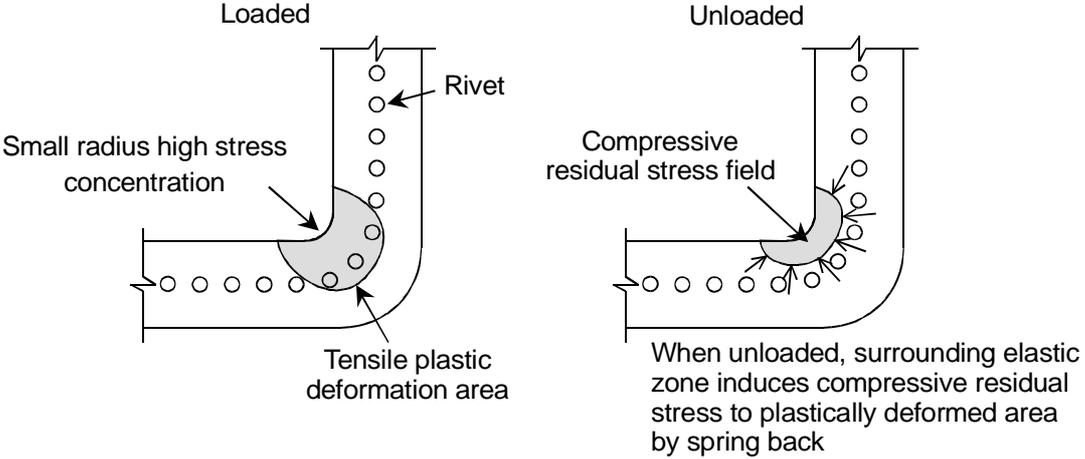
- (1) Following the regulations of the British Aviation Bureau, a periodical proof pressure test with a pressure load twice that of normal cabin pressure was conducted during the internal pressure fatigue test. Crack initiation was observed after 18,000 pressurizing cycles in that test. However, tensile plastic deformation was induced at the corners of the windows by the proof pressure load. The plastically deformed zone formed a compressive residual stress field when the proof-pressure was removed, which resulted in longer fatigue life, because a compressive residual stress field has the same effect as reduced mean stress conditions (See Fig. 2).

Fig. 4 Deformation at Window Corner by Loading and Unloading of Overload.

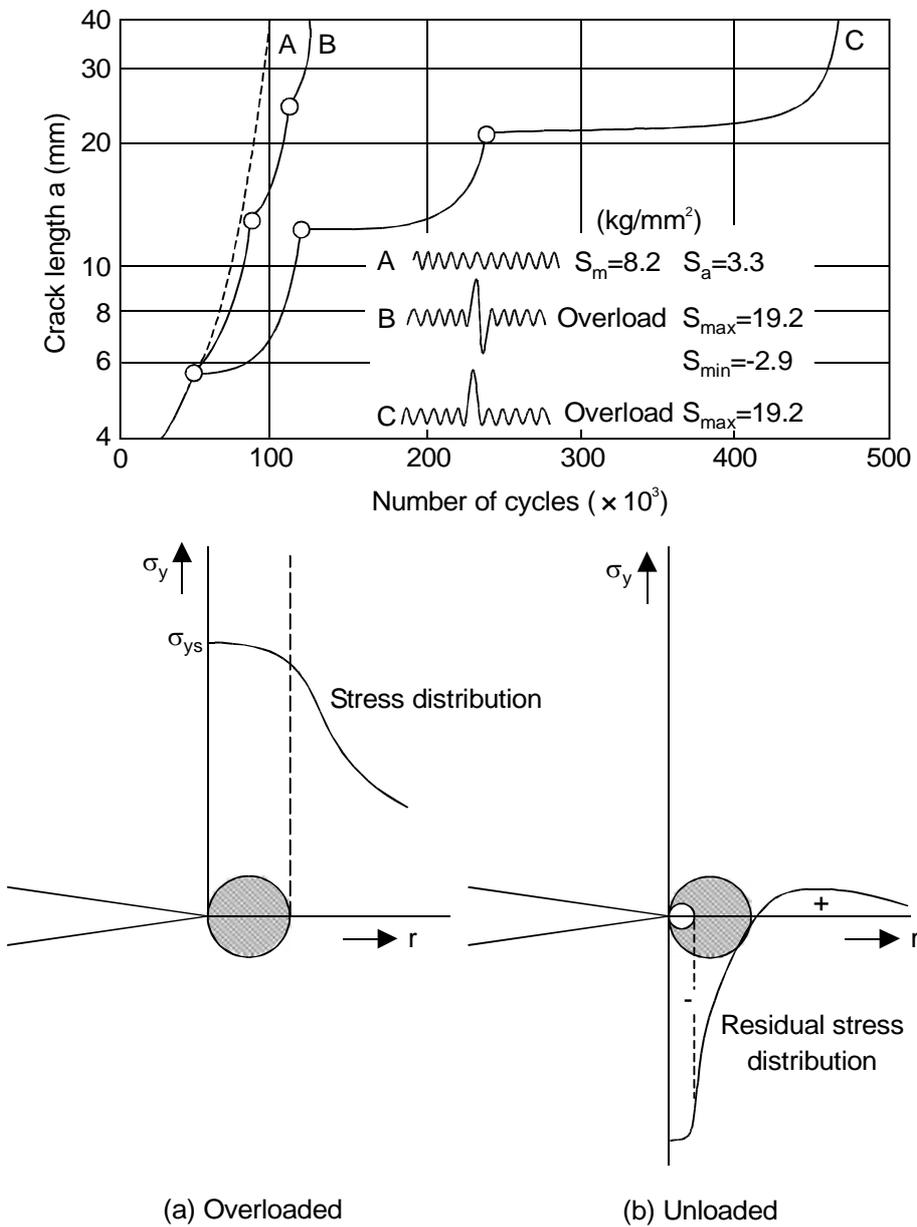
Figure 6 shows the relationship between the crack length (a) and number of fatigue cycles (N) for a constant amplitude fatigue test with periodical overload cycles as given in the Figure. The fatigue life for case C is four times longer than that for case A as a result of the residual compressive stress induced by the tensile overload. The mechanism for this effect is explained by (a) and (b) in the same Figure. It can also be explained by the concept of crack closure and plastic wake model.

Fig. 5 Relation Between Crack Length and Fatigue Cycles Under Periodical Overloads.
