Crash of B-747 of El Al Israel Airlines by Fatigue Failure of Engine Fuse Pin

Oct. 4th, 1992, near Schiphol Airport, Amsterdam, The Netherlands

KOBAYASHI, Hideo (Yokohama National University) and
TERADA, Hiroyuki (Japan Aerospace Technology Foundation)

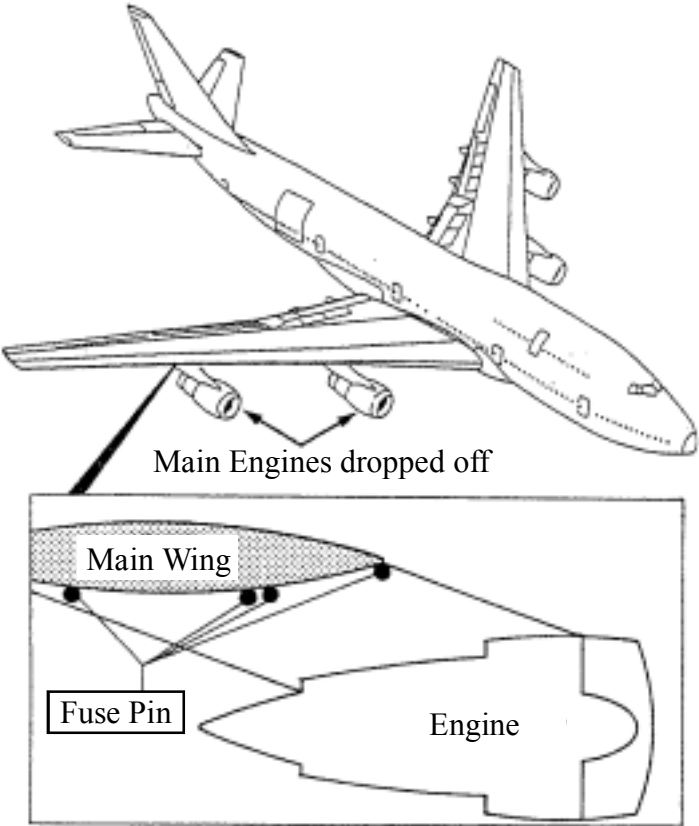
Fig. 1 Schematic Structure of Pylon.

Pylon fuse pin (Pylon is the structural component connecting the jet engine to the main wing. The role of the fuse pin is to allow the engine to separate from the wing under the strong impact load that occurs in the event of a crash or hard landing in order to protect the fuselage from engine fire.)

(1) A fuse pin of the No.3 engine fractured as a result of corrosion fatigue. (The engine is sustained by

four fuse pins.) As a result, the engine became unstable and began to vibrate. The vibration caused fuel to leak. The leaking fuel caught fire, and then the other fuse pins were torn off by overload and heating, and the engines finally dropped off.

The fuse pin is manufactured with a notch deliberately included so that it will break under the impact load in the event of emergency. However, a cylindrical pin with a notch is likely to be subjected to excessive corrosion and fatigue damage. Therefore, the fuse pin was replaced by a new type without a notch.

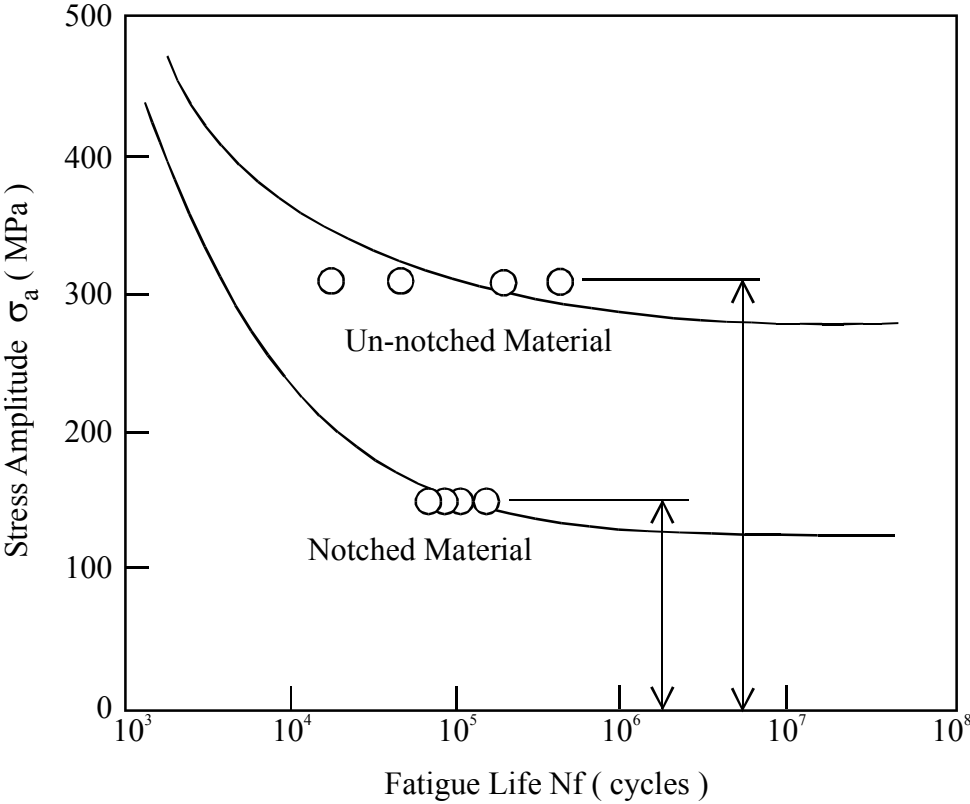
Fig. 2 Relation Between Stress Amplitude and Fatigue Life of Fuse Pin.

The fuse pin of the pylon should be designed as a fail-safe component. The relation between the stress amplitude on the fuse pin and the fatigue life is shown in Fig. 2. The fatigue lifetimes of fuse pins without notches vary considerably so that each of the four fuse pins holding the engine to the wing will generally have different lifetimes. Therefore, if the engine is attached to the wing by four fuse pins without notches, normally it will not drop off even if one of these fuse pins reaches the end of its fatigue lifetime and becomes broken, and the integrity of the structural system would be maintained. In the case of the notched fuse pin, the variation of the fatigue lifetime is much smaller. The notch provides a location for crack initiation and accelerates the crack growth. Consequently, the failure of one notched fuse pin triggers the

failure of the rest in a short period. This almost instantaneous fracture of all four fuse pins is what occurred in the accidents of China Airlines and El-Al Israel Airlines.

The role of the fuse pin is to allow the engine to break off under the impact load in the event of a crash landing or other hard landing in order to protect the fuselage from engine fire, because a dragged engine can often become the source of an intensive external fire that leads to the loss of many lives. In order for the fuse pins to function properly, they should always be kept free from corrosion damage and fatigue load in order to avoid unexpected failure during normal operation.
