Fire during Ethylidenenorbornene Manufacturing
【October 18th, 1973 Kawasaki, Kanagawa, Japan】

Mitsuo Kobayashi (Graduate School of New Frontier Sciences, University of Tokyo)
Masamitsu Tamura (Graduate School of New Frontier Sciences, University of Tokyo)

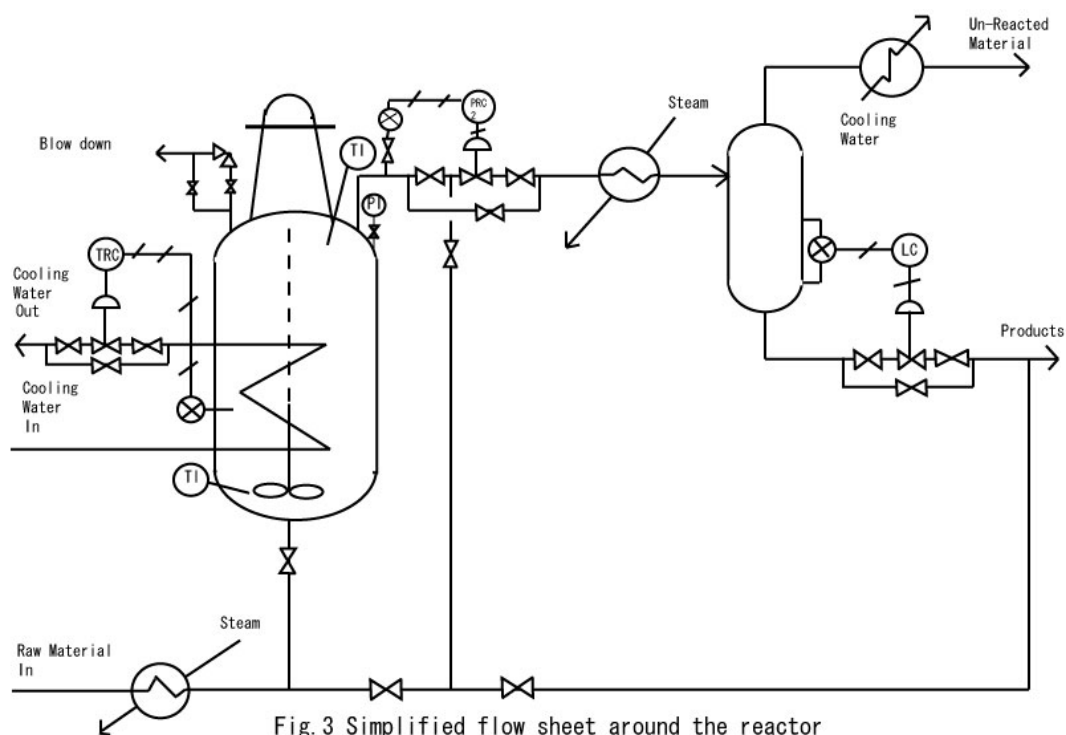
Fig. 3 Simplified flow sheet around the reactor

On the day of the accident, the DA reactor for the VNB synthesis was stopped due to problems of the CPD separation section. The outline of the process is shown in Fig. 2. Agitation was stopped soon after the supply of raw materials was stopped. The pressure control valve at the reactor outlet was closed manually. The reactor pressure rose after temporarily falling as a result of the supply stop, and then the pressure was released by opening the bypass valve of the control valve. The same operation was repeated. Soon after the operation, the reactor pressure rose suddenly, and the safety valve mounted in the upper part of the reactor operated. A fire was soon occurred in the upper part of the reactor. First a flame spouted out suddenly from the safety valve inlet flange. In addition, a slightly larger flame rose with a small sound in the upper part of the reactor. After few seconds, a large flame suddenly wrapped the reactor. At that moment a slightly larger sound was heard, but it was not recognized as an explosion, because there was no damage to the slate roof or window glass of the nearby building.

The cause of the fire was concluded to be an increase of the temperature and pressure in the reactor as the result of a runaway reaction. High-temperature gas and liquid spouted out through the flange, which used a thermally weak Teflon gasket was used.
