Explosion of Acetylene Hydrogenation Section in Ethylene Plant

【July 7th, 1973 Tokuyama, Yamaguchi, Japan】

Hiroshi Koseki (National Research Institute of Fire and Disaster)

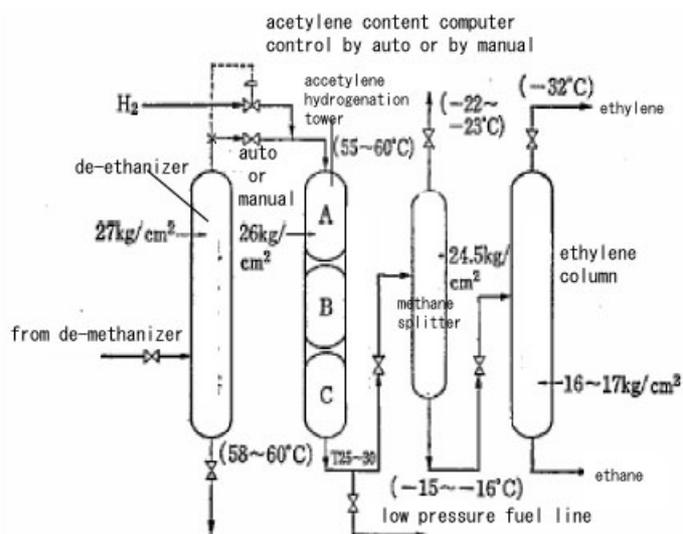
Fig.2 simplified flow sheet around the hydrogenation section

consists of mainly ethylene and a slight amount of acetylene. If the hydrogenation conditions are not ideal, ethylene is hydrogenated and may generate a large amount of heat. In the worst case, it might cause an exothermic decomposition reaction of ethylene. Therefore, this hydrogenation process is the most problematic section of the ethylene manufacturing process, as well as the high-temperature cracking furnace in the ethylene plant. The important points in the control of hydrogenation are to supply only a necessary amount of hydrogen for acetylene hydrogenation and to raise the selectivity of acetylene hydrogenation. The temperature range permitted to maintain the best selectivity is very narrow, so careful attention is required for temperature control, and so on.

At 21:00, although the normal operating temperature was 60 °C at the middle section of the hydrogenation reactor B, it had risen to 90 °C, but the control operator seemed not to be aware of it. At 21:30, the thermometer at the hydrogenation reactor B middle section showed a temperature of 120 °C. The control operator, who discovered the abnormally high temperature, introduced ethylene gas from another plant into the hydrogenation reactor for cooling. Simultaneously, the required amount of hydrogen for the hydrogenation process was supplied by the automatic control. At 21:38, the control operator noticed the rapid temperature rise, and he stopped the supply of the hydrogen manually.

When the supply of ethylene started, the temperature indicated by the thermometer started to increase rapidly. The temperature recorder was scaled out over a maximum temperature of 200 °C. At the operator's console, a temperature of 970 °C was observed at the middle section thermometer at 21:45. The middle section thermometer lowered to 750 °C at 22:00, but the thermometer of the lower section showed a temperature of 896 °C.

After 22:00, the temperature at the lower section of hydrogenation reactor B exceeded 1000 °C, the outlet piping became red-hot, and the gas leaked from the valve flange and ignited. At around 22:15, the hydrogenation reactor B outlet pipe was destroyed by the high temperature, the gas that leaked from the pipe exploded, and a large-scale fire occurred.

Although, only a slight amount of acetylene was to be hydrogenated selectively in the reactor, excess hydrogen was supplied when the crude ethylene supply was stopped. So nearly the entire ethylene in the reactor was hydrogenated. Furthermore, although some metal based catalysts are used for this hydrogenation, it is known that a hydrogenation catalyst of palladium, which was used, causes an exothermic decomposition reaction of ethylene at temperatures over 400 °C.

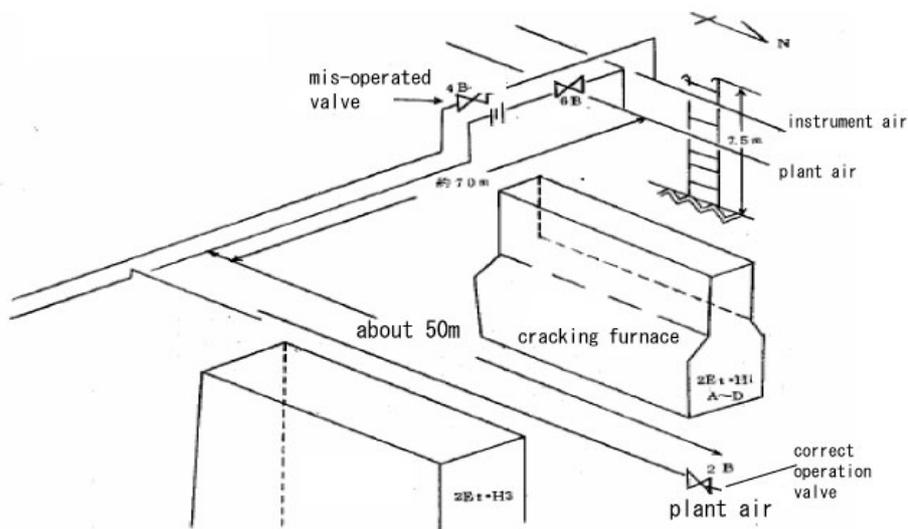
Fig. 3 location of the air piping valve

At around 18:50, instruments of the control room all failed simultaneously. The control operators who came in for the emergency shutdown work could not find the cause. Few minutes before the incident, a field operator opened the six inch valve of the work air piping (Y A) and closed the four inch IA valve near the six inch valve by mistake, instead of closing the two inch YA valve for de-coking the cracking furnace. Therefore, the control instruments took the failure position, the plant entered an emergency shutdown, and black smoke rose from the flare stack. The operator was surprised at the black smoke, and returned the IA valve to the open position.

The accident was triggered when the IA was stopped by closing the IA valve by mistake instead of the YA valve. Therefore, it is also possible to consider the accident to be caused by typical human error. However, what must be considered here is why the human error was caused, and whether or not the human error could have been

prevented. The piping and valves concerning the accident are shown in Fig.4. Although the reason for mistaking the valve, which was mounted at interval of 1 00 m cannot be known for certain, some problems can be pointed out regarding the design of the facilities and the condition of the management.

To begin with, all of the valves were mounted on racks, under the floor or in the ceiling. As the de-coking of the cracking furnace is executed several times per year, the YA valve is an often used. Therefore the valve should have been placed where operation and confirmation could be performed easily.

Next, "why the IA valve was closed" is a problem in the operation control aspect. Closing the IA valve is absolutely forbidden when the plant is on stream. For a valve that is absolutely forbidden to be turned on and off during normal operation, the person responsible for the operation must take measures to prohibit the turning of the valve. At least, color coding or hanging cards on the valve must be conducted to capture the attention of the workers. Ideally, the valve should be sealed in the presence of a manager or supervisor after the valve was set in the correct position. Valves that are absolutely forbidden to be turned are the valves that may cause damage to the safety or control of the plant if turned from the specified position, including the IA valve and the block valve of the pressure safety valve. When the author joined a certain petrochemical company in 1966, the mark "CSO(C)" was put near some of the valves in the Piping and Instrument Diagram (P&ID), which is one of the basic design drawings for a chemical plant. The author was taught that this mark means "Car Seal Open (Closed)", indicating that the marked valves had to be sealed because they are forbidden to be turned.

In the subject of the facilities, many kinds of alarms at the reactors were improved and the vessels that contained large amounts of liquefied gas were remodeled so that de-pressure or discharge could be carried out rapidly. Labeling and other measures to distinguish the piping and valves were done more thoroughly in order to prevent mistakes in operation. Finally, the water sprinkling system and other systems for fire prevention were improved.
