**Explosion of Resin Factory in Osaka**  
**【August 20th, 1982 Sakai, Osaka, Japan】**

Haruhiko Itagaki. (National Institute of Industrial Safety)

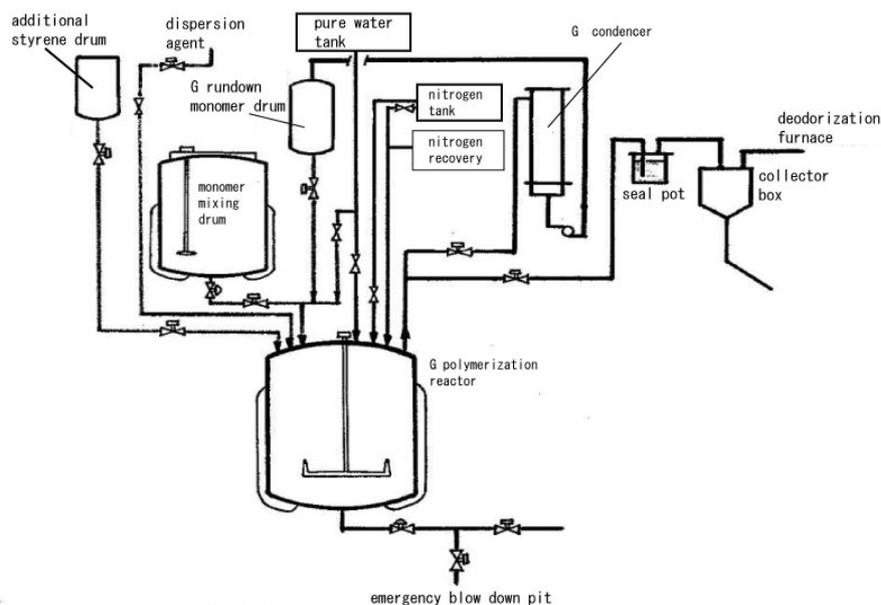
Fig.1 Flow sheet of G polymerization reaction system

The 400V power supply of the polymerization section failed at around midnight. The agitators and pumps for cooling water of the C and G polymerization reactors stopped, so cooling of the reactors stopped. In order to continue cooling, lukewarm supply water was switched to cold water manually. One ton of cold water was added to each reactor to cool them. Some time after, the polymerization reaction in the two reactors became a runaway reaction, and white smoky gas spouted from the manhole of the C reactor. The alarm of the deodorizing furnace rang, and the safety valve of the furnace automatically operated, redirecting the gas directly to the stack for combustion tail gas bypassing the furnace. At that time, the concentration of the combustible gas at the furnace inlet was 35% of the lower explosion limit, and the temperature in the furnace exceeded 830 °C. The first explosion occurred in the exhaust gas duct, and damage occurred only in the furnace system.

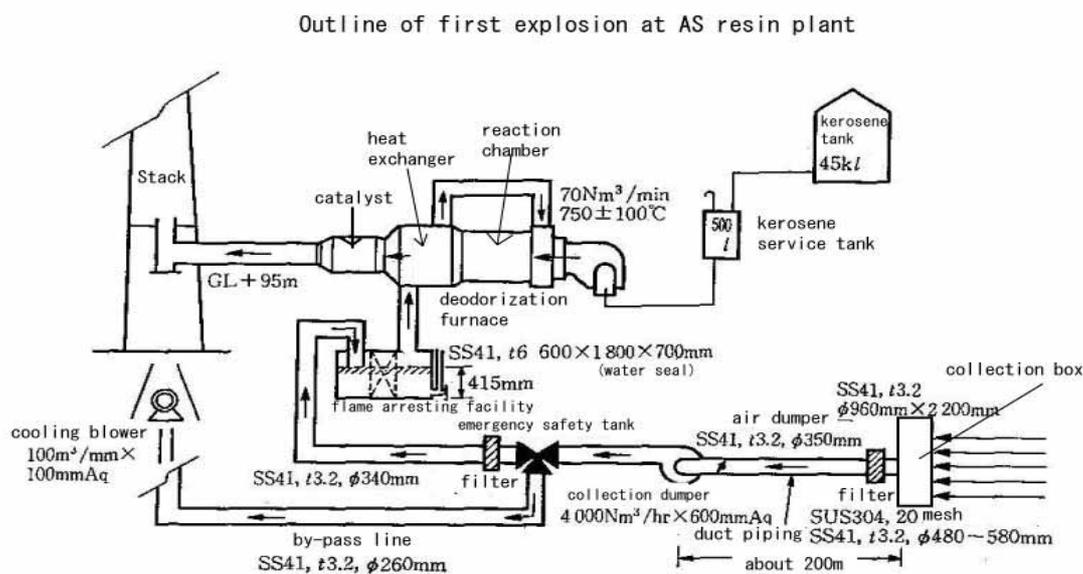
Fig.2 Flow sheet of the deodorization furnace

The reason why a large amount of gas flowed into the furnace system is explained below. The liquid in the C and G reactors separated into two layers, a polymer layer and a monomer layer, because agitation in the reactors stopped. Furthermore, since the heat of reaction was not being removed, a rapid polymerization reaction occurred, and the liquid temperature reached the boiling point as a result of heat generated by the exothermic reaction. The remained monomer evaporated, and a combustible gas was formed. The combustible gas flowed from the pressure regulating valve via the vent gas collector to the furnace system. The furnace system diagram is shown in Fig.2.

The furnace had the following instrumentation system installed for safety: when the combustible gas composition exceeds 50% of the lower explosion limit, or the furnace temperature is over 830 °C, the gas is redirected through bypass piping and led to the stack which discharges the gas after it is burned. In this accident case, the instrumentation system worked as designed.

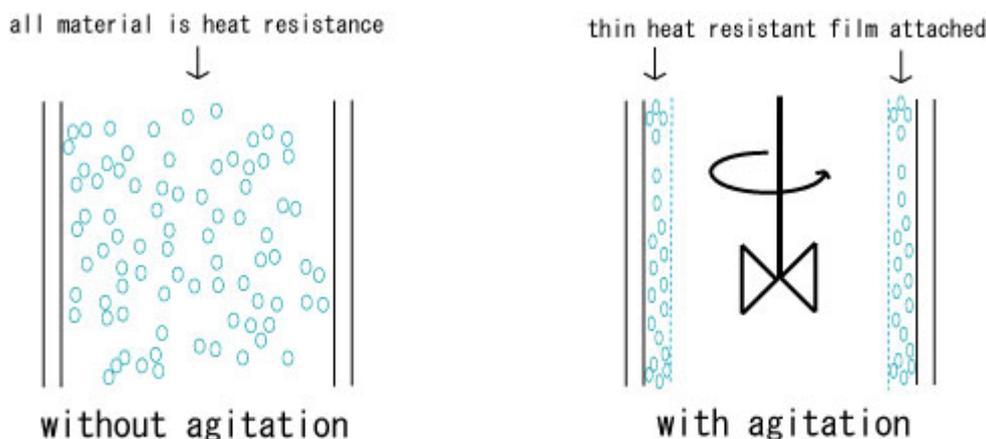
Fig. 3 Effect of an agitation -1 heat transfer

To begin with, the effect of the agitation stop is discussed. The problem can be considered from two aspects. The first is heat transfer. When agitation stops in a big vessel with a diameter of 2 meters, it is not possible to cool the liquid in the vessel. Agitation makes a laminar film on the heat transfer surface thinner, decreasing heat transfer resistance, equalizing the temperature of the content liquid, and thus cooling is carried out. Considering the size of the agitation drum, which is on an industrial scale, it is apparent that effective heat transfer is not possible, if the agitation stops. Furthermore, the polymer in the reactor is prevented from separating from the monomer by agitation, causing the reaction to advance at a moderate rate. The polymer, which is solid and has a high density, separates from the low density monomer, if the agitation stops. The monomer layer with no polymer has high reaction potential. As agitation stopped, heat could not be removed from the monomer layer, and a hot spot was easily formed. The polymerization in the monomer layer advanced, and a runaway reaction occurred. As a result of the temperature rise, it seems to have been unavoidable that the monomer evaporated, its pressure rose, and the vent gas of the monomer increased.

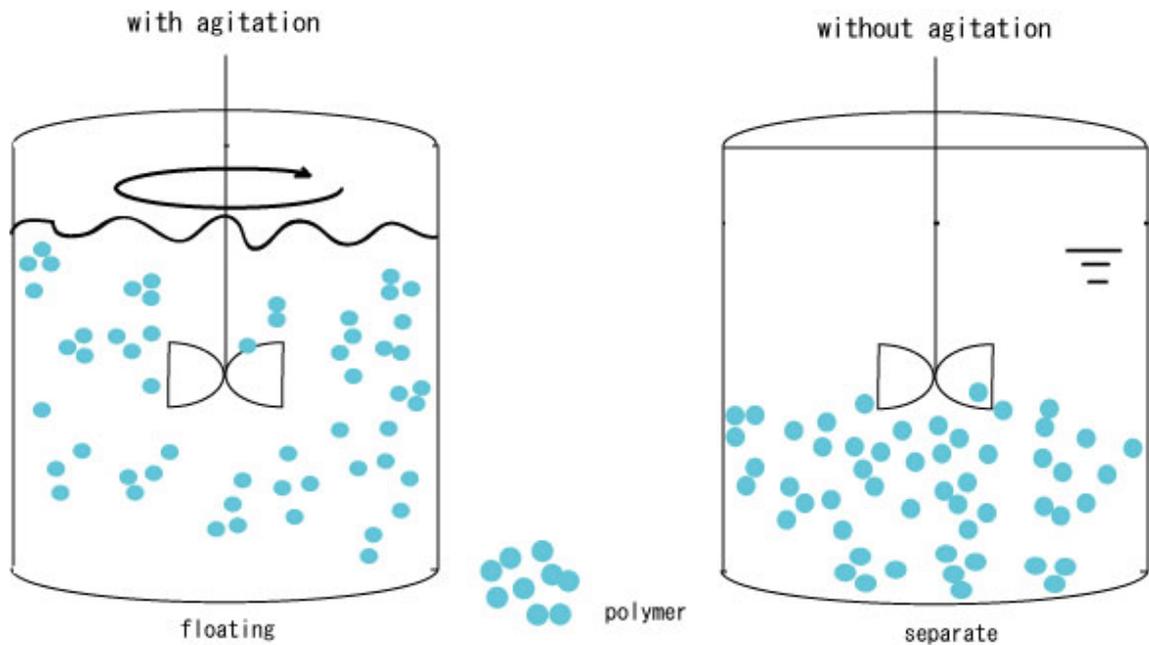
Fig. 4 Effect of an agitation -2 mixing

The next aspect is the small capacity of the furnace. As only two out of five resin reactors were in operation at the time of the power failure, a bypass was inevitable. The combustible gas-air mixture that was redirected to the stack did not burn for that reason, and the explosion occurred as a result. The exact reason why the combustible gas-air mixture was formed is unknown, but there seemed to be some problems in the deodorization system of the vent gas. It can be supposed that there were some problems in the vent gas system that might cause an explosion under the conditions resulting from a power failure.

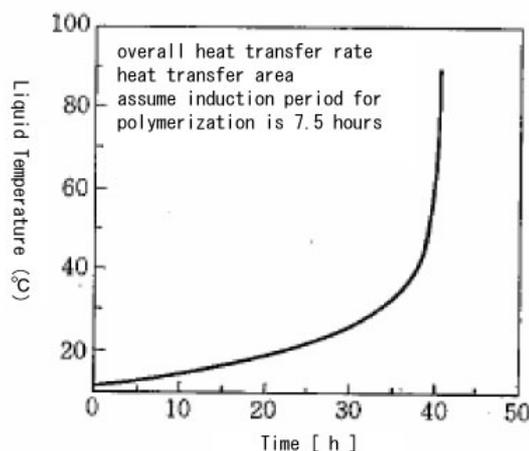
Fig.6 experiment result of the liquid temperature increasing in the monomer mixing drum

After careful experiments, it was confirmed that the monomers in the mixing drum had begun to react at a relatively low temperature and thus the gas leakage occurred. Since the size and force of the explosion could be explained if leakage from the monomer mixing drum was assumed, it was concluded that the gas leakage was caused by a rise in pressure due to a polymerization reaction that had occurred during the long hours of storage in the drum.

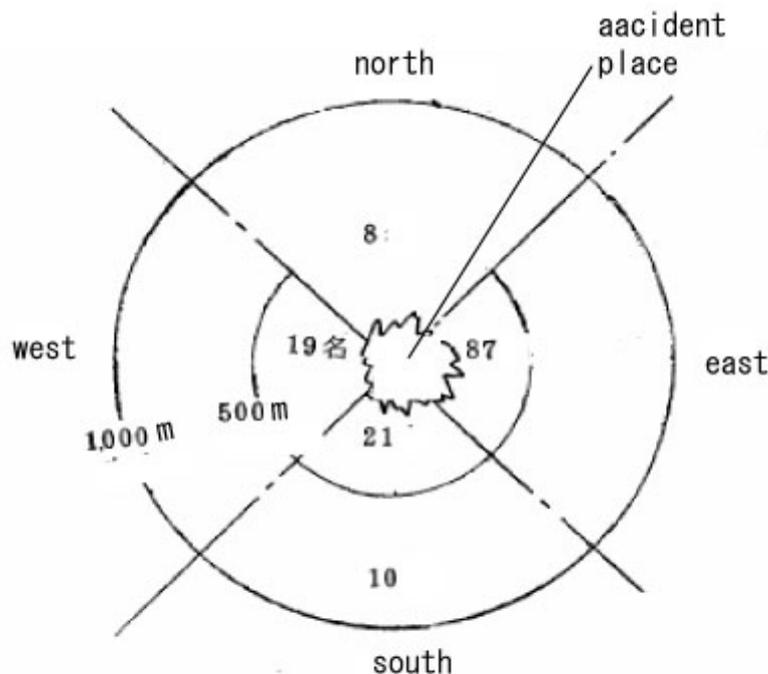
Fig. 7 distribution of human damage

All of the human damage caused by the second explosion was the deaths of six persons and the injured of 207 persons. Among the injured the number of inhabitants of the neighboring area was 178.

The physical damage was as follows; 1733 buildings of 2812 households in the area within the average radius of 1400m were damaged. As the factory in the densely populated area, considerable damage was caused to the neighboring area.
