Fire and Explosion at Bituminization Facility in Power Reactor and Nuclear Fuel Development Corp.

【March 11th, 1997 Tokai, Ibaraki, Japan 】

Haruhiko Itagaki (National Institute of Industrial Safety)

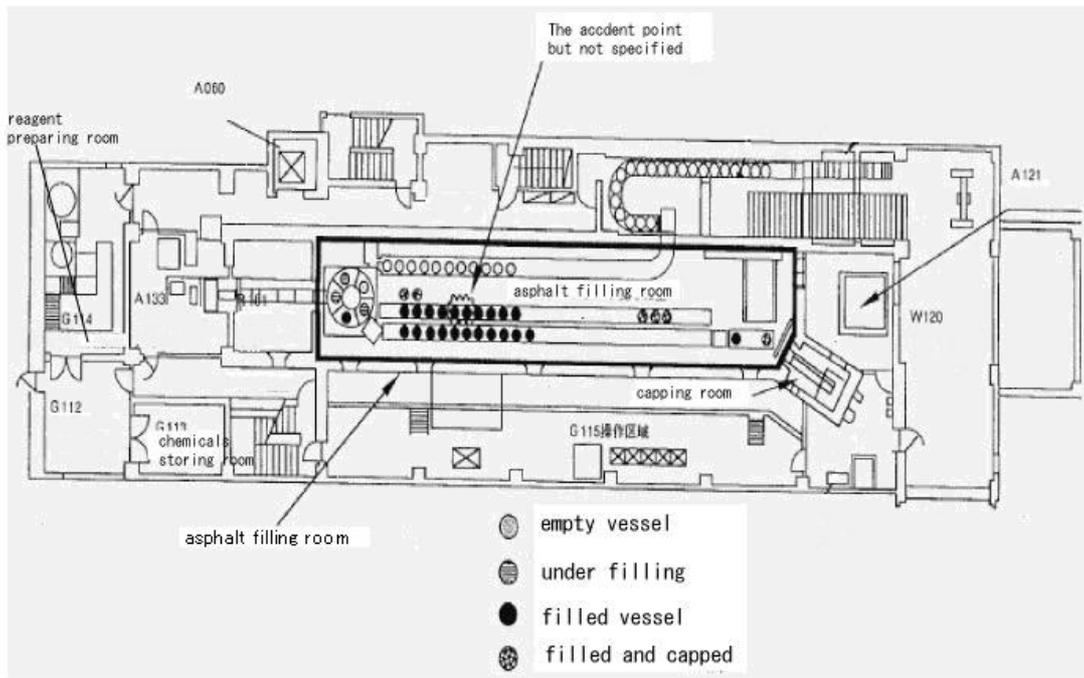
Fig.1 sketch of the fired place

The extruder room and the drum can filling room, which comprises the central part of the facilities, are shown in Fig.1 as the place where the fire occurred, and the outline of the treatment process is shown in Fig.2.

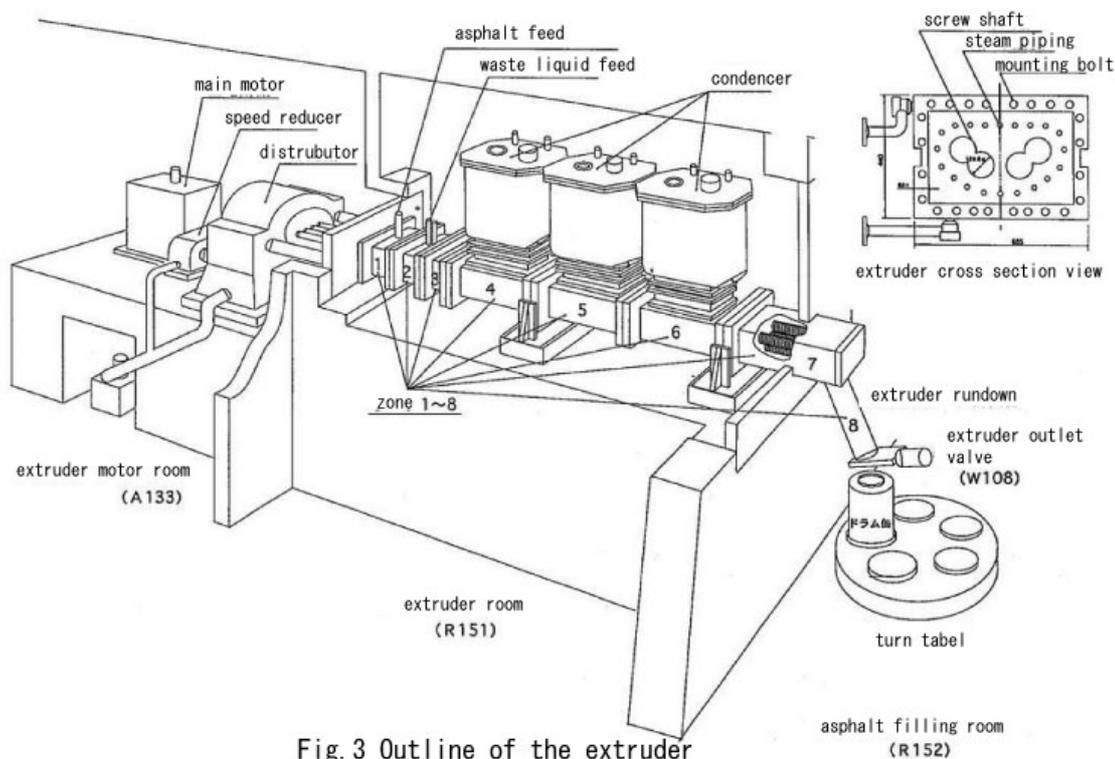
Fig. 3 Outline of the extruder

In the extruder, raw materials asphalt and the waste liquid were fed and extruded in the downstream direction by the rotation of the screw shaft, and at the same time the materials were heated by shearing stress, causing the moisture in the feed to evaporate. The condensers, which were mounted at the top of the extruder, condensed and removed the steam. In the latter part of the extruder, the mixing of the asphalt with nitrate and other materials in the waste liquid was carried out, the asphalt and nitrate/nitrite mixture was discharged in a molten state from the outlet at the final stage, and the mixture was filled into the drum cans on the turntable. After natural
