## Hydrogen Gas Explosion in Non-industrial Refuse Incineration Facility

【July 6th, 1995 Isehara, Kanagawa, Japan】

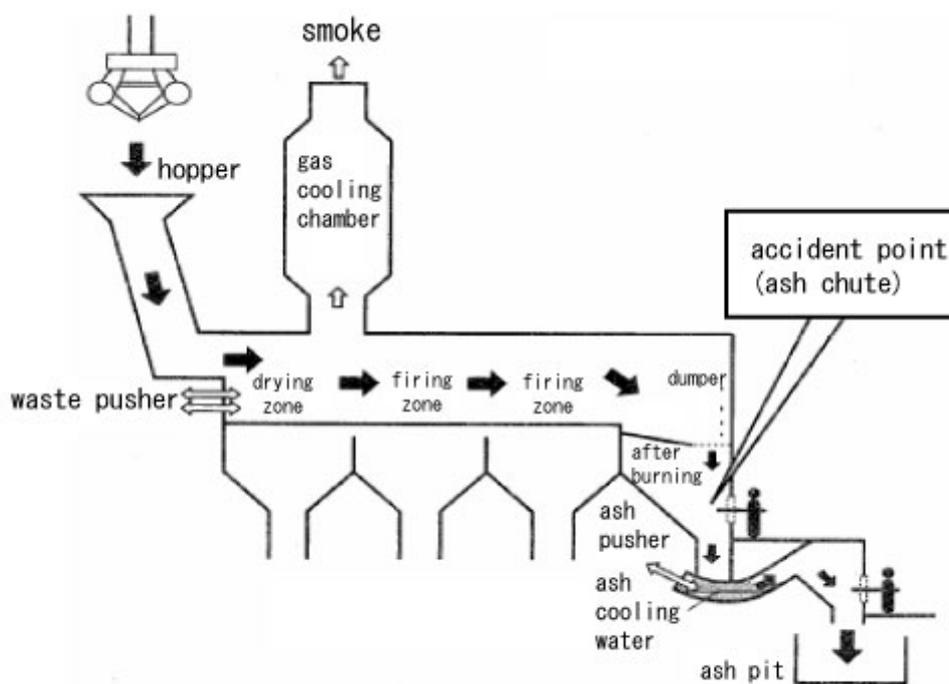
Fig.1 outline of the incinerator

At around 01:00, the ash chute damper of the No.1 incinerator, which was a continuous stoker type, showed an abnormality (Refer to Fig.1). The moisture in the refuse that is put into the hopper of the incinerator is removed in the drying zone. Then, the refuse is moved to the combustion zone. Hot air is supplied from below in the drying zone and the combustion zone. The monitor inside of the incinerator showed the accumulation of ash in the post-combustion part of the incinerator. So, the ash pusher in the post-combustion lower section was operated manually, but the ash pusher did not work well and the workers gave up combustion and stopped the combustion furnace. They stopped charge of refuse to the combustion furnace and started the operation called “fire burial”, which finished at around 04:00.

After the day shift workers took over the operation, they started the inspection work. The operators saw that the ash was filled in the post-combustion zone when they opened the inspection door. They tried to remove the ash from the inspection door using a shovel, but they could only remove the ash slightly because there was a solid layer, which seemed to contain a clinker. A clinker is something like a volcanic rock, which is formed by the solidification of some molten material such as high temperature

aluminum with adhesion of the incinerated ash. The explosion occurred inside the ash chute, when the operators were trying to crush the clinker with a long prodding chisel with injecting water intermittently. Besides, water injection was not carried out when this explosion occurred. Owing to exposure to high-temperature gas and ash which spouted out from the inspection door, the three workers received serious burns.

The explosion was estimated to have occurred as follows: a combustible gas mainly containing hydrogen was formed in the ash chute and in the ash pusher, the gas mixed with the air from the inspection door to form a combustible gas-air mixture, and the mixture was ignited by hot clinker or some other ignition sources.

The hydrogen was supposed to have been generated by a chemical reaction between the water injected into the ash chute and the hot aluminum contained in the clinker and in the ash, and this hypothesis was confirmed by experiments. Although aluminum is not allowed to be put in the incinerator, a large amount of aluminum was contained in the non-industrial waste since the non-industrial waste was not correctly separated.

From the operation perspective, incineration treatment of crushed material with a high aluminum content was stopped, nitrogen was introduced for purging a combustible gas generated when blockage was removed, sufficient cooling time and safety confirmation steps were executed prior to the removing work, water injection was stopped, etc..

At the facilities, an industrial camera and the thermometer for early detection of blockage were prepared, and the capacity of the ash pusher was increased. Furthermore, for management aspects, a work standard was prepared.
