Explosion and Fire of Dibenzoyl Peroxide Factory

【May 26th, 1990 Itabashi, Tokyo, Japan】

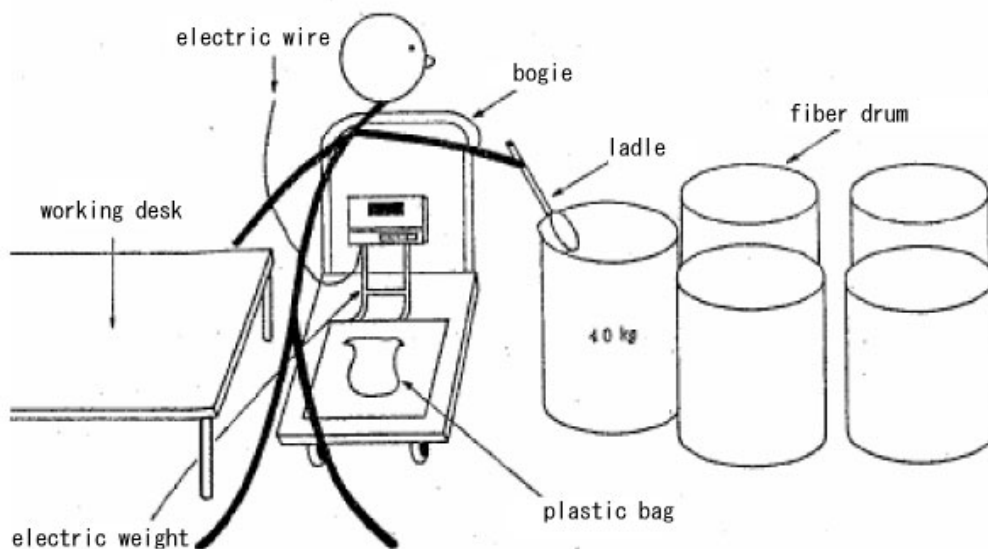
Fig.1 explanation of sub - division work

A combustible gas-air mixture was generated by evaporation of methanol that remained in the BPO product contained in the fiber drum. The combustible gas-air mixture was thought to have been ignited by electrostatic discharge of subdividing operators. Then the fire spread to BPO powder that was in a floating state in the fiber drum, and next, it was estimated that the BPO powder exploded. In addition, the explosion spread to other BPO in the subdivision room. An operator saw the first fire.

Another possible cause of the explosion was that BPO dust or BPO decomposed gas that was generated by friction filled the room and was ignited by an electrical spark due to breakage of a fluorescent lamp. There is a possibility that some BPO spilled while being transported to the subdivision room and that the BPO got into the bearings

of the dolly, where it was decomposed by friction. However, the damage of fluorescent lamps that was observed after the accident might have been a result of the explosion.
