Explosion of Methanol Distillation Column of Detergent Manufacturing Plant

【June 26th, 1991 Ichihara, Chiba, Japan】

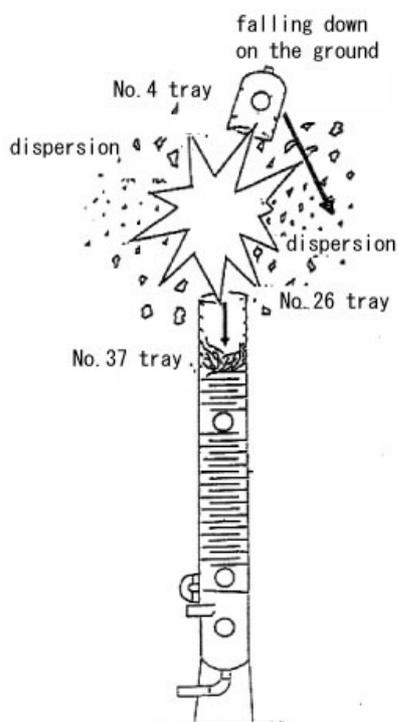
Fig.2 damage of the reactor

The elucidation of the cause was difficult. At first, the facts related to the column where the accident occurred were arranged in the usual way. At this point, it was noticed that the scattered fragments had come from only the upper part of the column, from around the fourth tray to the 26th tray from the top. In addition, the time course of the entire operation was arranged.

Here, the damage to the methanol rectifying column is shown in Fig.2 and the photograph of the column after the accident is shown in Fig.3.

In addition, the explosion pressure was estimated to be 16 MPa at the center of the explosion and 11 MPa at the lower part of the explosion, and the TNT equivalent of the explosion was judged to be 10 to 50 kg.

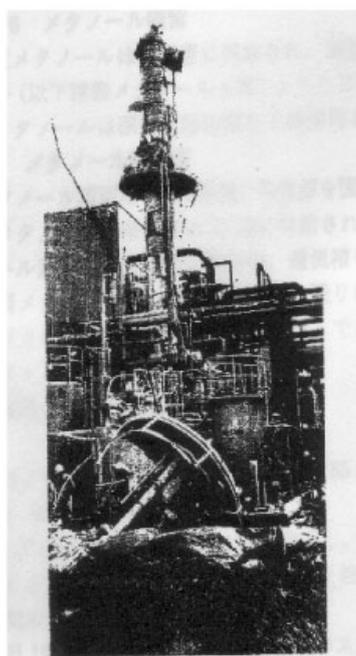
Fig.3 Rectifying column photo after explosion

At around 10:15, an explosion occurred in the upper part of the methanol rectifying column. The upper part of the column and the ancillary piping fractured, and the fractured parts were scattered by the explosion. Simultaneously, a fire occurred near the column by methanol.

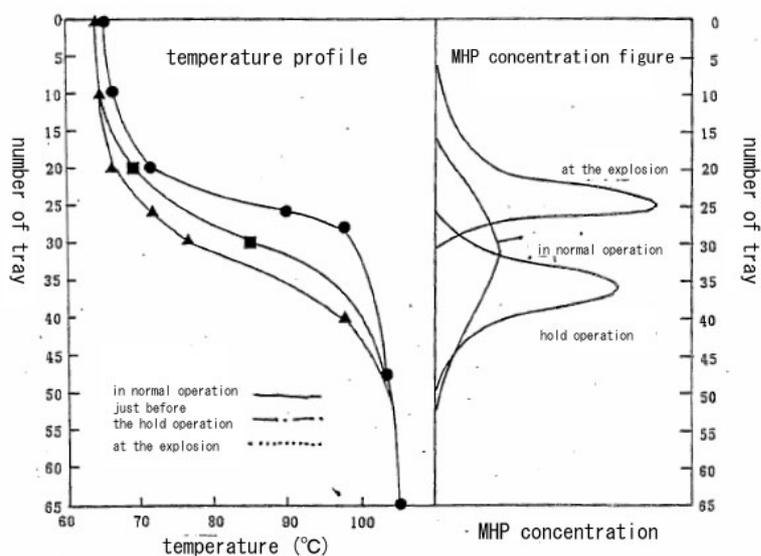
Fig.4 relation between MHP concentration and temperature profile in the column

When the distillation was simulated in the MHP-methanol-water system, the simulation result showed that MHP is concentrated in the column and reaches concentrations of over 10% in the total reflux operation or the high reflux ratio operation. When the rectifying column was checked, discoloration of column material was observed. The discoloration seemed to be caused by MHP, and the position of the discoloration accorded almost exactly with the place where the MHP concentration was highest in the simulation. The concept is shown in Fig.4.

- 2) In the distillation of a multi-component system that includes a middle fraction, the middle fraction can be concentrated to unexpectedly high concentration level as shown Fig.4 during the total reflux operation when the distillate is not rundown outside. It is necessary to sufficiently understand this fact.

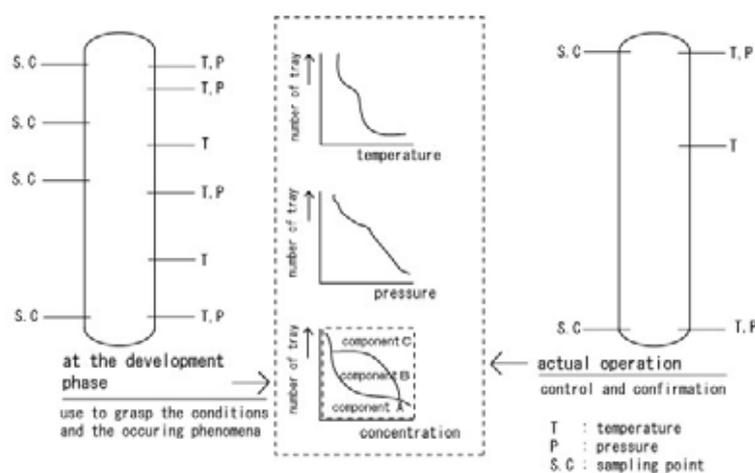
Fig.5 difference between the measuring points at the development phase of the new technology and the measuring points at commercial plant

- 1) In the development of a new process, the safety measures might not be sufficient even if sufficient examination and analysis is performed. Based on the issues mentioned above, it is necessary to thoroughly investigate and examine each of the reactions and physical properties involved in the process. At that the time, it is also necessary to consult with the specialists from outside of the company. Some phenomena only become known after performing continuous operation in a large-scale plant. In order to prepare for unexpected phenomena, it is desirable to mount many sampling points and measuring instruments, which may appear to be unnecessary at first.
