Fire and Explosion of LPG Tanks at Feyzin, France

【January 4th, 1966 Feyzin, France】

Mitsuo Kobayashi (Graduate School of New Frontier Sciences, University of Tokyo)

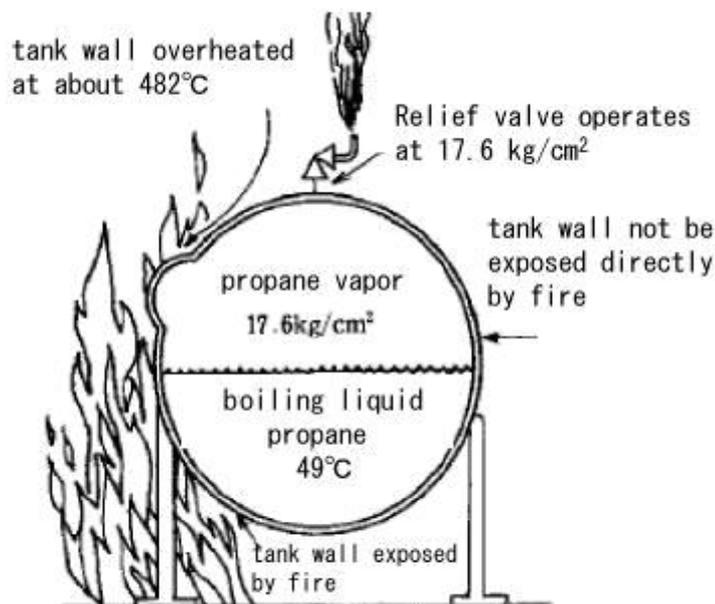
The BLEVE phenomenon that occurs in the LPG tank was shown in Fig.1. First,

a fire was generated under the spherical tank. The LPG in the tank was heated, and the tank internal pressure rose. The LPG vapor was discharged to the atmosphere when the internal pressure rose above the setting pressure of the safety relief valve, and this vapor caught fire. The surface of the wall above the liquid level was strongly heated, causing the strength of the wall to deteriorate. Finally, the wall ruptured under the internal pressure. As a result of the rupture, the pressure inside the tank dropped to atmospheric pressure instantaneously, and the BLEVE phenomenon happened. The large vapor that resulted became an enormous fireball.

Fig.1 Explanation of BLEVE

The explosion of the tank is explained by the BLEVE phenomenon, which has already been introduced (Refer to Fig.1). The accident at Feyzin is the first one that has been explained by the BLEVE phenomenon.

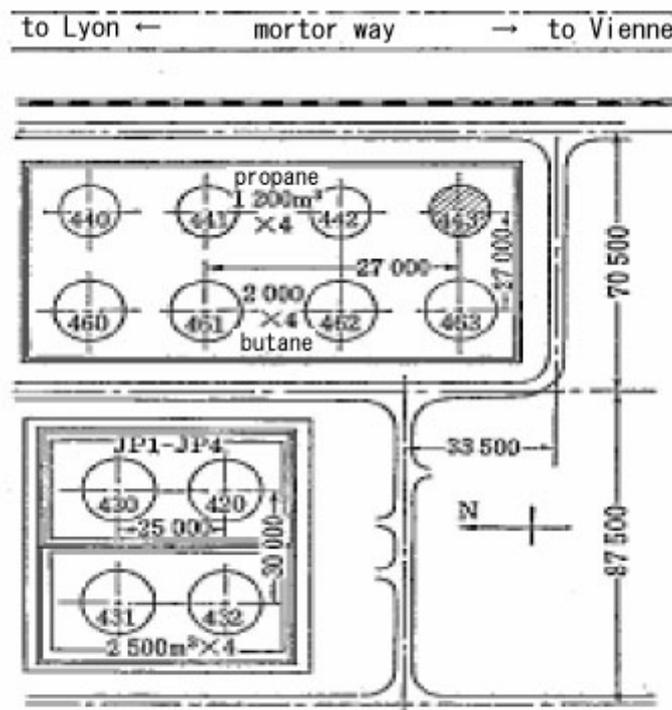
Fig. 2 location of the spherical tanks

It is presumed that the leaked LPG spread along the ground and was ignited by a car that was driving down the local road. The propane vapor was thought to have been ignited by a cigarette of the driver or the high temperature of the engine of the car that had just stopped.

Although the direct cause of the ignition is that the stopping of the traffic was delayed, the fundamental problem seems to be the layout of the area. The construction of the highway had been permitted with only a distance of slightly over 50m from the group of enormous LPG tanks. Moreover, from the photographs, it

appears that there was no dike around the LPG tanks. In this situation, when a large amount of LPG leaked, the LPG vapor flows along the ground to the highway. The main causes of the ignition are that the distance regulation was insufficient and there was no dike around the tanks.

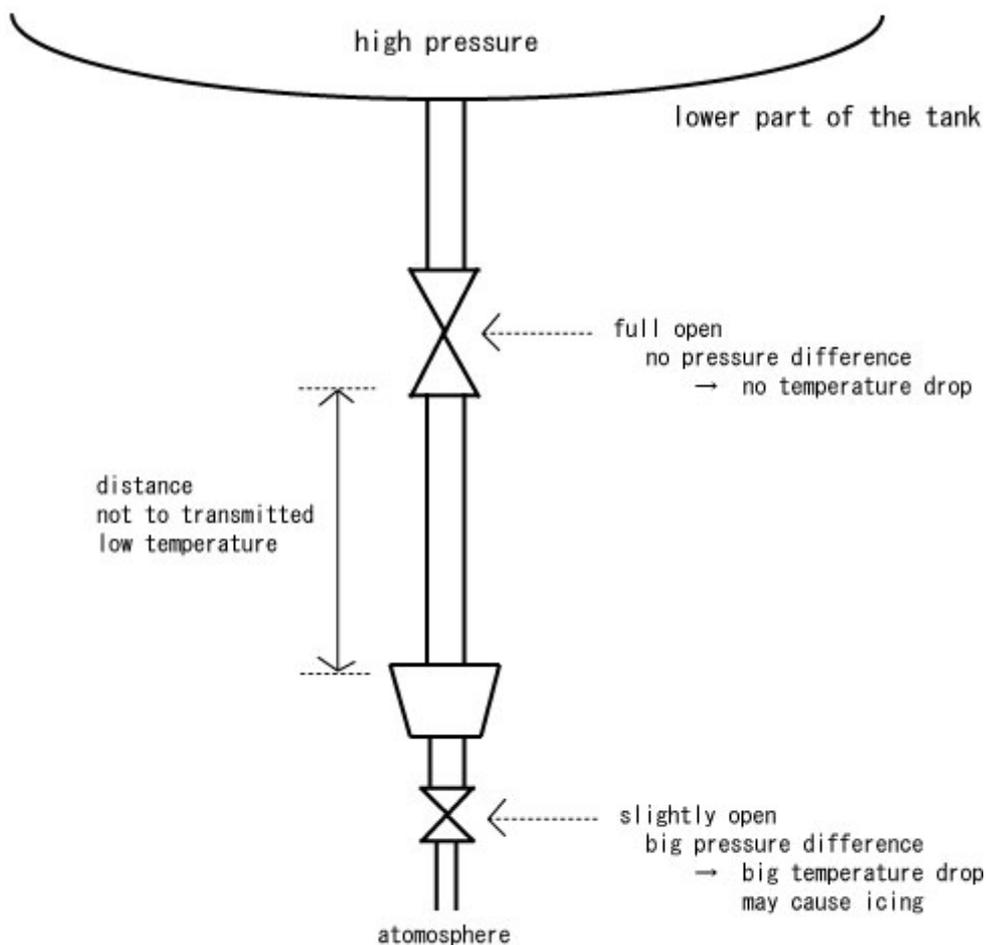
It seems that the leakage was caused by the freezing of the valve by the drain work. However, the freezing is a result and not a cause in fact. For LPG, in this case propane, the temperature drops to -40 if the pressure is lowered to atmospheric pressure. At this temperature, not only is the moisture in the air frozen, but the moisture also reacts with LPG, forming a solid hydrate. The hydrate formation does

not require an extremely low temperature. Apparently, either the valve handle was stuck by the frozen moisture or the valve could not be closed tightly as a result of the hydrate formation.

Considering the possibility of ice formation, usually two drain valves and sampling valves are mounted on the bottom of LPG tanks in series. An example of this situation is shown in Fig.3. The usual operation for opening the valves at the beginning of use is as follows. First, the upstream valve is opened fully, and the inlet side of the downstream valve is pressurized. Next, the downstream valve is gradually opened starting from the slight open, adjusted to create the necessary flow rate. Because the downstream valve inlet is pressurized, the temperature at upstream valve does not drop. The outlet side of the downstream valve is cooled under the operation, and it is also important to ensure that there is sufficient distance so that the upstream valve does not drop to a low temperature. This accident was believed to have been caused as follows: the upstream valve was not opened fully and the pressure at the outlet of the first valve was near the atmospheric pressure, so the upstream valve was cooled by the pressure difference. It is absolutely forbidden to operate valves like this. Therefore, the cause of the accident is either the operator's human error or a mistake on the management side in not to explaining the meaning and proper execution of the operation.

Moreover, another one of the causes is that the operator did not close the downstream valve. There is not a clear description of why this valve was not closed. It is presumed that either ice was generated in the downstream valve like in the upstream valve or a rapid large LPG leak occurred at the end of drain work. If a large LPG leak occurred, the operators may have panicked when they could not close the upstream valve and therefore may have not remembered to close the downstream valve. Basically they had to decrease the downstream valve opening when the LPG began to appear in the drain water. Then the valve could have been closed quickly at the end of drain work. Either they forgot to carry out this procedure or they could not close the second valve because it had also become stuck by freezing.

Fig. 3 image of open drain valve

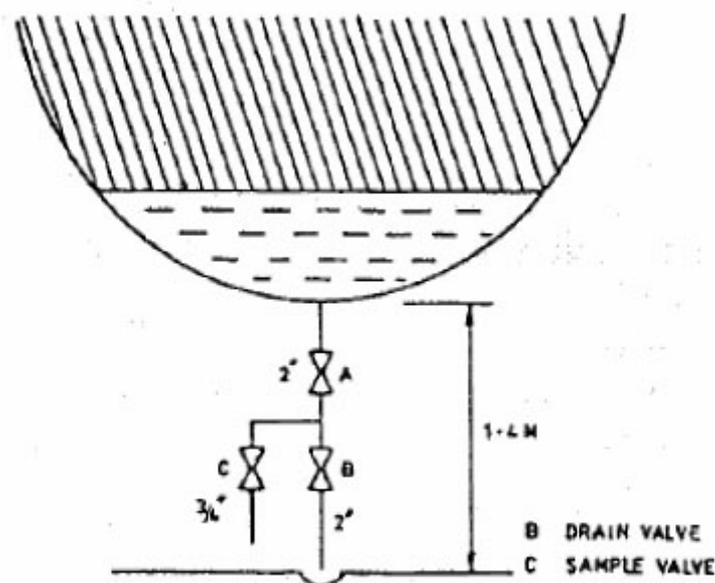
Fig.4 valve structure of the tank

a) Generally, redundant sampling valves and drain valves are installed in series. In the tank involved in this accident, the double valve was already installed. In the LPG tank, doubling of the drain valves is a minimum requirement. The reason why the double valve is a necessary choice is that in the case of a single valve, there is a strong possibility that the valve main body will be cooled, hurting the closeout function of the valve by icing of the water in the air, generation of the hydrates, and other factors. Moreover, the distance between the two valves should be sufficiently long so that the low temperature of the second valve will not affect the first valve. The size of the second valve should be 1/2 inches or less for sampling and as small as possible for draining work. Fig.4 shows the composition of the draining and sampling valves of the tank where the accident occurred. It is desirable that a distance of 1m or more should be kept between valve A and valve B and between valve A and valve C. Also, the size of valve B should be 3/4 inches or less.

b) Adequate education and training of the use of double valves is necessary. The operation described below has to be done completely: the first valve must be opened fully and flow adjustment must be done only with the second valve, because the temperature of the first valve must not drop. The reason is shown in the "Cause" section. Also, a thorough monitoring of the draining work should be attempted.
